Greenwich Hospital Redevelopment

Stage 1 - Early Works

DILAPIDATION REPORT

10th September 2024

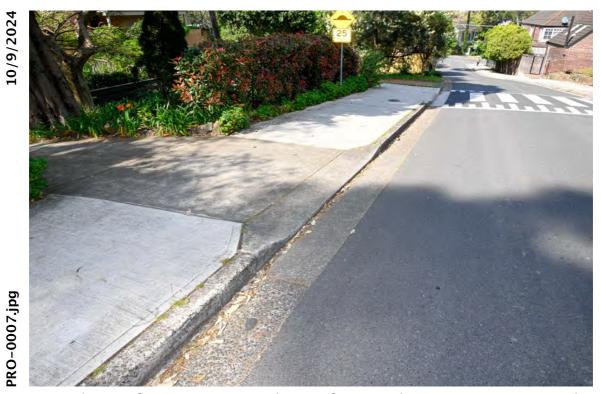
Hospital access from St Vincents Road. Area of power pole no. GL72349. Eastern side of the road. Heading south. Damaged road and gutter.

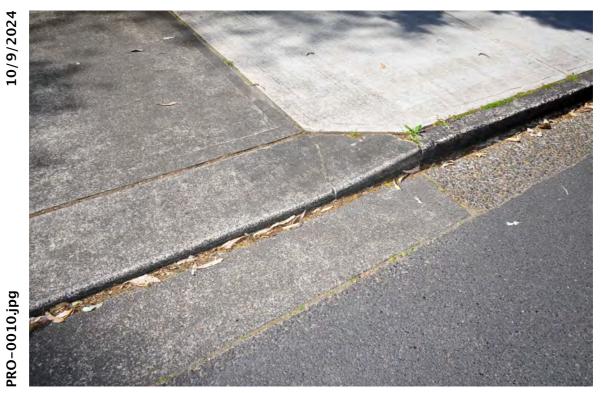
Hospital access from St Vincents Road. Area of power pole no. GL72349. Eastern side of the road. Heading south. Crossover to 18 St Vincents Road. Cracked shoulder of the layback.

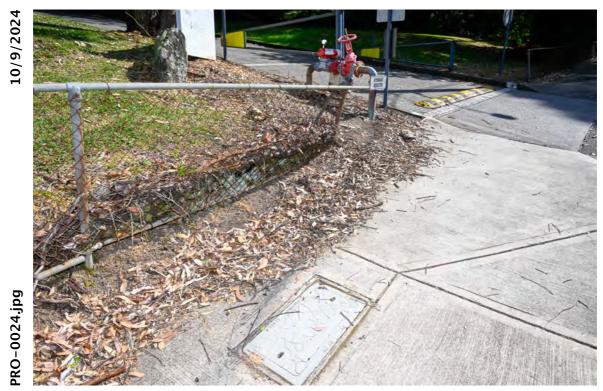
Hospital access from St Vincents Road. Western side of the road. Area of the pedestrian crossing. Damaged fencing.

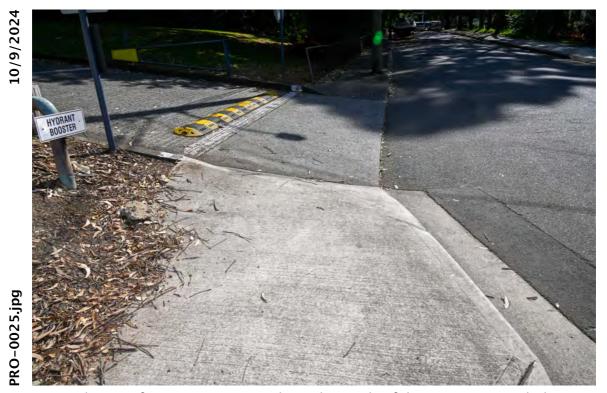
Hospital access from St Vincents Road. Western side of the road. Area of the pedestrian crossing. Damaged fencing.

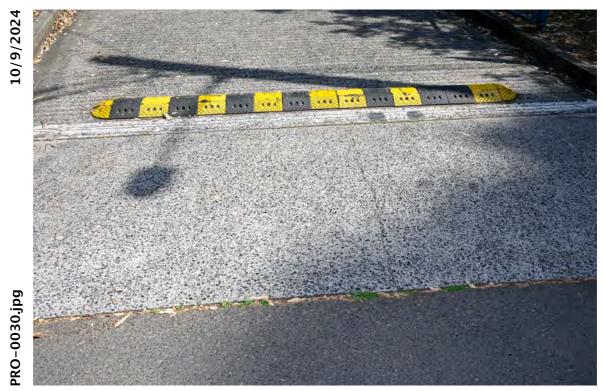
Hospital access from St Vincents Road. Intersection with the access road. Cracked paving.

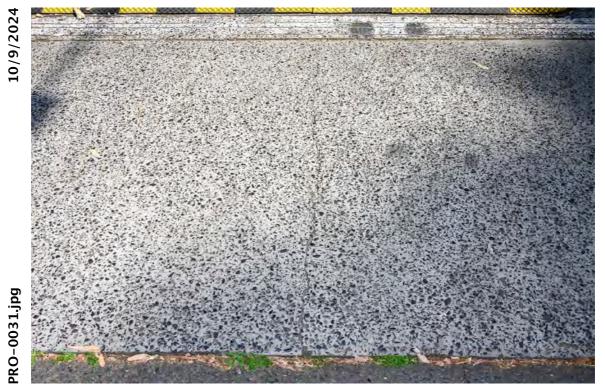
Hospital access from St Vincents Road. Intersection with the access road. Cracked paving.

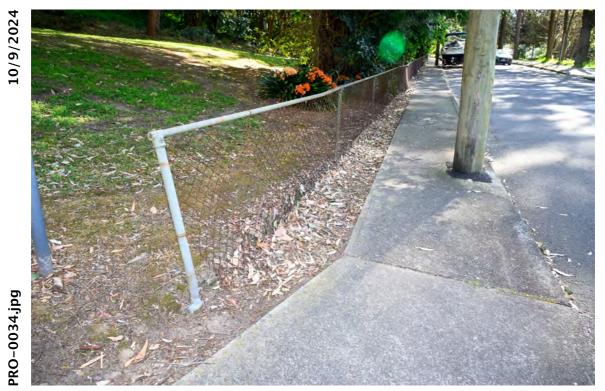
Hospital access from St Vincents Road. Northern side of the intersection with the access road. Damaged fencing. Area of power pole no. GL72349.

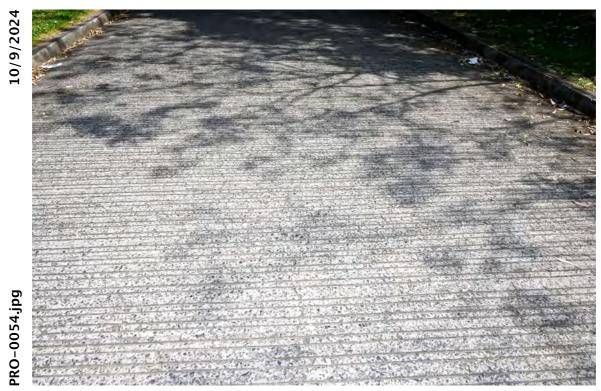
Hospital access road from St Vincents Road. Heading west / uphill towards Pallister House. Cracked paving.

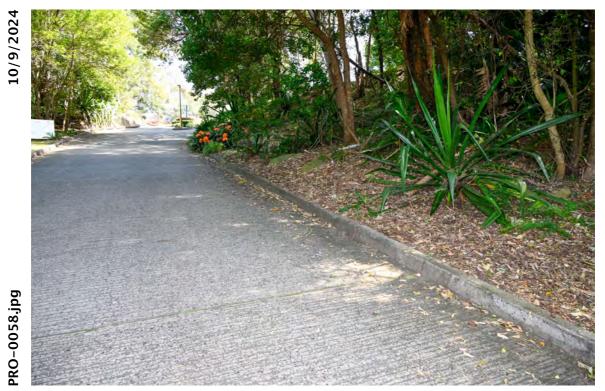
Hospital access road from St Vincents Road. Heading west / uphill towards Pallister House. Cracked paving.

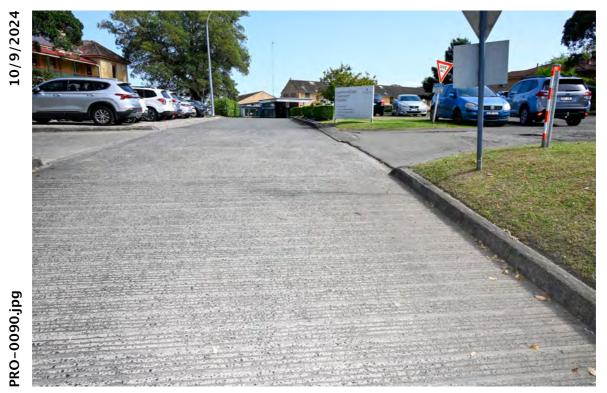
Hospital access road from St Vincents Road. Heading west / uphill towards Pallister House. Damaged PVC drain pipe.

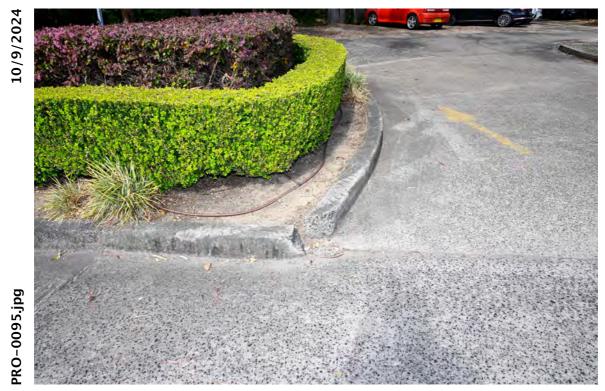
Hospital access road from St Vincents Road. Access / exit to Pallister House. Damaged kerb.

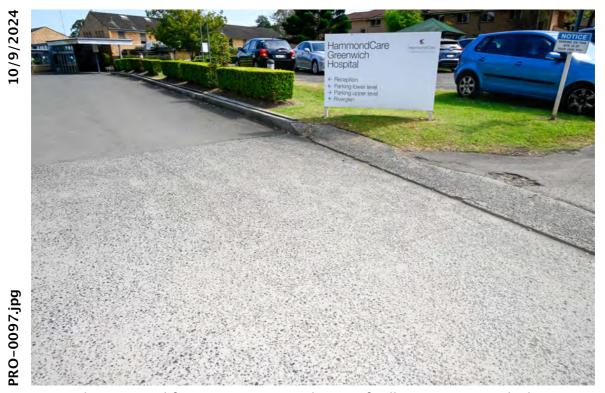
Hospital access road from St Vincents Road. Area of Pallister House. Cracked paving.

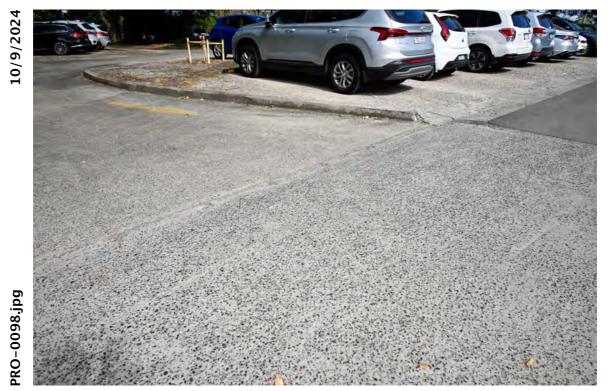
Hospital access road from St Vincents Road. Area of Pallister House. Cracked paving.

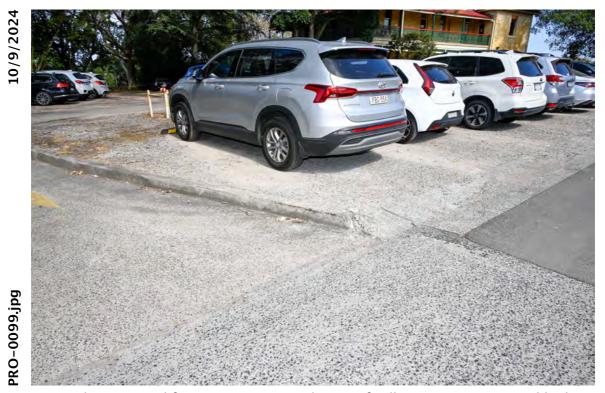
Hospital access road from St Vincents Road. Area of Pallister House. Damaged kerb.

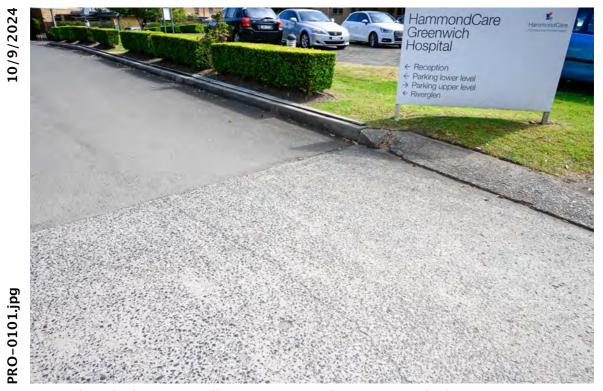
Internal road adjacent to Pallister House. Heading west. Cracked paving.

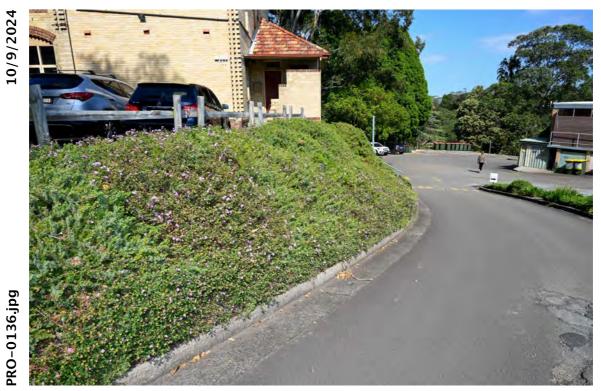
Internal road between Pallister House and 'Health & Care'. Heading south-west / downhill. Damaged road paving. Area of proposed road works.

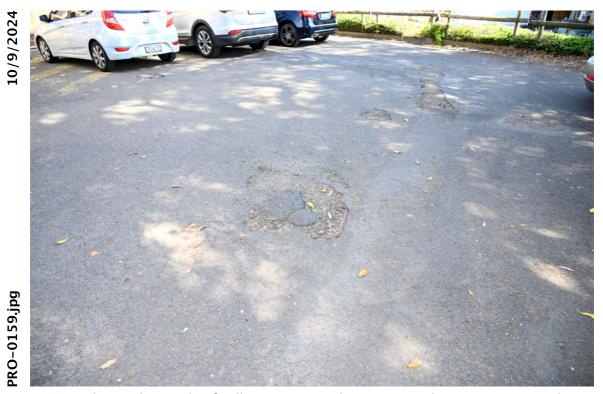
Area on the northern side of Pallister House. Adjacent car parking area. Damaged paving.

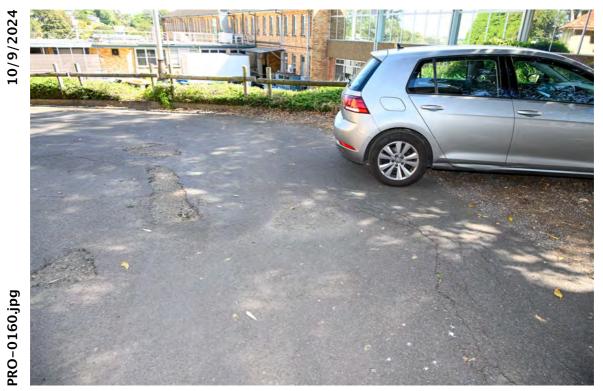
Area on the northern side of Pallister House. Adjacent car parking area. Damaged paving.

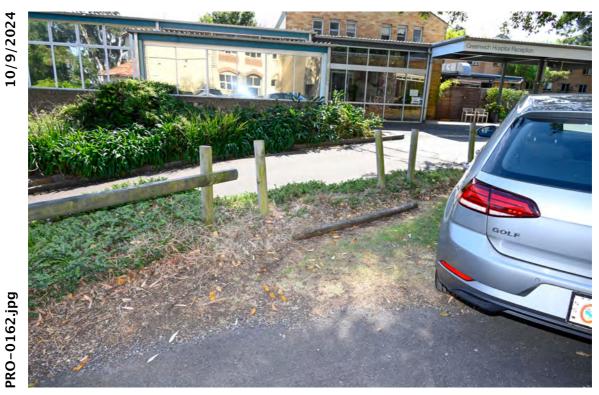
Area on the northern side of Pallister House. Adjacent car parking area. Damaged timber barricades.

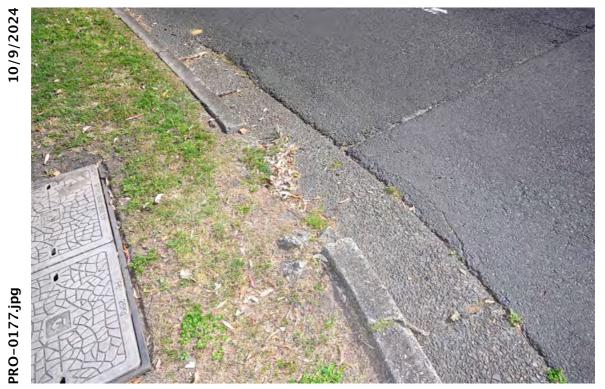
Hospital access from River Road. Area of the proposed substation works. Western side of the intersection. Heading west. Area of the 'Sprinkler Booster'. Damaged kerb.

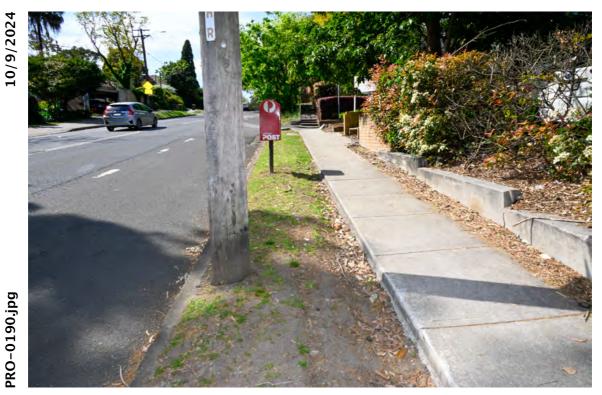
Hospital access from River Road. Area of the proposed substation works. Western side of the intersection. Heading east. Area of the 'Sprinkler Booster' and power pole no. GL72380. Damaged retaining wall.

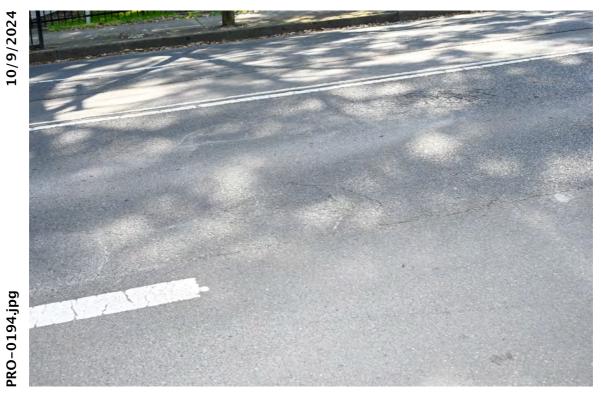
Hospital access from River Road. Area of the proposed substation works. Western side of the intersection. Heading east. Area of the 'Sprinkler Booster' and power pole no. GL72380. Cracked and crazing road paving.

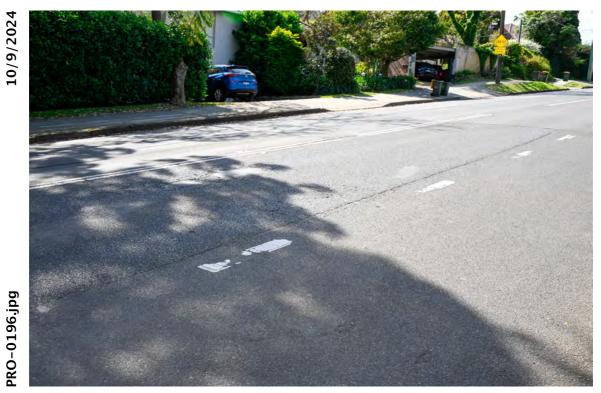
Hospital access from River Road. Area of the proposed substation works. Western side of the intersection. Heading east. Area of the 'Sprinkler Booster' and power pole no. GL72380. Cracked and crazing road paving.

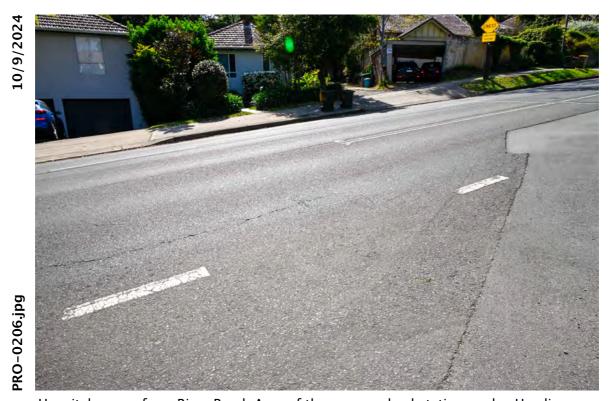
Hospital access from River Road. Area of the proposed substation works. Heading east. Cracked road paving.

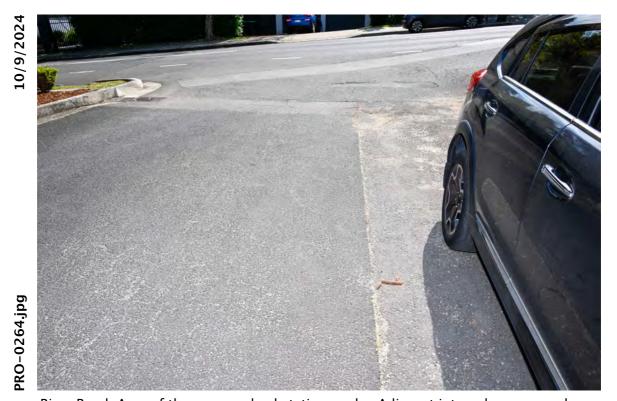
River Road. Area of the proposed substation works. Adjacent internal access road. Heading north towards River Road. Cracked and crazed road paving.

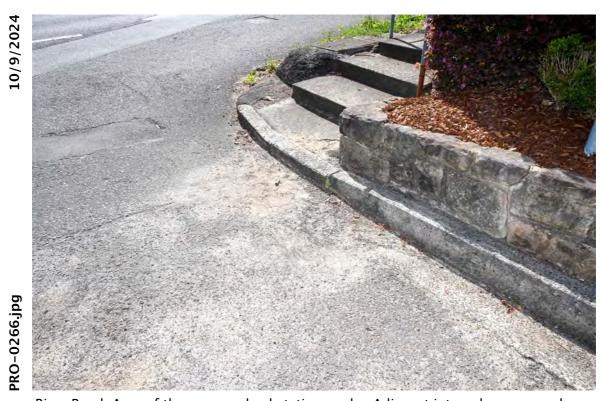
River Road. Area of the proposed substation works. Adjacent internal access road. Heading north towards River Road. Sediment on the road way.

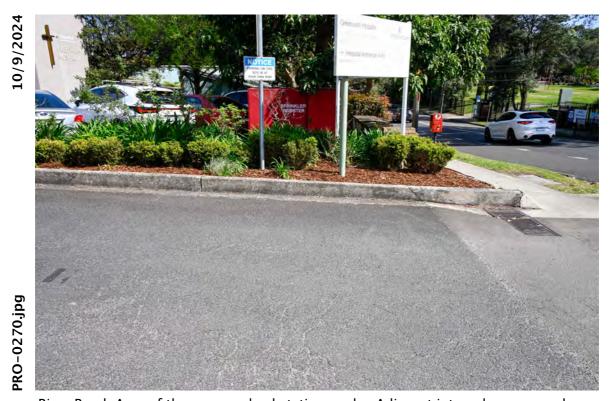
River Road. Area of the proposed substation works. Adjacent internal access road. Heading north towards River Road. Cracked paving.

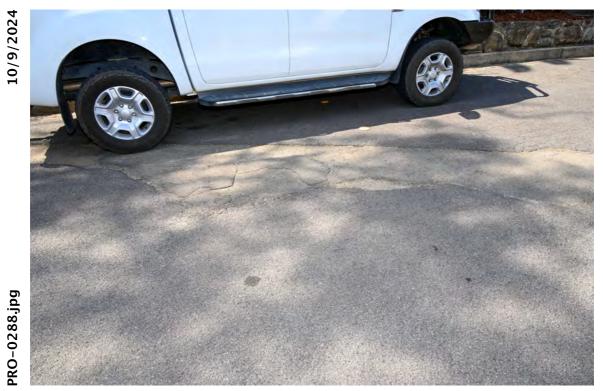
Internal access road from River Road. Heading south approaching the overhead walkway. Damaged road paving.

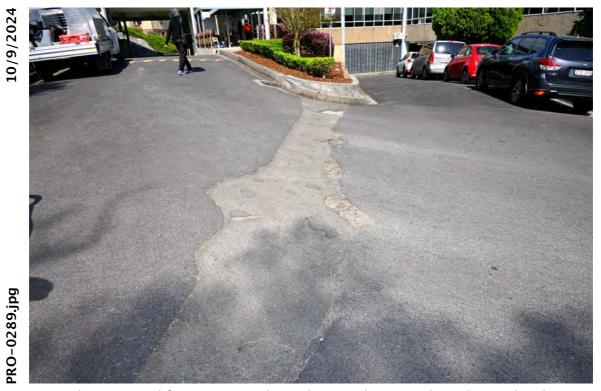
Internal access road from River Road. Heading south approaching the overhead walkway. Damaged road paving.

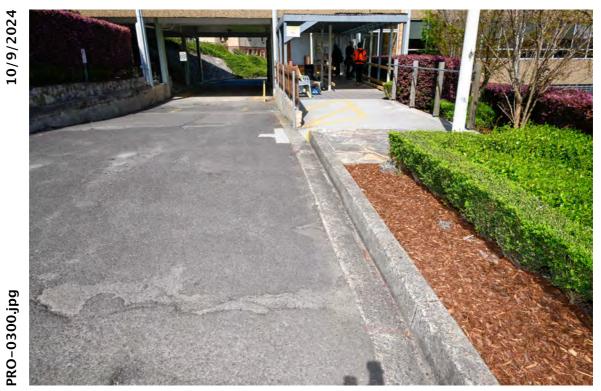
Internal access road from River Road. Heading south approaching the overhead walkway. Damaged road paving.

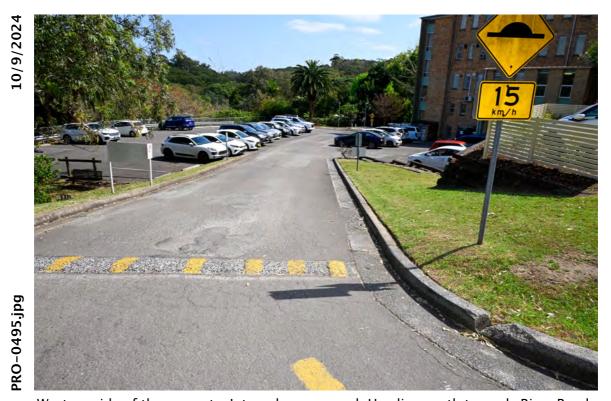
Western side of the property. Internal access road. Heading north towards River Road. Damaged road paving.

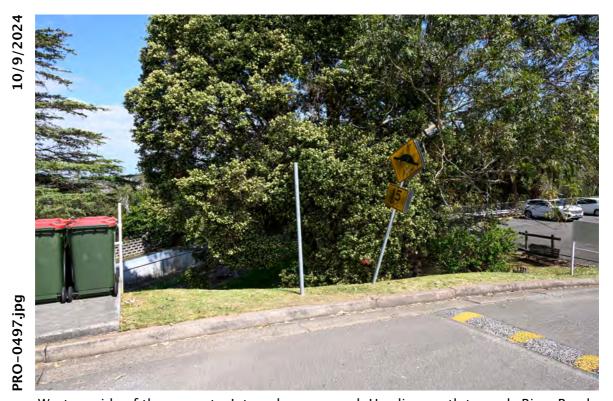
Western side of the property. Internal access road. Heading north towards River Road. Lean on the street sign.

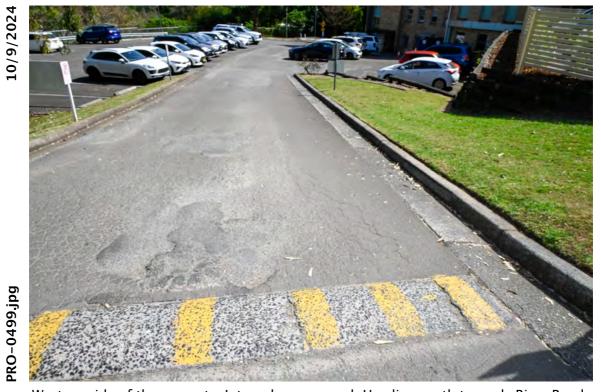
Western side of the property. Internal access road. Heading north towards River Road. Damaged road paving.

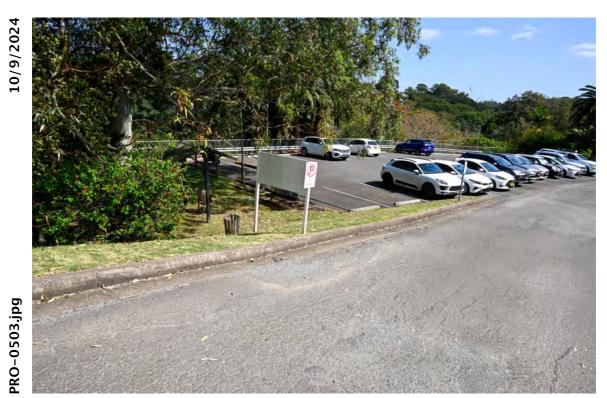
Western side of the property. Internal access road. Heading north towards River Road. Damaged road paving.

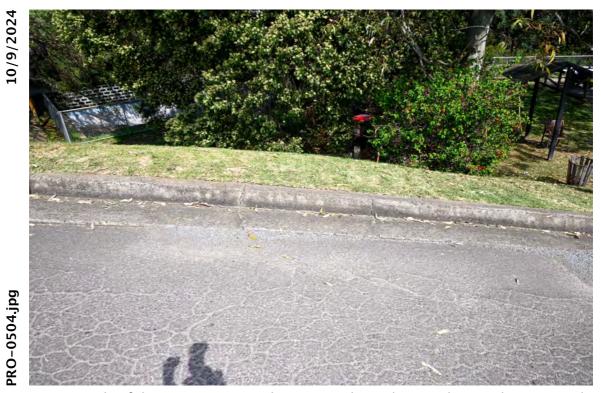
Western side of the property. Internal access road. Heading north towards River Road. Damaged road paving.

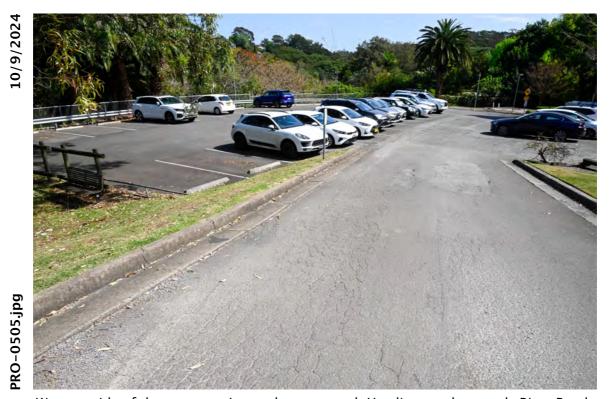
Western side of the property. Internal access road. Heading north towards River Road. Damaged road paving.

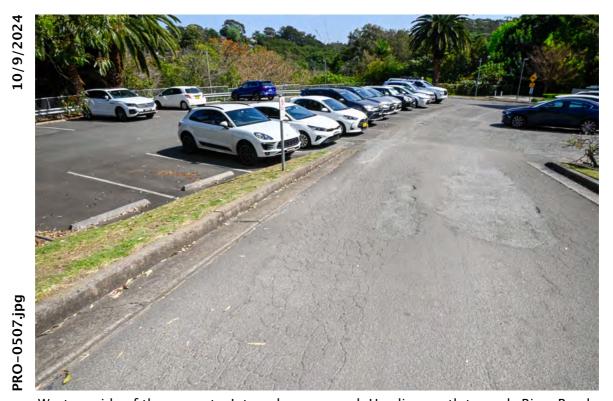
Western side of the property. Internal access road. Heading north towards River Road. Damaged road paving.

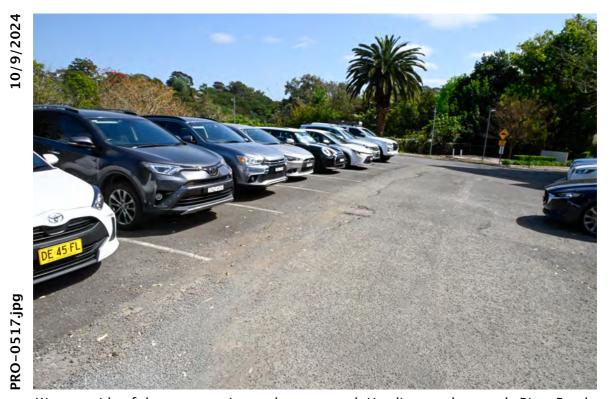
Western side of the property. Internal access road. Heading north towards River Road. Damaged road paving.

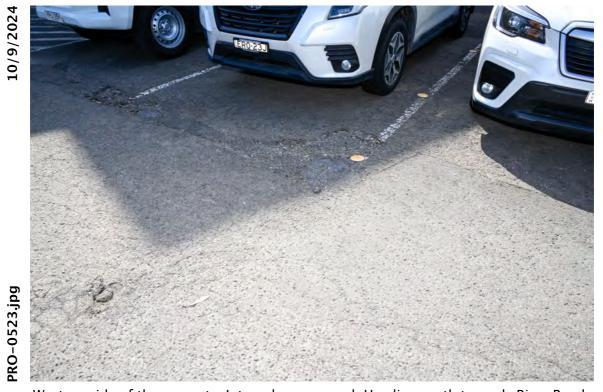
Western side of the property. Internal access road. Heading north towards River Road. Damaged road paving.

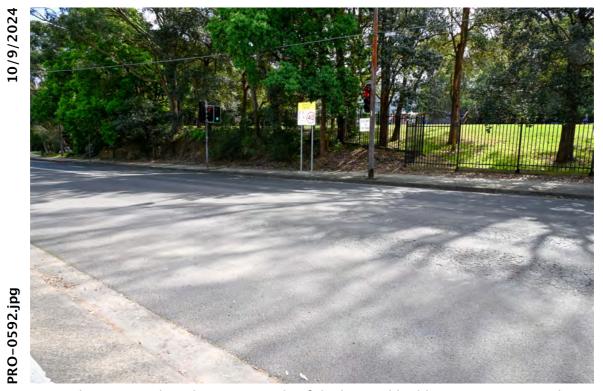
Internal access road on the western side of the hospital building. Intersection with River Road. Cracked and crazed road paving.
