Greenwich Hospital Redevelopment

Stage 1 - Early Works

DILAPIDATION REPORT

10th September 2024

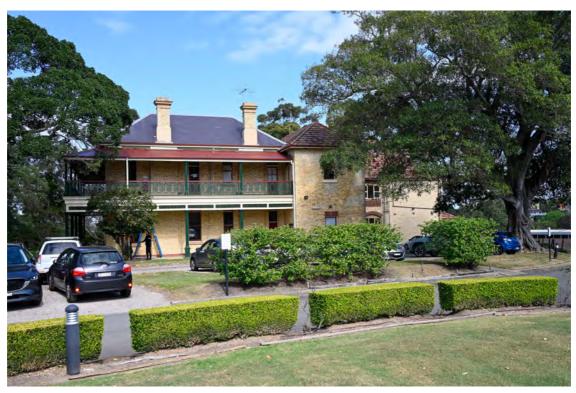
PRO-0002.jpg

Hospital access from St Vincents Road. Power pole no. GL72349. Facing west from the eastern side of the road.

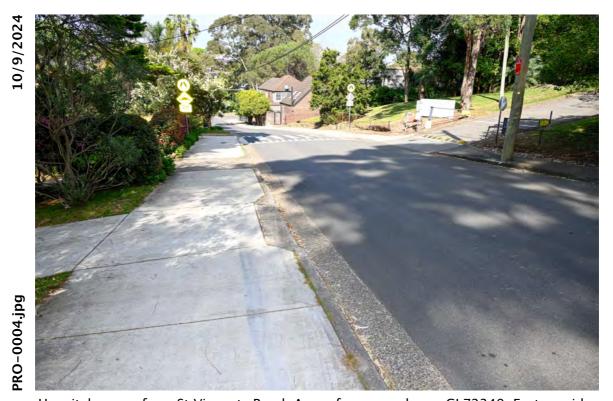
Hospital access from St Vincents Road. Area of power pole no. GL72349. Eastern side of the road. Heading south.

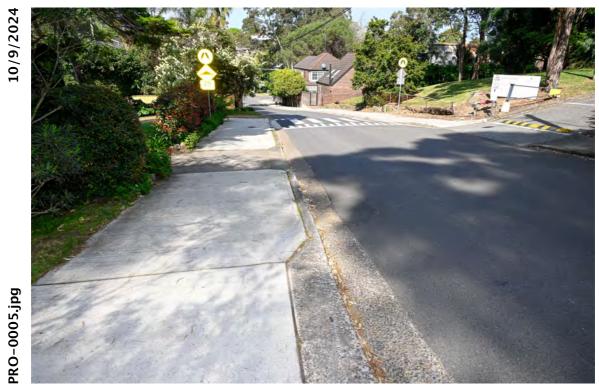
Hospital access from St Vincents Road. Area of power pole no. GL72349. Eastern side of the road. Heading south.

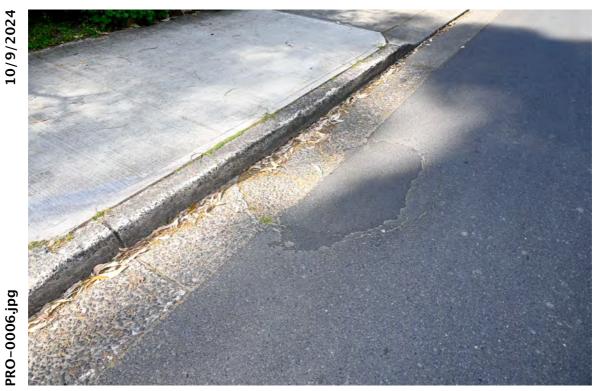
Hospital access from St Vincents Road. Area of power pole no. GL72349. Eastern side of the road. Heading south. Damaged road and gutter.

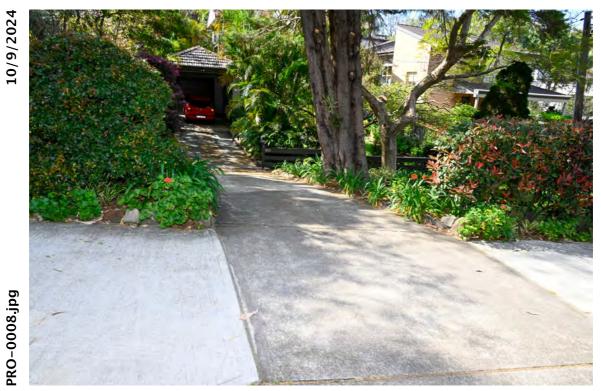
Hospital access from St Vincents Road. Area of power pole no. GL72349. Eastern side of the road. Heading south. Crossover to 18 St Vincents Road.

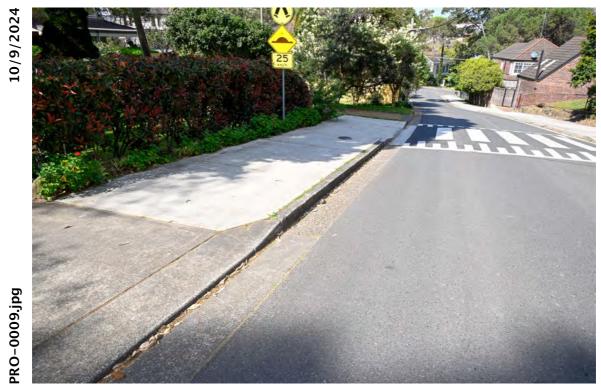
Hospital access from St Vincents Road. Area of power pole no. GL72349. Eastern side of the road. Heading south. Crossover to 18 St Vincents Road.

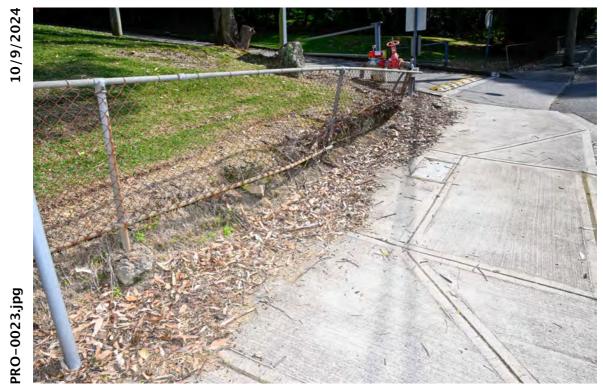
Hospital access from St Vincents Road. Western side of the road. Area of the pedestrian crossing. Damaged fencing.

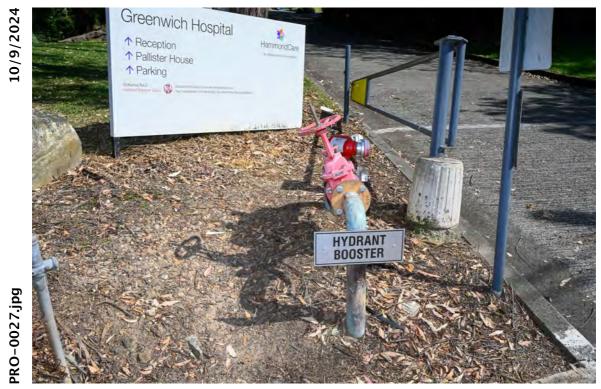
Hospital access from St Vincents Road. Southern side of the intersection with the access road. Hydrant Booster.

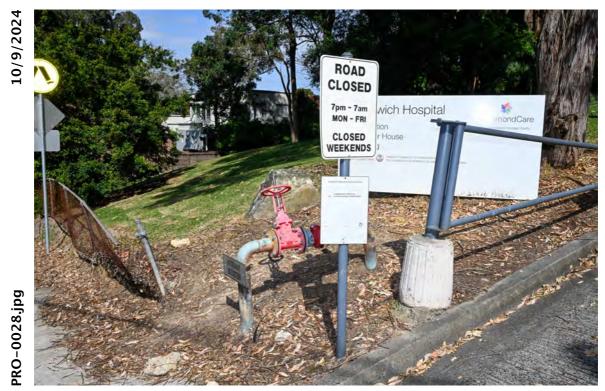
Hospital access from St Vincents Road. Southern side of the intersection with the access road. Hydrant Booster.

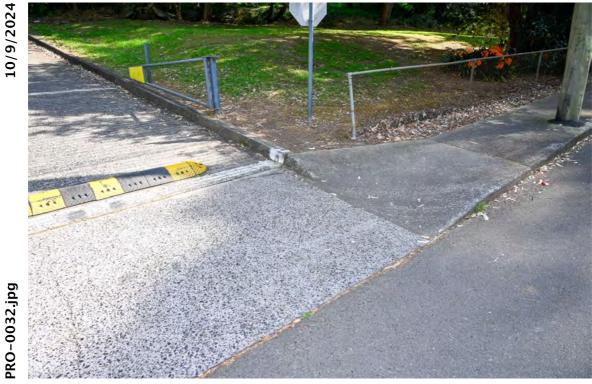
Hospital access from St Vincents Road. Intersection with the access road. Cracked paving.

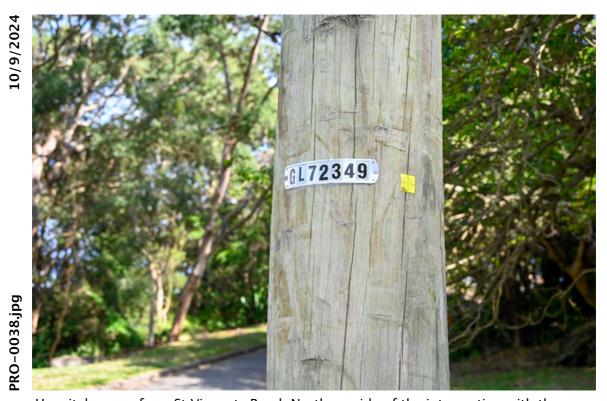
Hospital access from St Vincents Road. Northern side of the intersection with the access road. Power pole no. GL72349.

Hospital access from St Vincents Road. Northern side of the intersection with the access road. Power pole no. GL72349. Chipped kerb.

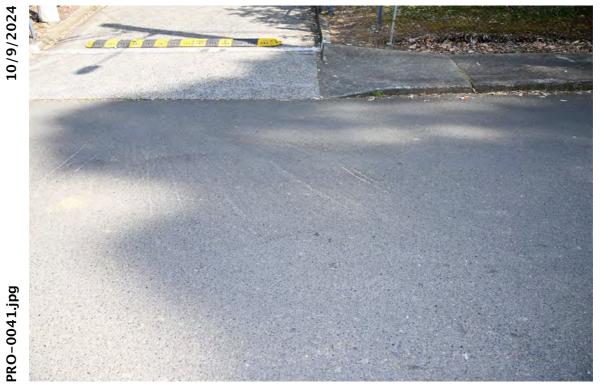
Hospital access from St Vincents Road. Intersection with the access road. Gouges in the road paving.

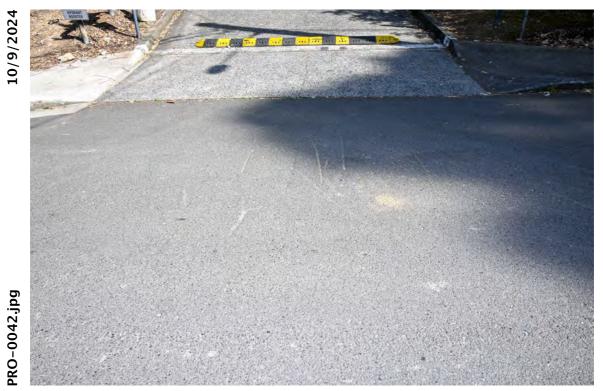
Hospital access from St Vincents Road. Intersection with the access road. Gouges in the road paving.

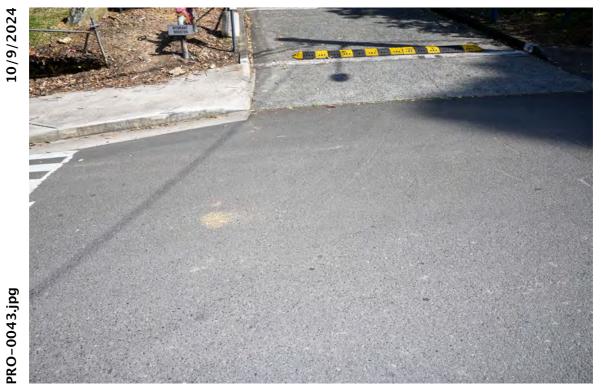
Hospital access from St Vincents Road. Intersection with the access road. Gouges in the road paving.

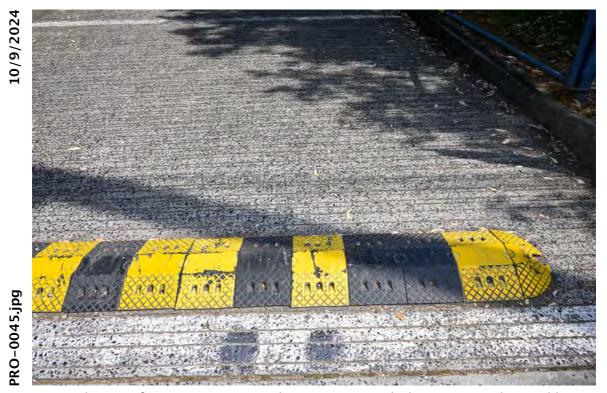
Hospital access from St Vincents Road. Intersection with the access road. Speed hump.

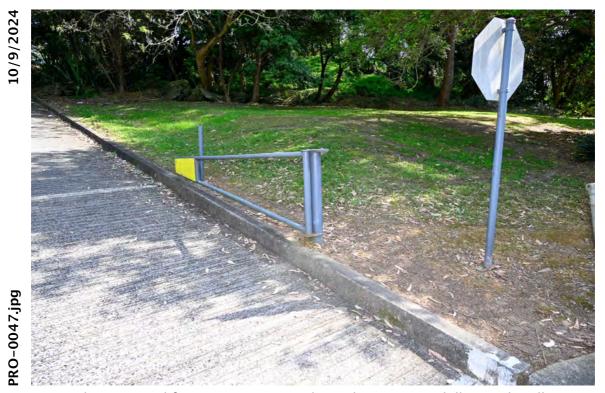
Hospital access road from St Vincents Road. Heading west / uphill towards Pallister House. Gates.

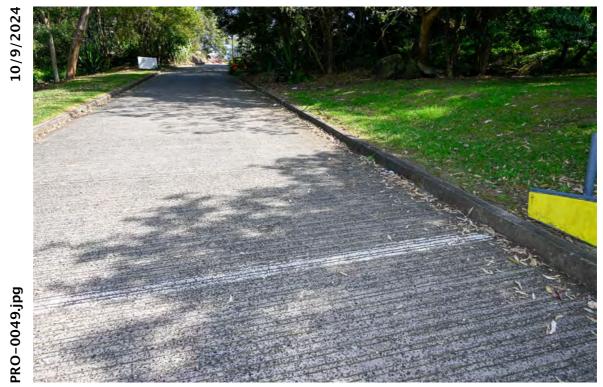
Hospital access road from St Vincents Road. Heading west / uphill towards Pallister House.

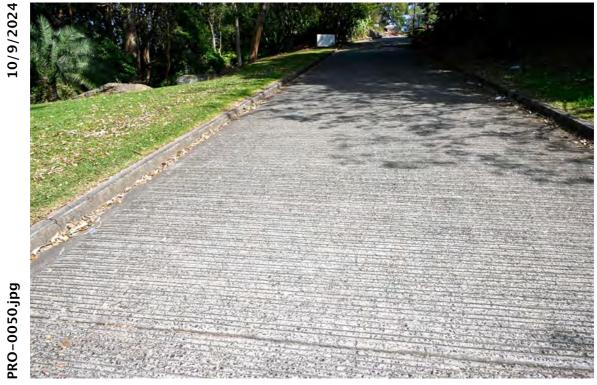
Hospital access road from St Vincents Road. Heading west / uphill towards Pallister House.

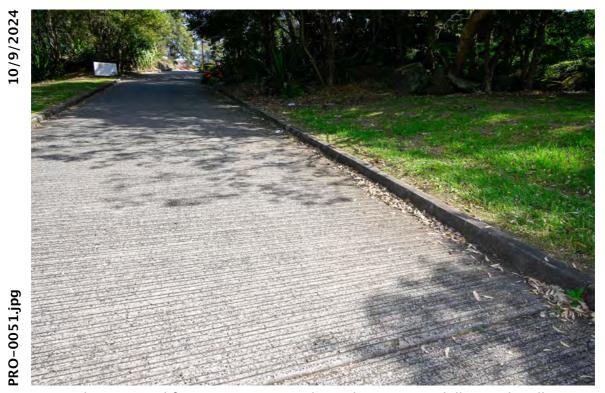
Hospital access road from St Vincents Road. Heading west / uphill towards Pallister House.

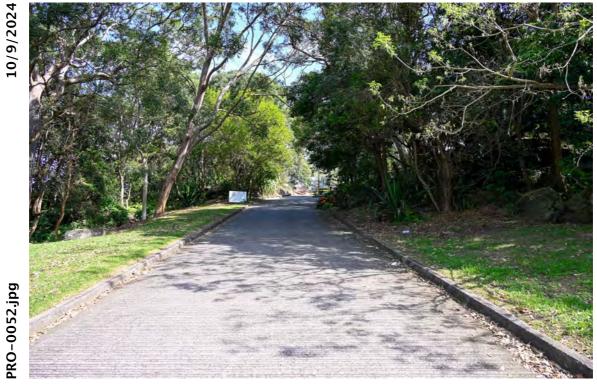
Hospital access road from St Vincents Road. Heading west / uphill towards Pallister House.

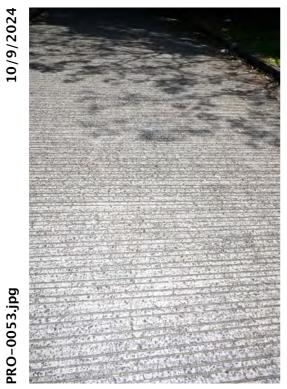
Hospital access road from St Vincents Road. Heading west / uphill towards Pallister House.

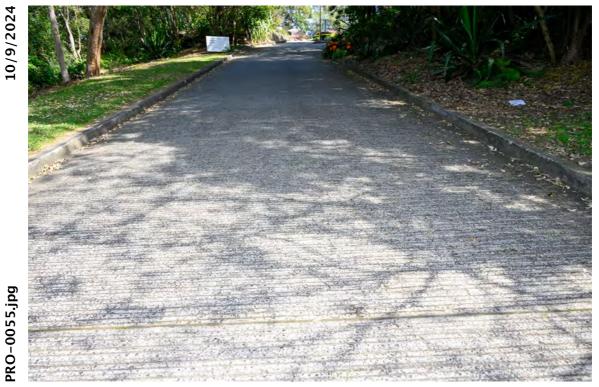
Hospital access road from St Vincents Road. Heading west / uphill towards Pallister House. Cracked paving.

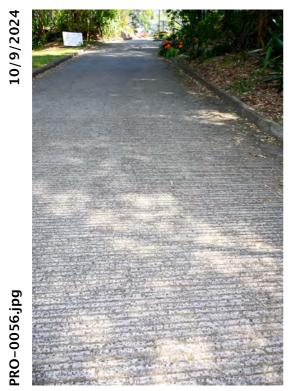
Hospital access road from St Vincents Road. Heading west / uphill towards Pallister House. Cracked paving.

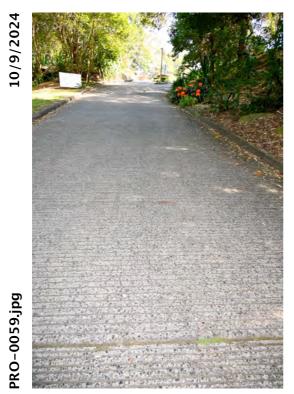
Hospital access road from St Vincents Road. Heading west / uphill towards Pallister House. Cracked paving.

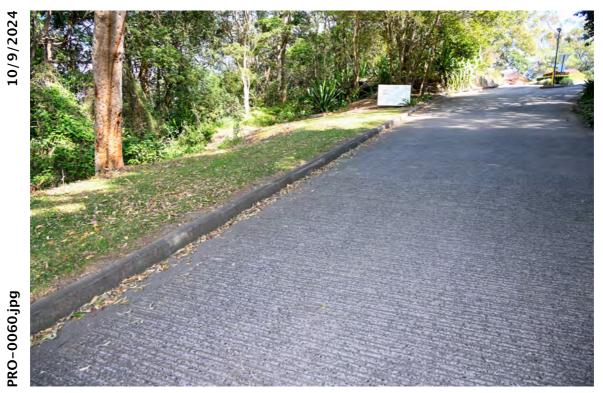
Hospital access road from St Vincents Road. Heading west / uphill towards Pallister House. Cracked paving.

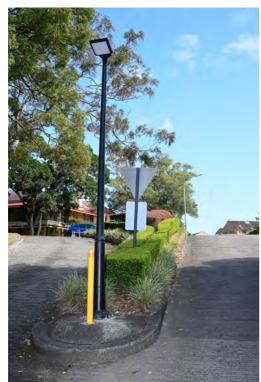
PRO-0075.jpg

Hospital access road from St Vincents Road. Heading west / uphill towards Pallister House.

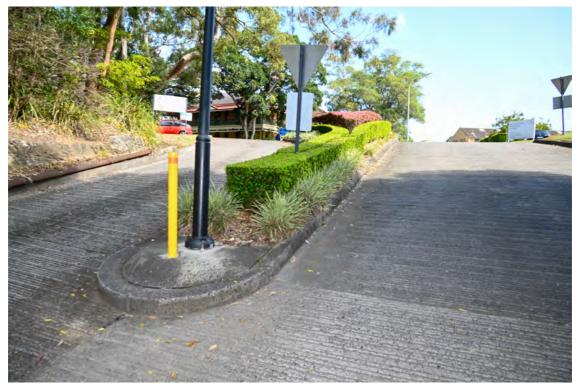
PRO-0077.jpg

Hospital access road from St Vincents Road. Heading west / uphill towards Pallister House. Light pole and bollard.

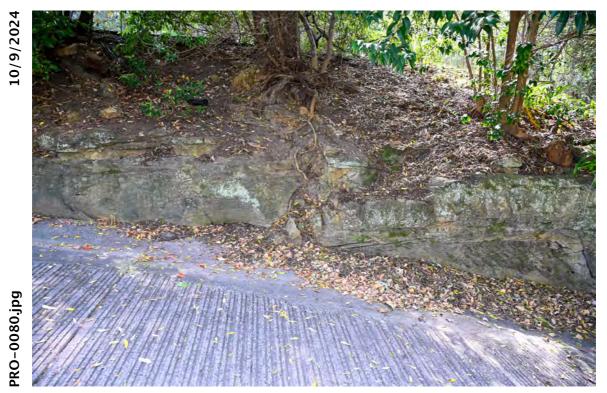
Hospital access road from St Vincents Road. Heading west / uphill towards Pallister House. Rock face on the northern side of the road.

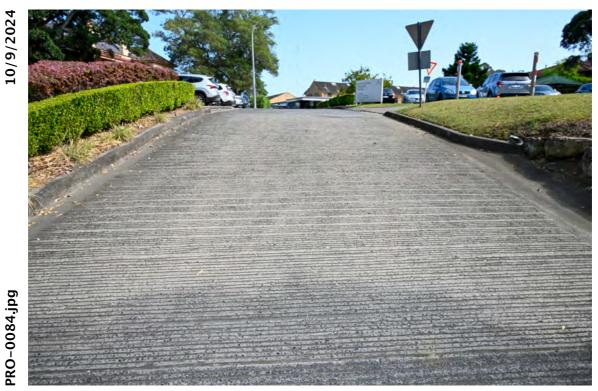
Hospital access road from St Vincents Road. Heading west / uphill towards Pallister House. Cracked paving.

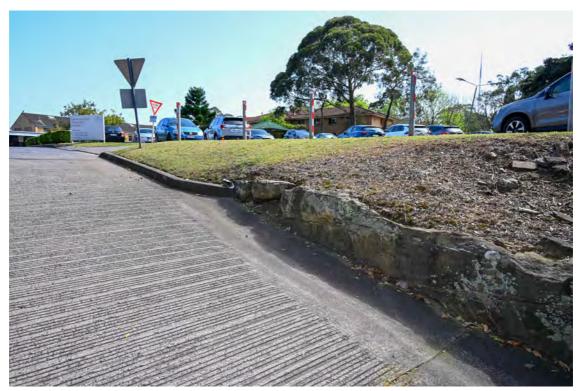
PRO-0085.jpg

Hospital access road from St Vincents Road. Heading west / uphill towards Pallister House. Cracked paving.

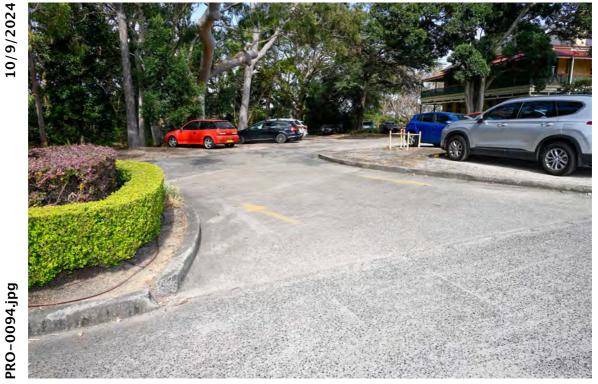
Hospital access road from St Vincents Road. Area of Pallister House. Adjacent parking area. Damaged asphalt paving.

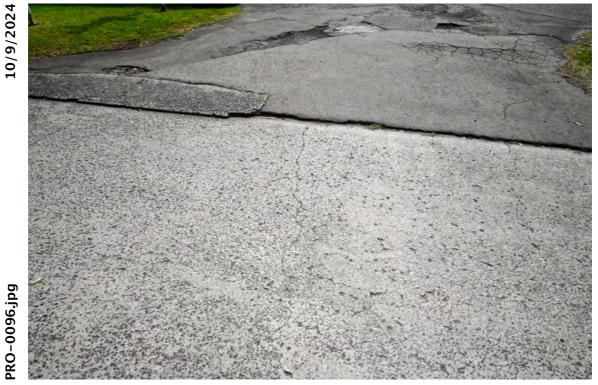
Hospital access road from St Vincents Road. Access / exit to Pallister House. Damaged kerb.

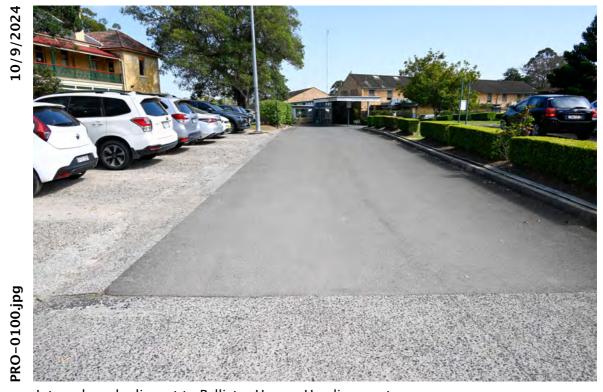
Internal road adjacent to Pallister House. Heading west.

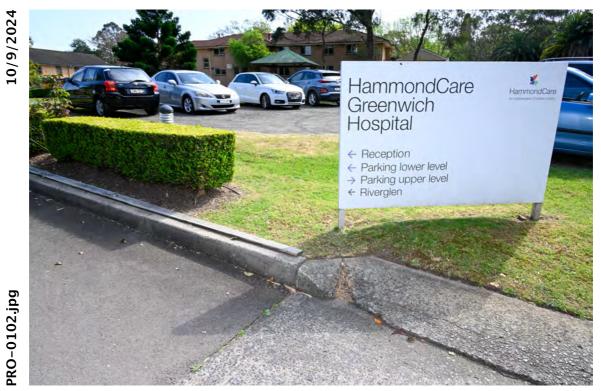
Internal road adjacent to Pallister House. Heading west. Northern side of the road.

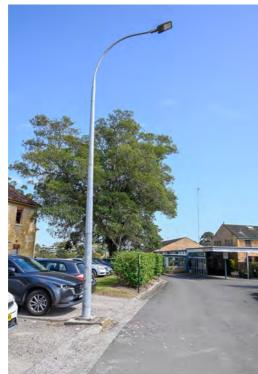
PRO-0107.jpg

Internal road adjacent to Pallister House. Heading west. Light pole.

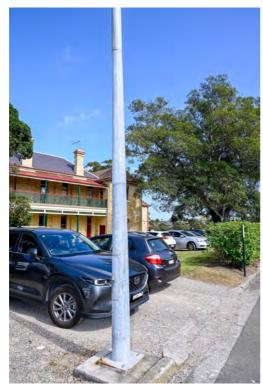
PRO-0108.jpg

Internal road adjacent to Pallister House. Heading west. Light pole.

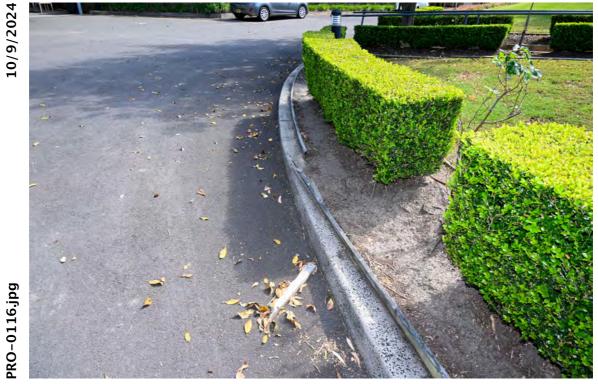
PRO-0117.jpg

Internal road adjacent to Pallister House. Heading west. Damaged timber edging.

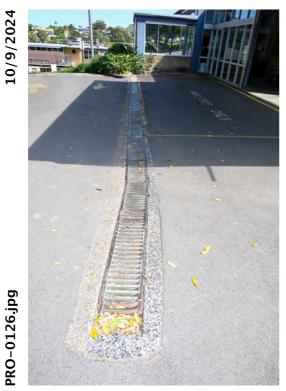
Internal road between Pallister House and 'Ambulatory Services'. Heading south-west. Strip drain.

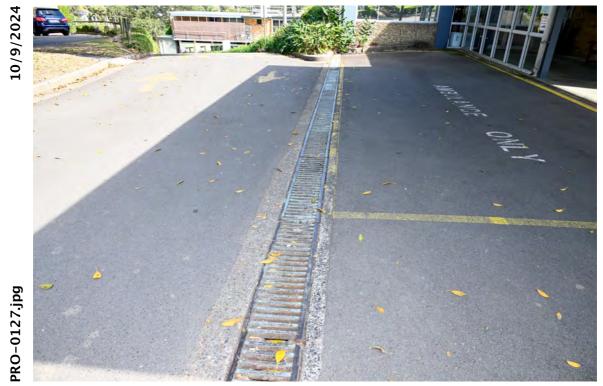
Internal road between Pallister House and 'Ambulatory Services'. Heading south-west. Strip drain.

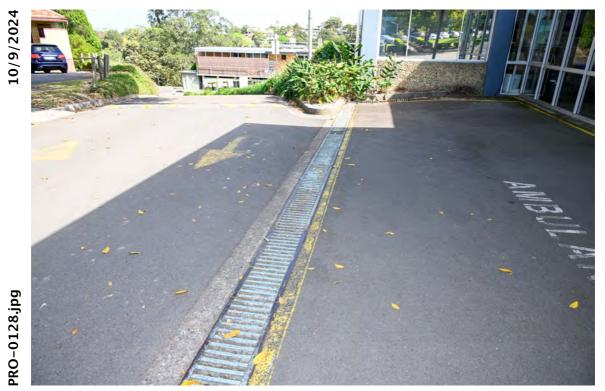
PRO-0129.jpg

Internal road between Pallister House and 'Ambulatory Services'. Heading south-west. Strip drain.

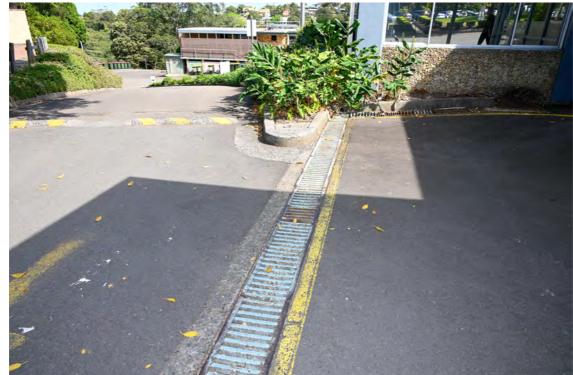
Internal road between Pallister House and 'Ambulatory Services'. Heading south-west. Strip drain.

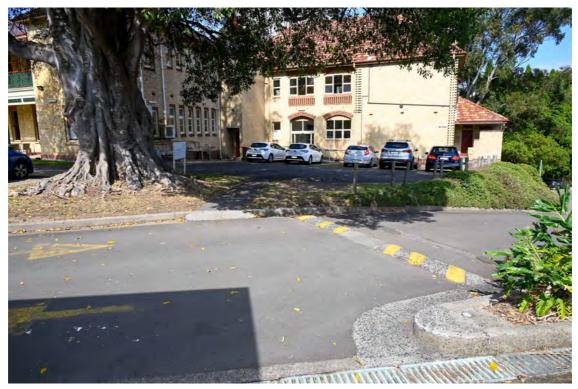
Internal road between Pallister House and 'Ambulatory Services'. Heading south-west. Area of the speed bump.

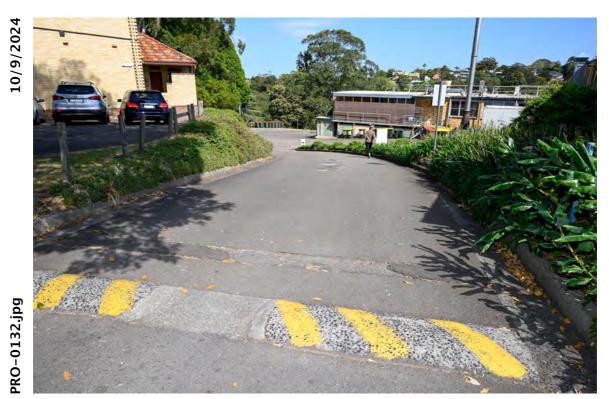
PRO-0133.jpg

Internal road between Pallister House and 'Ambulatory Services'. Heading south-west. Area of the speed bump.

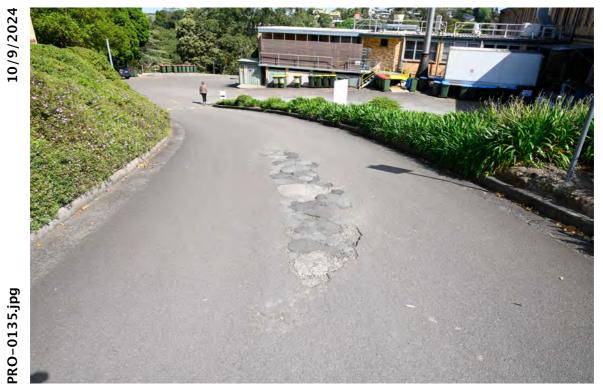
Internal road between Pallister House and 'Health & Care'. Heading south-west / downhill. Damaged road paving. Area of proposed road works.

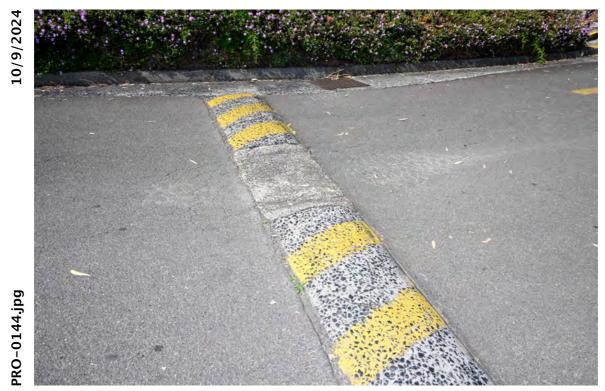
Internal road between Pallister House and 'Health & Care'. Heading south-west / downhill. Area of proposed road works.

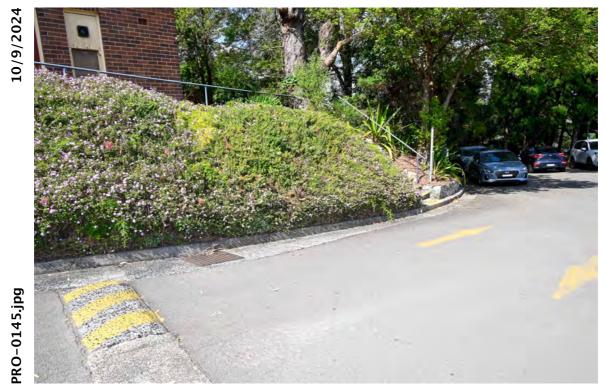
Internal road between Pallister House and 'Health & Care'. Heading south-west / downhill. Area of proposed road works.

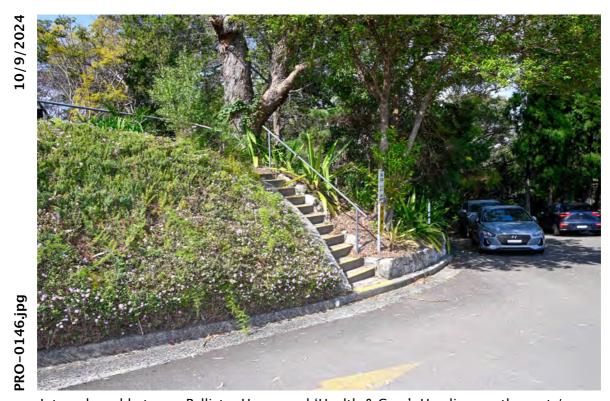
Internal road between Pallister House and 'Health & Care'. Heading south-west / downhill. Area of proposed road works.

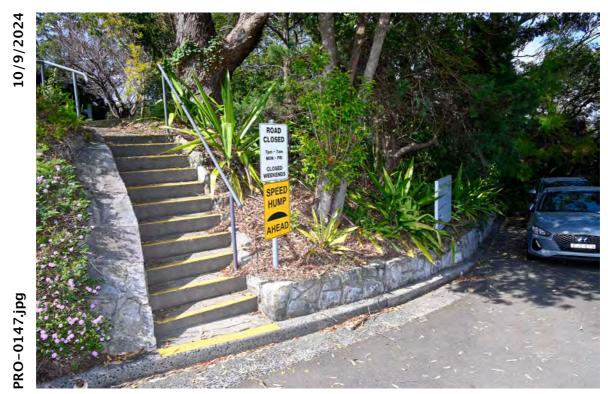
Internal road between Pallister House and 'Health & Care'. Heading south-west / downhill. Area of proposed road works.

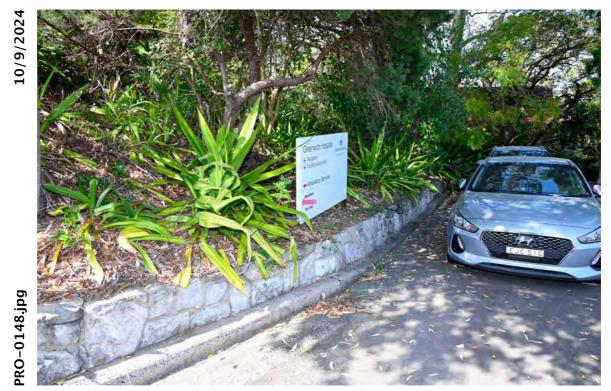
Internal road between Pallister House and 'Health & Care'. Heading south-west / downhill. Area of proposed road works.

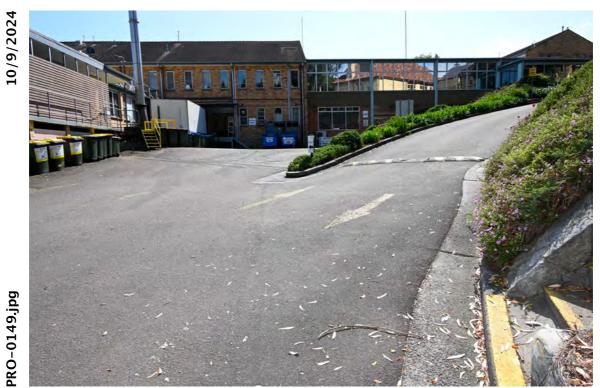
Area to the west and below Pallister House. Parking bays.

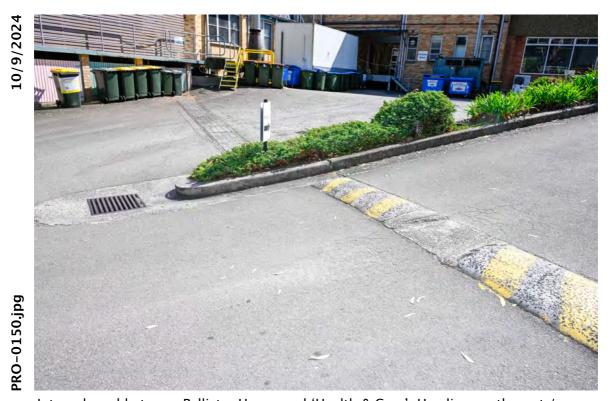
Internal road between Pallister House and 'Health & Care'. Heading north-east / uphill. Area of proposed road works.

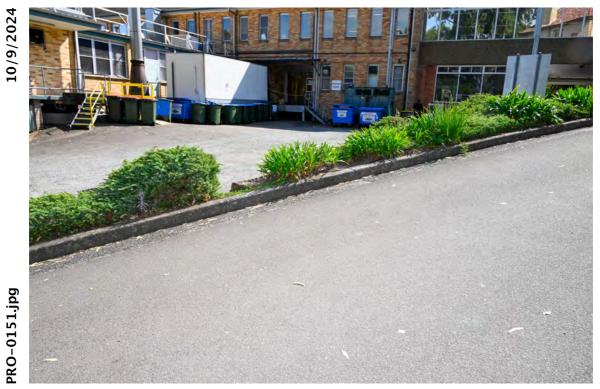
Internal road between Pallister House and 'Health & Care'. Heading north-east / uphill. Area of proposed road works.

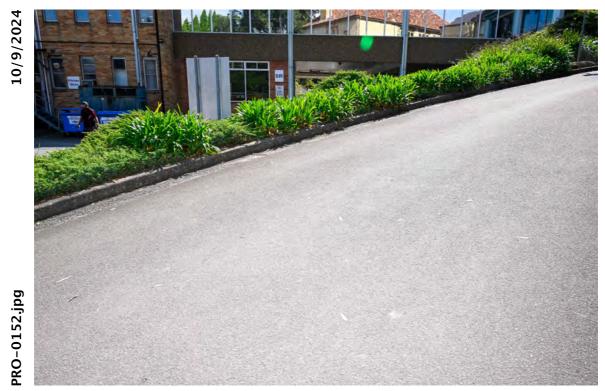
Internal road between Pallister House and 'Health & Care'. Heading north-east / uphill. Area of proposed road works.

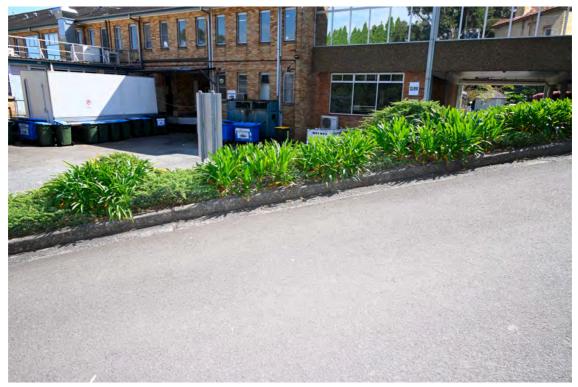
PRO-0153.jpg

Internal road between Pallister House and 'Health & Care'. Heading north-east / uphill. Area of proposed road works.

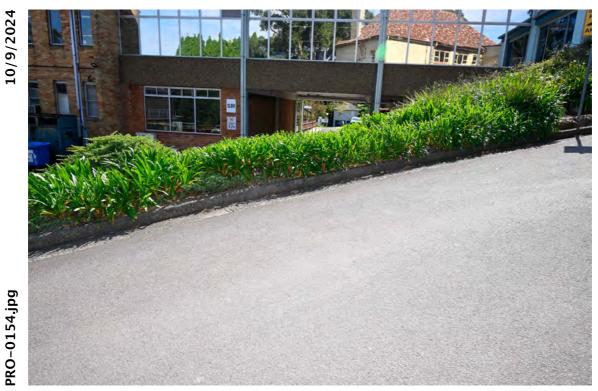
Internal road between Pallister House and 'Health & Care'. Heading north-east / uphill. Area of proposed road works.

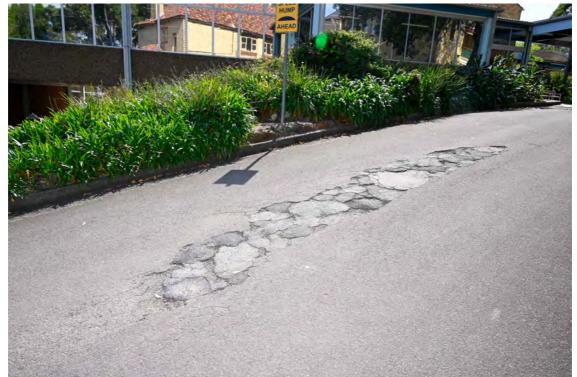
PRO-0155.jpg

Internal road between Pallister House and 'Health & Care'. Heading north-east / uphill. Area of proposed road works.

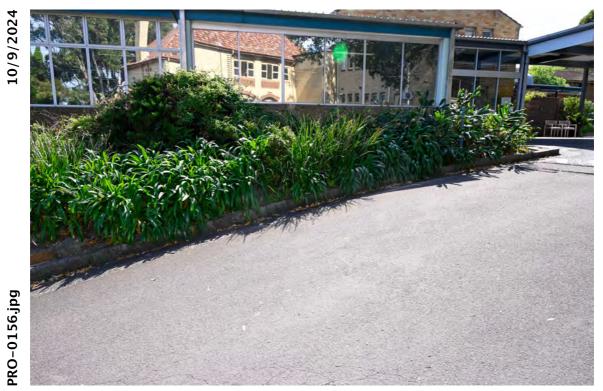
Internal road between Pallister House and 'Health & Care'. Heading north-east / uphill. Area of proposed road works.

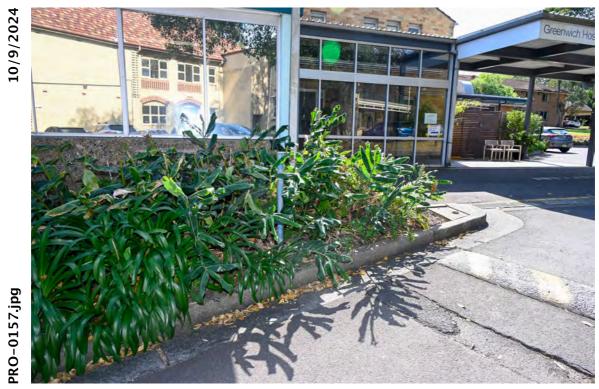
Internal road between Pallister House and 'Health & Care'. Heading north-east / uphill. Area of proposed road works.

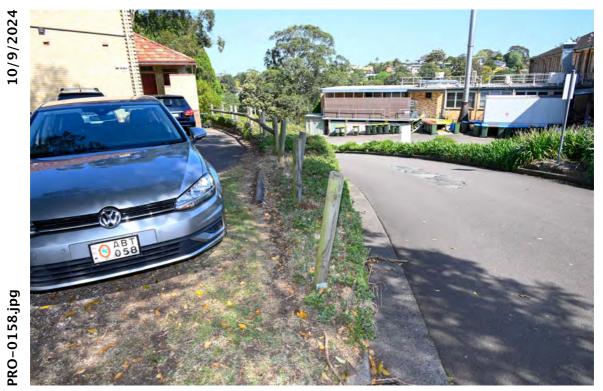
Internal road between Pallister House and 'Health & Care'. Heading north-east / uphill. Area of proposed road works.

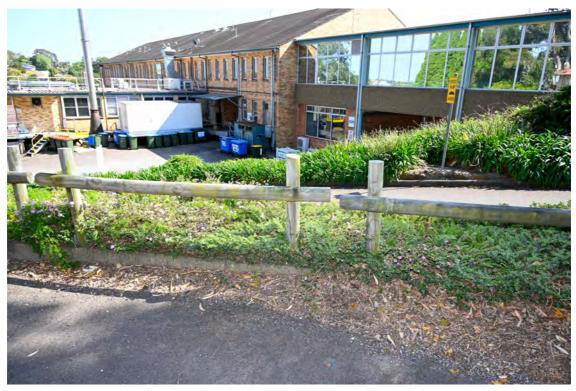
PRO-0163.jpg

Area on the northern side of Pallister House. Adjacent car parking area. Damaged timber barricades.

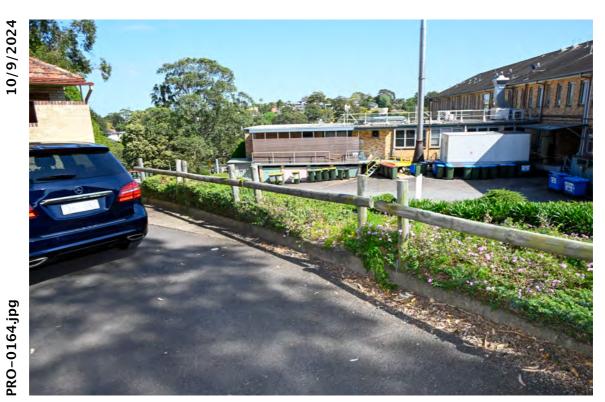
Area on the northern side of Pallister House. Adjacent car parking area. Timber barricades.

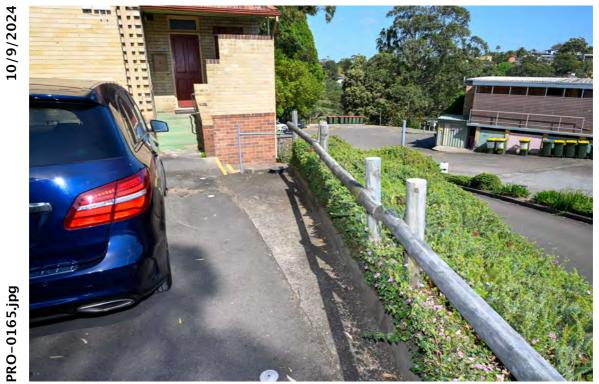
Area on the northern side of Pallister House. Adjacent car parking area. Timber barricades.

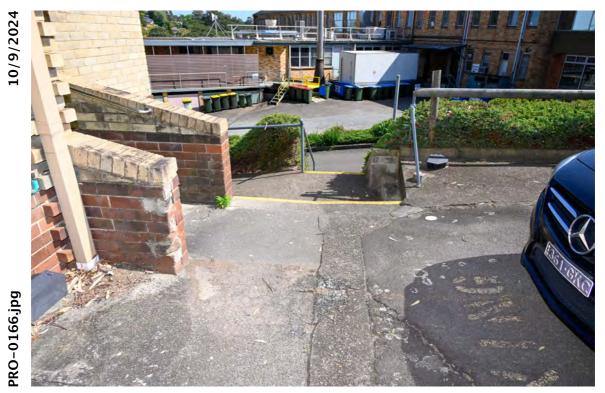
Area on the northern side of Pallister House. Adjacent car parking area. Timber barricades.

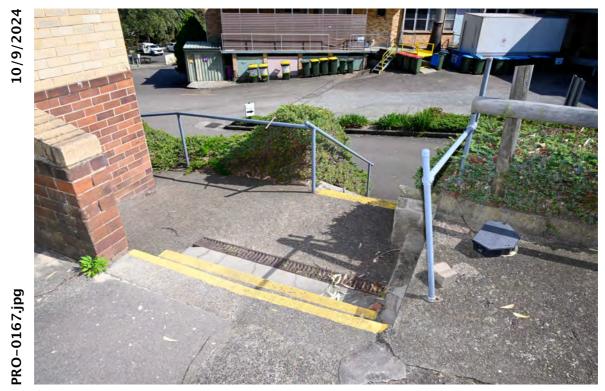
Area on the northern side of Pallister House. Adjacent car parking area. Steps leading down to the area of road works.

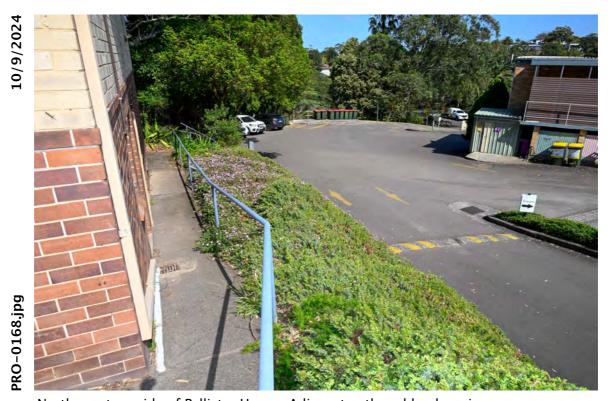
Area on the northern side of Pallister House. Adjacent car parking area. Steps leading down to the area of road works.

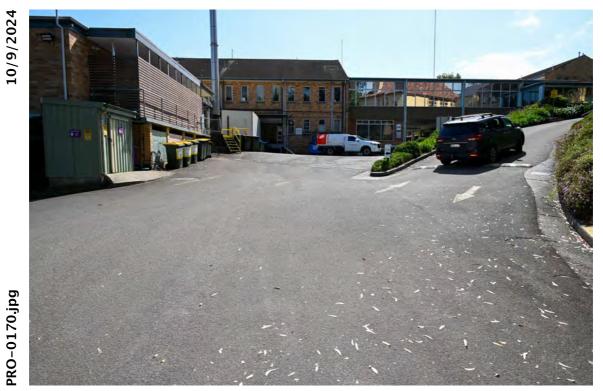
North-western side of Pallister House. Area of proposed road works. Facing northeast / uphill.

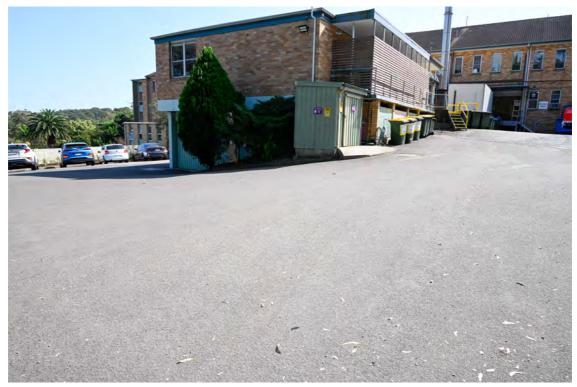
PRO-0171.jpg

North-western side of Pallister House. Area of proposed road works. Facing northeast / uphill.

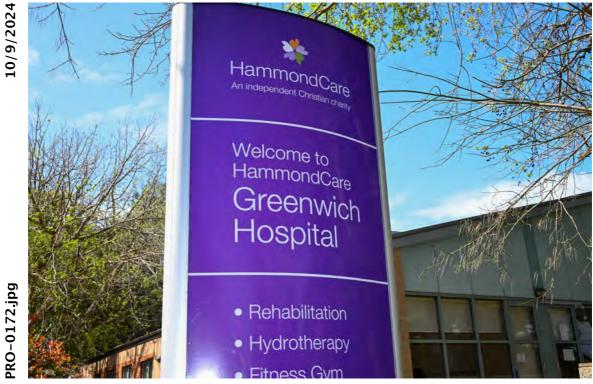
North-western side of Pallister House. Area of proposed road works.

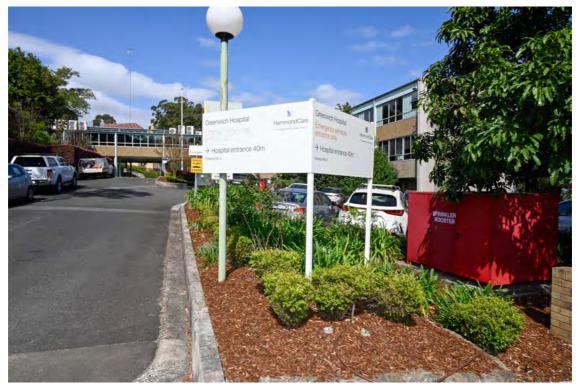
Greenwich Hospital access from River Road.

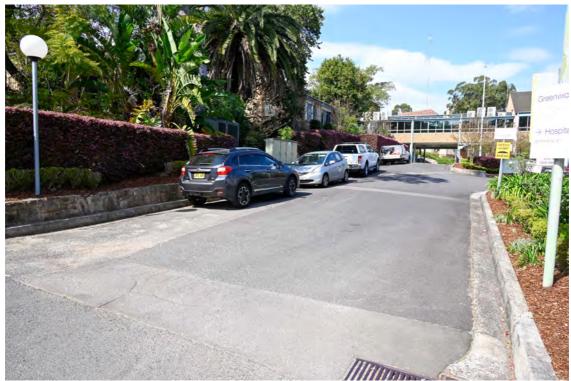
PRO-0173.jpg

Greenwich Hospital access from River Road. Area of the proposed substation works.

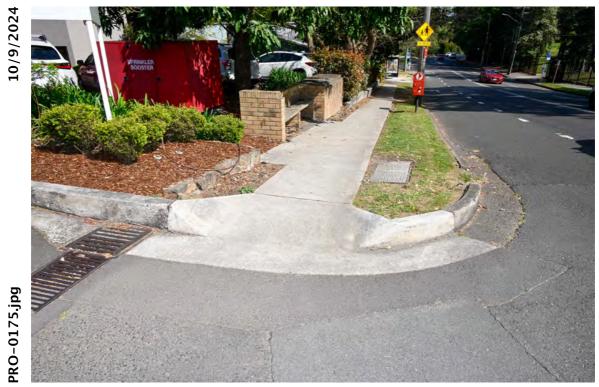
PRO-0174.jpg

Greenwich Hospital access from River Road. Area of the proposed substation works.

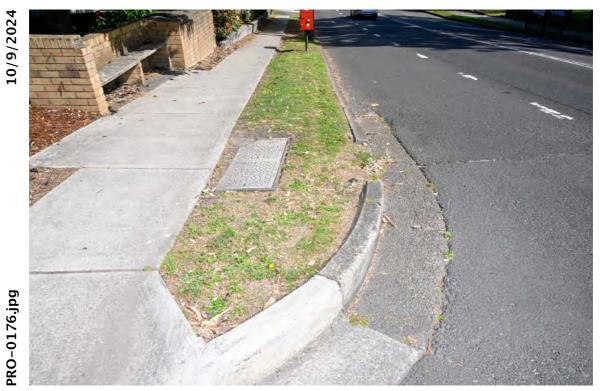
Hospital access from River Road. Area of the proposed substation works. Western side of the intersection.

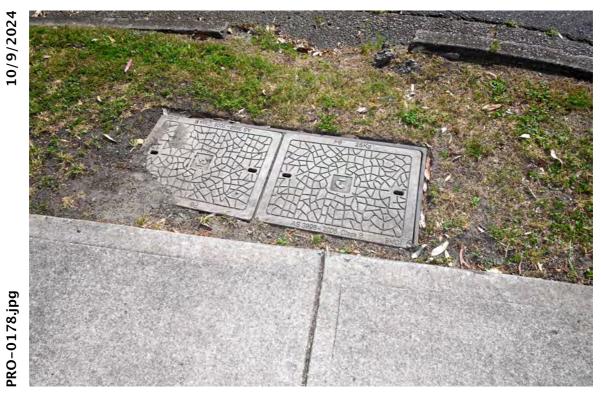
Hospital access from River Road. Area of the proposed substation works. Western side of the intersection. Heading west. Area of the 'Sprinkler Booster'. Damaged kerb.

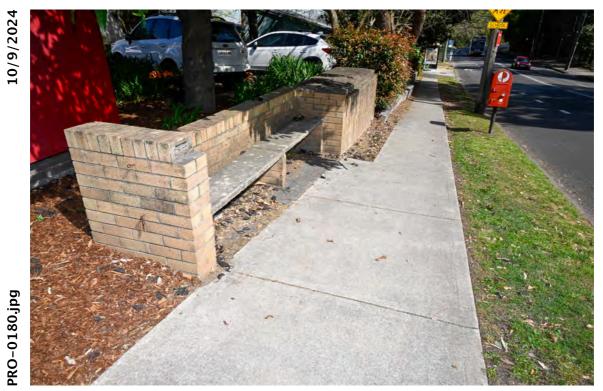
Hospital access from River Road. Area of the proposed substation works. Western side of the intersection. Heading west. Area of the 'Sprinkler Booster'.

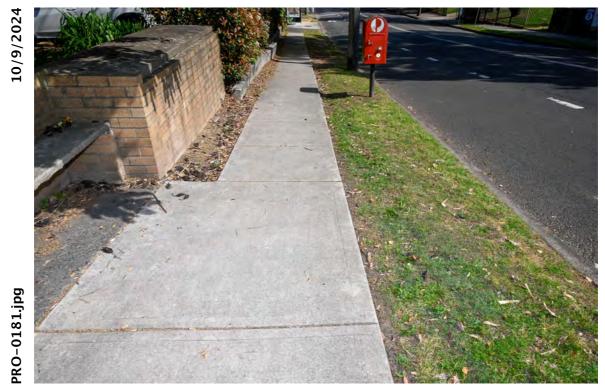
Hospital access from River Road. Area of the proposed substation works. Western side of the intersection. Heading west. Area of the 'Sprinkler Booster'.

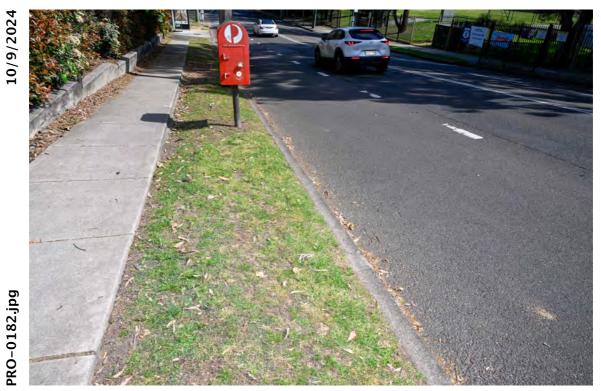
Hospital access from River Road. Area of the proposed substation works. Western side of the intersection. Heading west. Area of the 'Sprinkler Booster'.

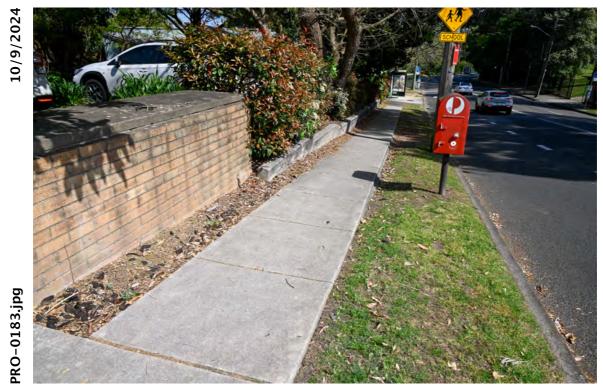
Hospital access from River Road. Area of the proposed substation works. Western side of the intersection. Heading west. Area of the 'Sprinkler Booster'.

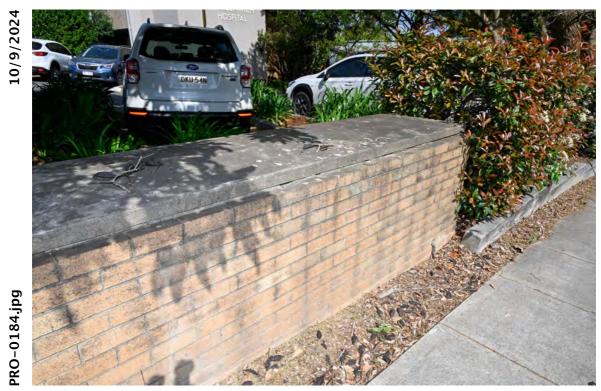
Hospital access from River Road. Area of the proposed substation works. Western side of the intersection. Heading west. Area of the 'Sprinkler Booster'.

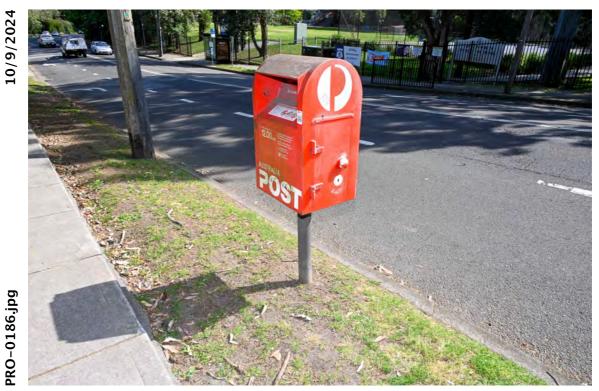
Hospital access from River Road. Area of the proposed substation works. Western side of the intersection. Heading west. Area of the 'Sprinkler Booster'. Mail box.

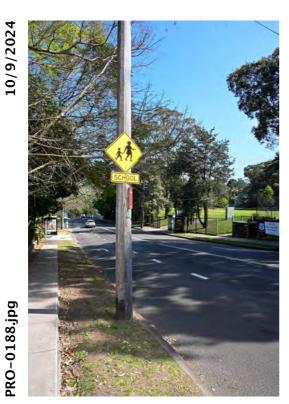
Hospital access from River Road. Area of the proposed substation works. Western side of the intersection. Heading west. Area of the 'Sprinkler Booster'. Power pole no. GL72380.

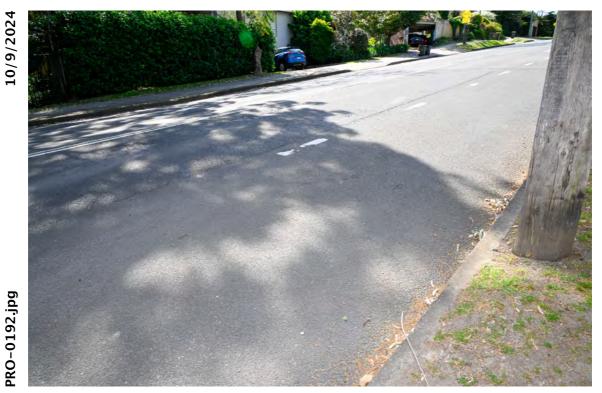
Hospital access from River Road. Area of the proposed substation works. Western side of the intersection. Heading east. Area of the 'Sprinkler Booster' and power pole no. GL72380. Damaged retaining wall.

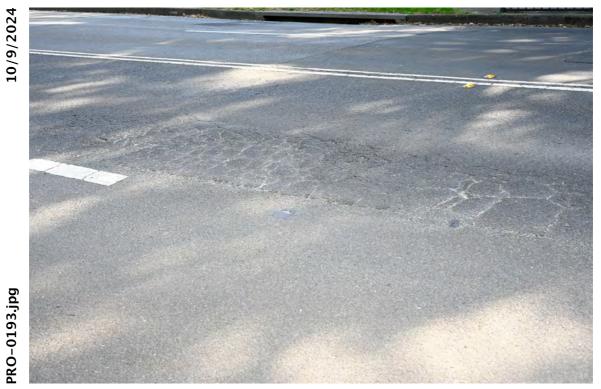
Hospital access from River Road. Area of the proposed substation works. Western side of the intersection. Heading east. Area of the 'Sprinkler Booster' and power pole no. GL72380. Road paving.

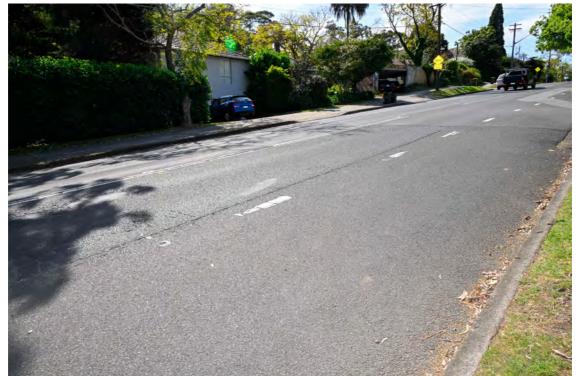
PRO-0197.jpg

Hospital access from River Road. Area of the proposed substation works. Western side of the intersection. Heading east. Area of the 'Sprinkler Booster' and power pole no. GL72380. Cracked and crazing road paving.

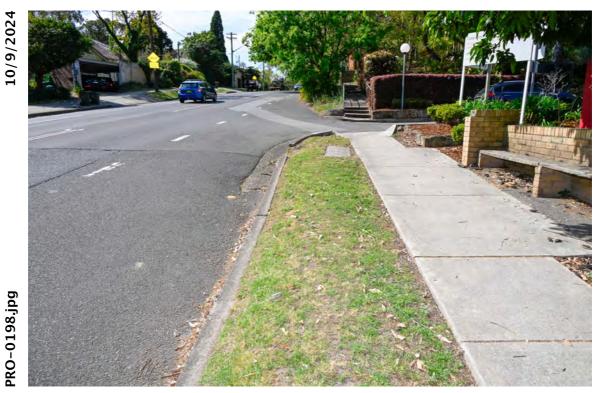
Hospital access from River Road. Area of the proposed substation works. Western side of the intersection. Heading east. Area of the 'Sprinkler Booster' and power pole no. GL72380. Cracked and crazing road paving.

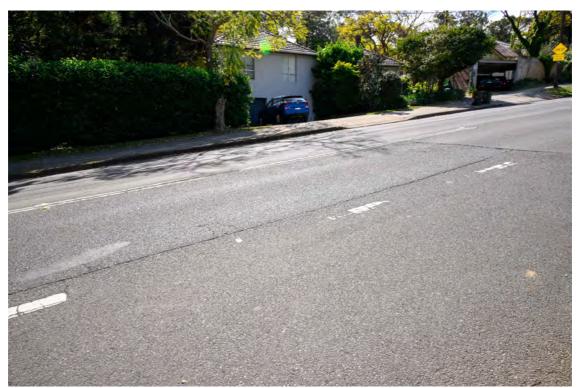
Hospital access from River Road. Area of the proposed substation works. Western side of the intersection. Heading east. Area of the 'Sprinkler Booster' and power pole no. GL72380.

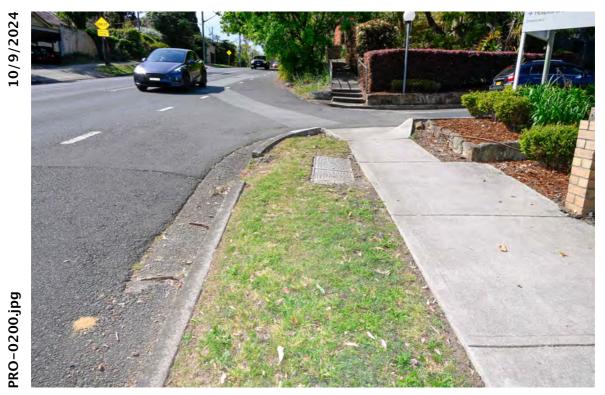
Hospital access from River Road. Area of the proposed substation works. Western side of the intersection. Heading east. Area of the 'Sprinkler Booster' and power pole no. GL72380.

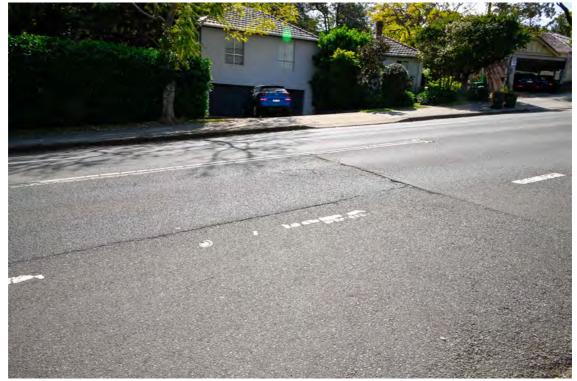
PRO-0201.jpg

Hospital access from River Road. Area of the proposed substation works. Western side of the intersection. Heading east. Area of the 'Sprinkler Booster' and power pole no. GL72380.

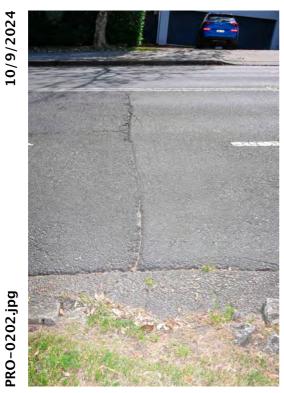
Hospital access from River Road. Area of the proposed substation works. Western side of the intersection. Heading east. Area of the 'Sprinkler Booster' and power pole no. GL72380.

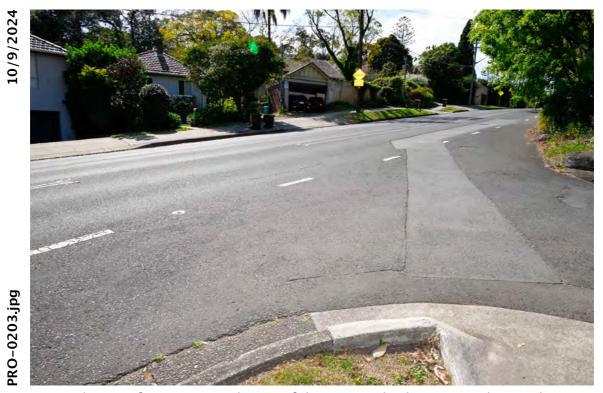
Hospital access from River Road. Area of the proposed substation works. Western side of the intersection. Heading east. Area of the 'Sprinkler Booster' and power pole no. GL72380. Damaged kerb.

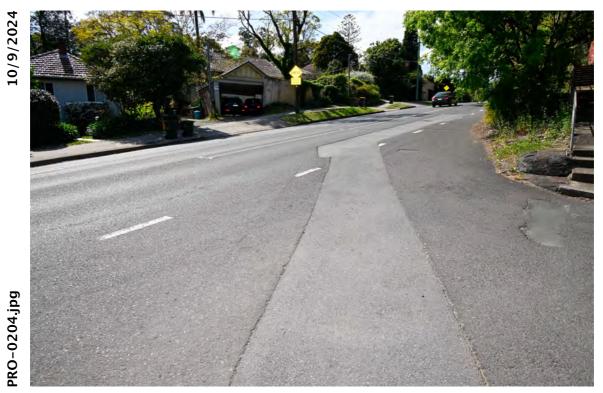
Hospital access from River Road. Area of the proposed substation works. Heading east.
