Greenwich Hospital Redevelopment

Stage 1 - Early Works

DILAPIDATION REPORT

10th September 2024

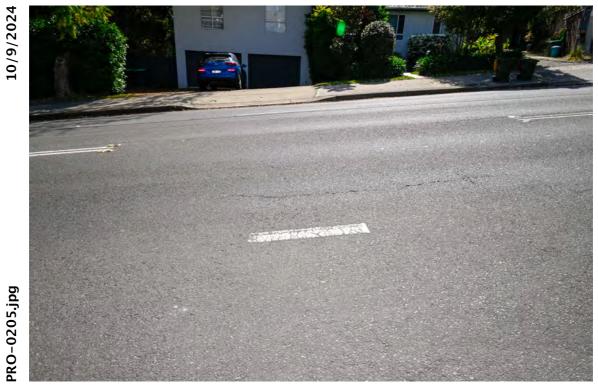
Hospital access from River Road. Area of the proposed substation works. Heading east.

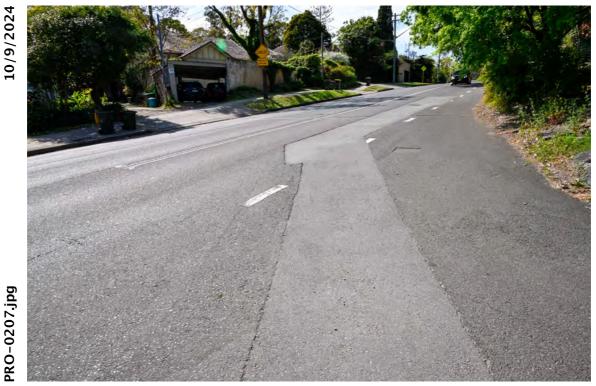
Hospital access from River Road. Area of the proposed substation works. Heading east. Cracked road paving.

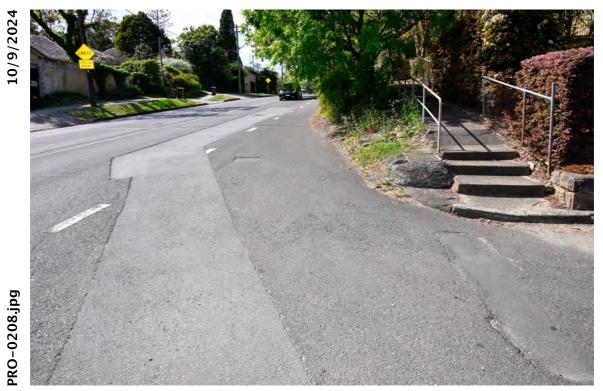
Hospital access from River Road. Area of the proposed substation works. Heading east. Road paving.

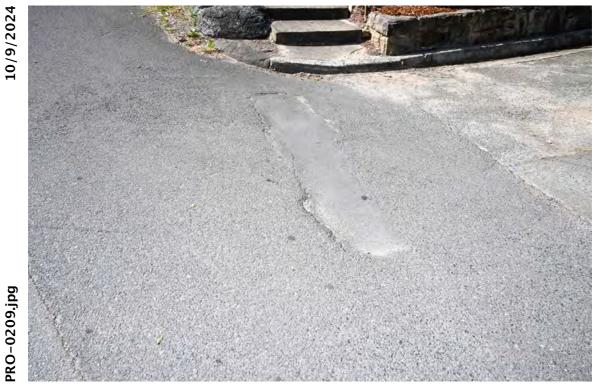
Hospital access from River Road. Area of the proposed substation works. Heading east. Road paving.

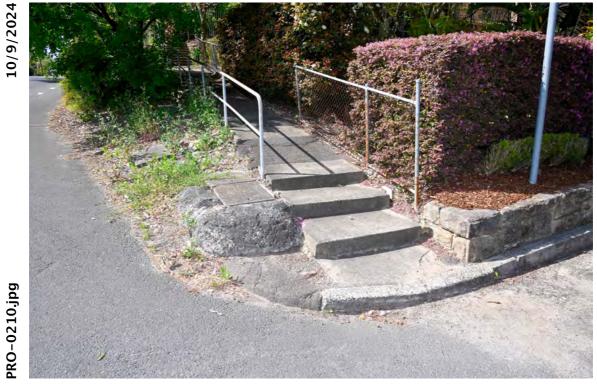
Hospital access from River Road. Area of the proposed substation works. Heading east. Road paving.

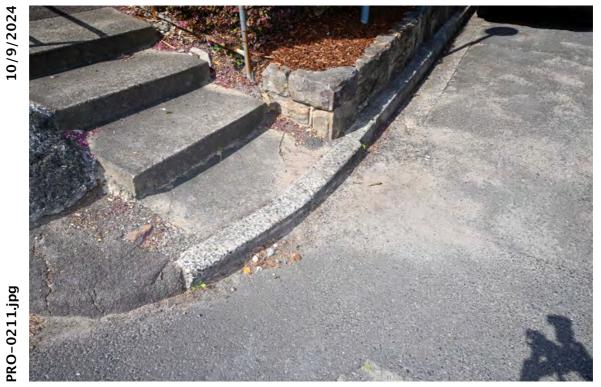
Hospital access from River Road. Area of the proposed substation works. Heading east. Footpath steps.

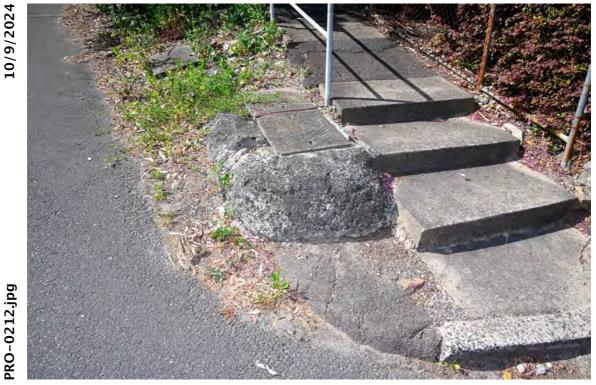
Hospital access from River Road. Area of the proposed substation works. Heading east. Footpath steps.

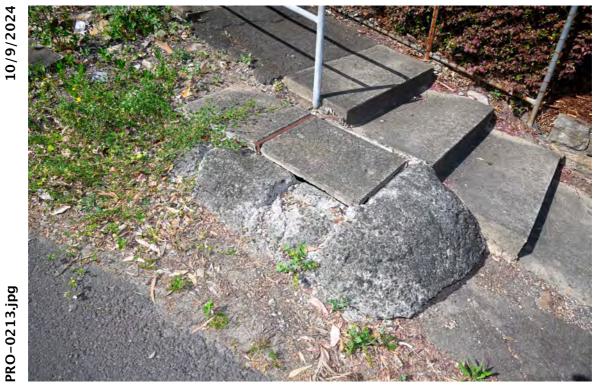
Hospital access from River Road. Area of the proposed substation works. Heading east. Footpath steps.

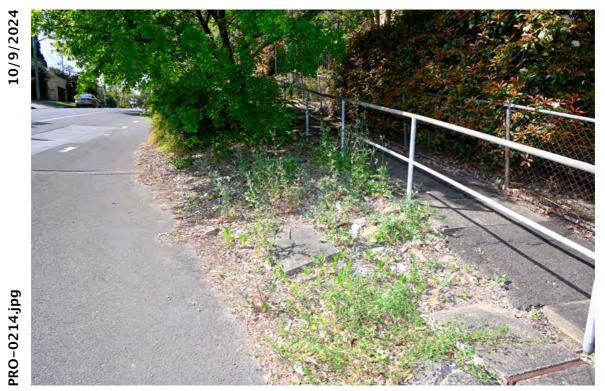
Hospital access from River Road. Area of the proposed substation works. Heading east. Footpath steps.

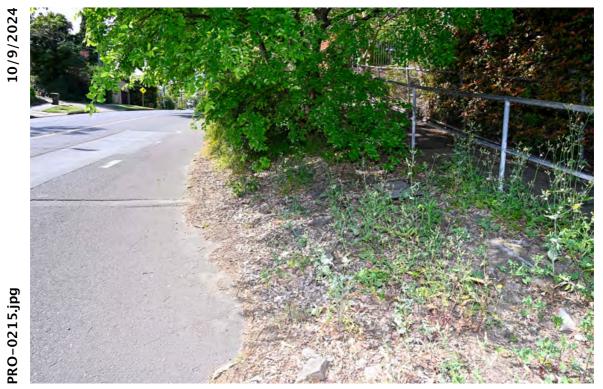
Hospital access from River Road. Area of the proposed substation works. Heading east. Nature strip.

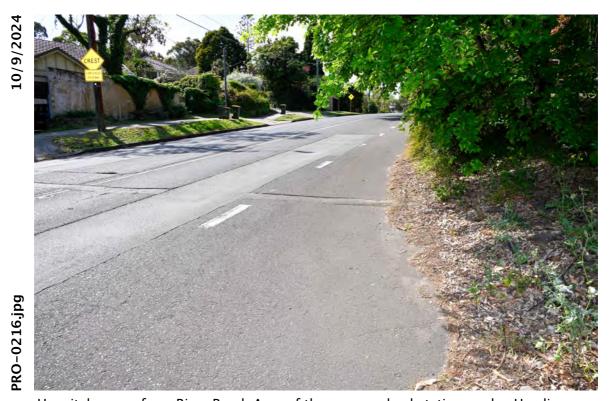
Hospital access from River Road. Area of the proposed substation works. Heading east. Nature strip.

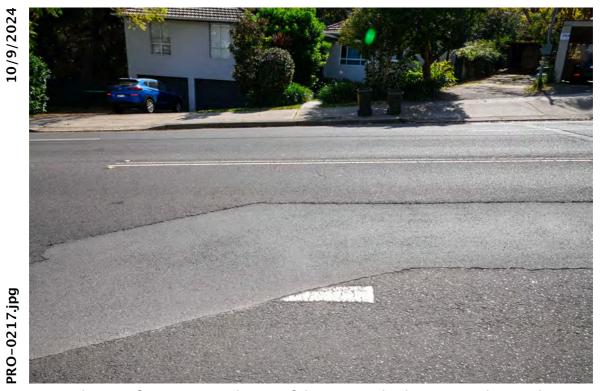
Hospital access from River Road. Area of the proposed substation works. Heading east. Road paving.

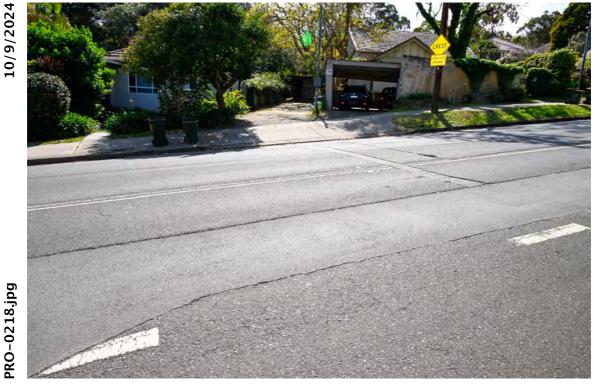
Hospital access from River Road. Area of the proposed substation works. Heading east. Road paving.

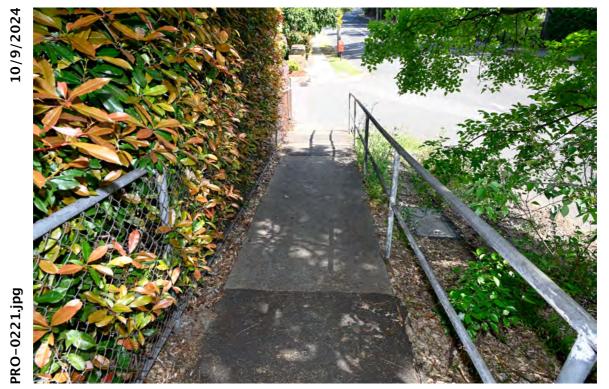
Hospital access from River Road. Area of the proposed substation works. Heading west. Footpath.

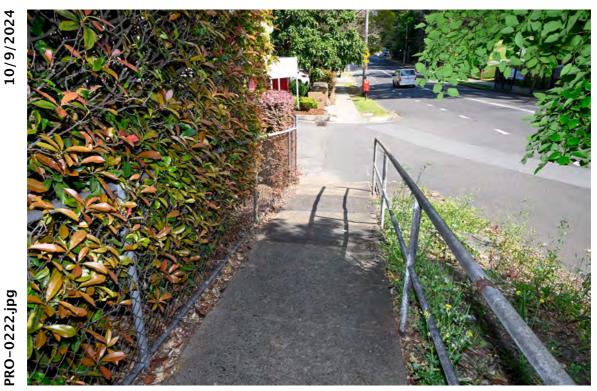
Hospital access from River Road. Area of the proposed substation works. Heading west. Footpath.

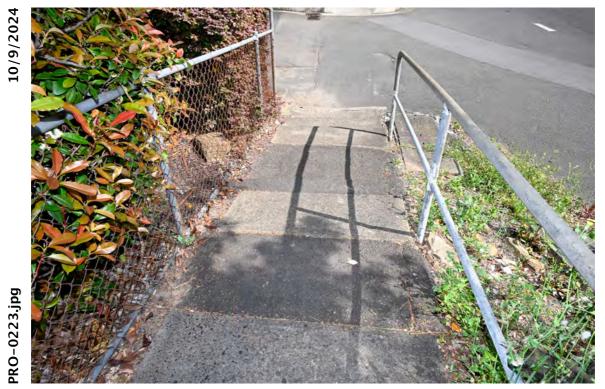
Hospital access from River Road. Area of the proposed substation works. Heading west. Footpath.

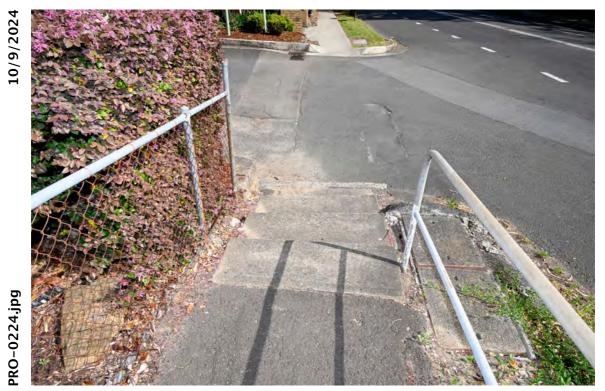
Hospital access from River Road. Area of the proposed substation works. Heading west. Footpath.

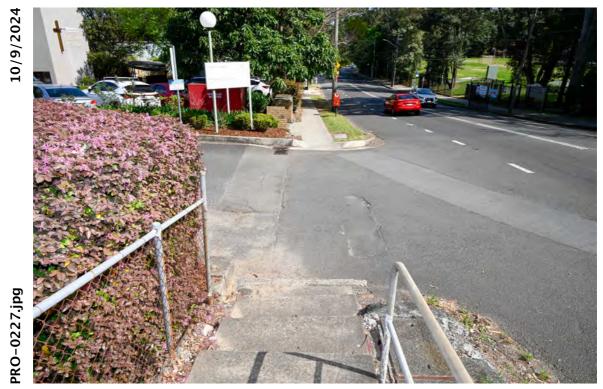
Hospital access from River Road. Area of the proposed substation works. Heading west. Road paving.

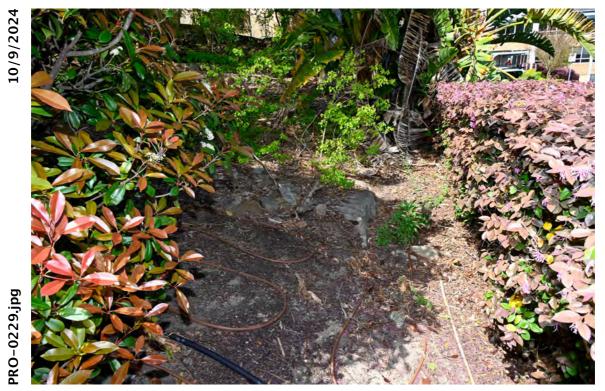
River Road. Area of the proposed substation works. Area on the eastern side of the internal access road.

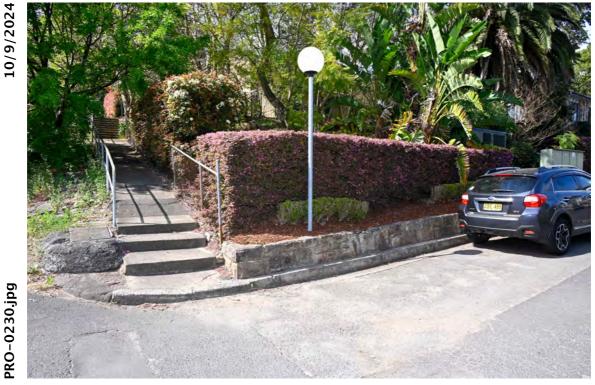
River Road. Area of the proposed substation works. Area on the eastern side of the internal access road.

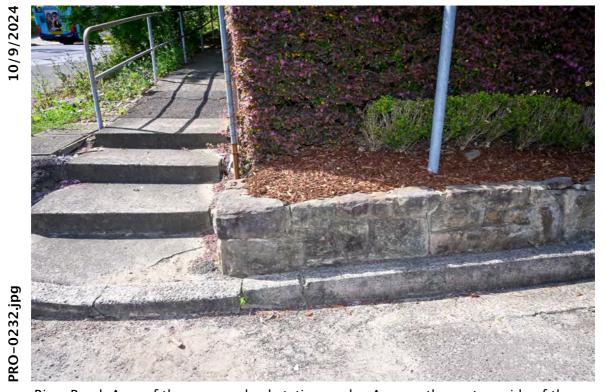
River Road. Area of the proposed substation works. Area on the eastern side of the internal access road.

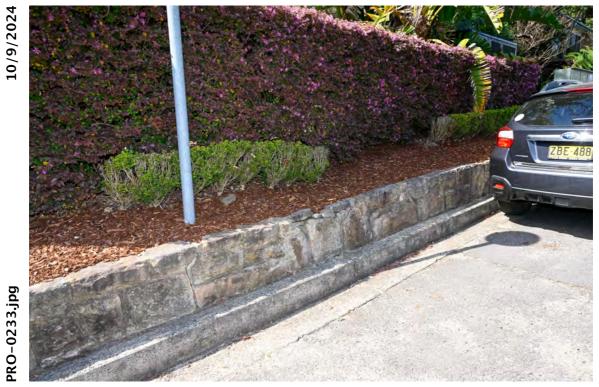
River Road. Area of the proposed substation works. Area on the eastern side of the internal access road. Record of the stone retaining wall.

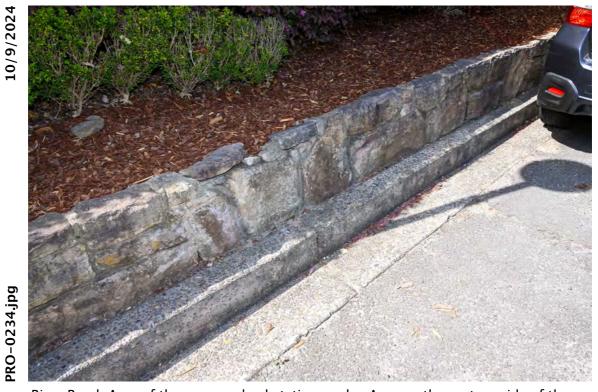
River Road. Area of the proposed substation works. Area on the eastern side of the internal access road. Record of the stone retaining wall.

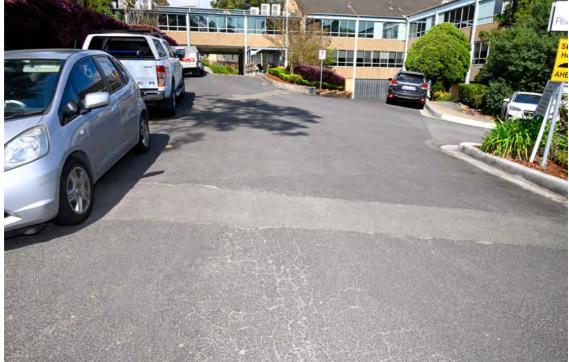
PRO-0236.jpg

crazed state of the road paving.

River Road. Area of the proposed substation works. Internal access road. Cracked and crazed state of the road paving.

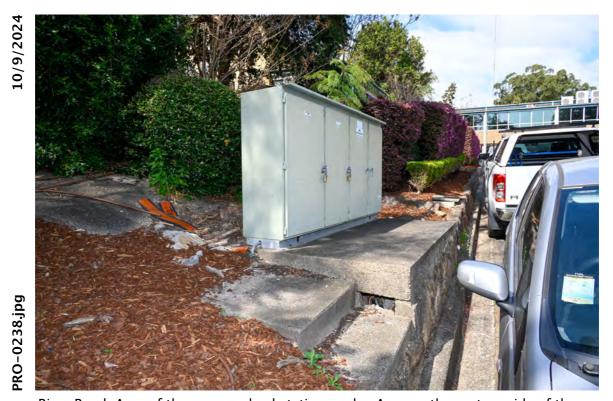
River Road. Area of the proposed substation works. Area on the eastern side of the internal access road. Electrical kiosk no. 2385.

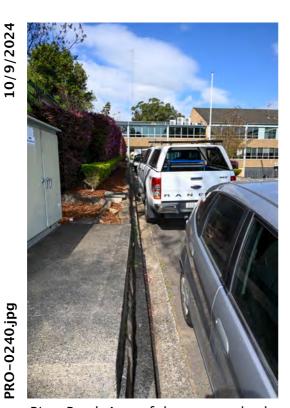
River Road. Area of the proposed substation works. Area on the eastern side of the internal access road. Stone retaining wall.

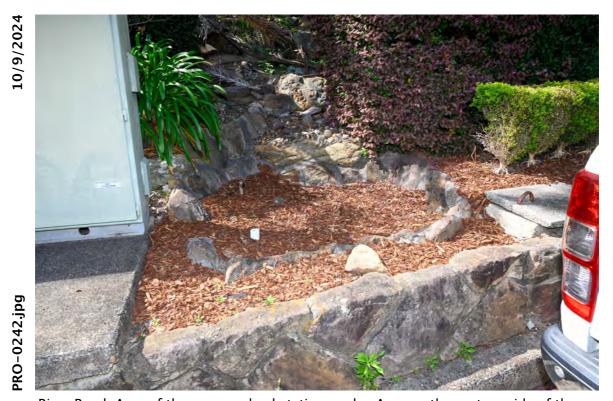
River Road. Area of the proposed substation works. Area on the eastern side of the internal access road. Stone retaining wall.

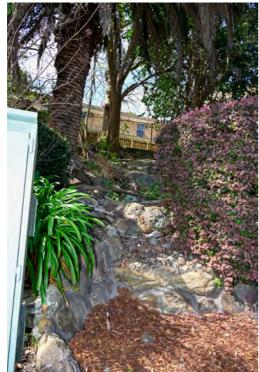
PRO-0243.jpg

River Road. Area of the proposed substation works. Area on the eastern side of the internal access road. Record of the landscaping.

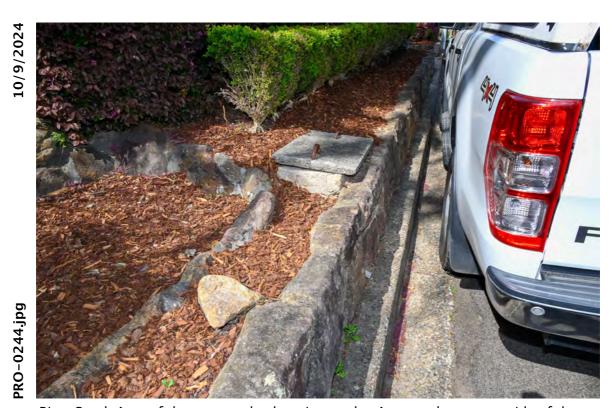
River Road. Area of the proposed substation works. Area on the eastern side of the internal access road. Record of the landscaping.

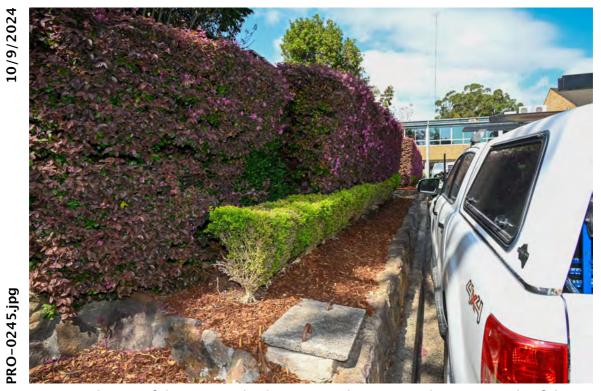
River Road. Area of the proposed substation works. Area on the eastern side of the internal access road. Record of the landscaping.

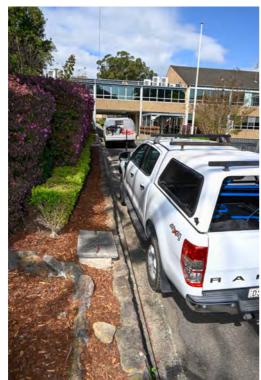
PRO-0257.jpg

River Road. Area of the proposed substation works. Area on the eastern side of the internal access road. Heading south.

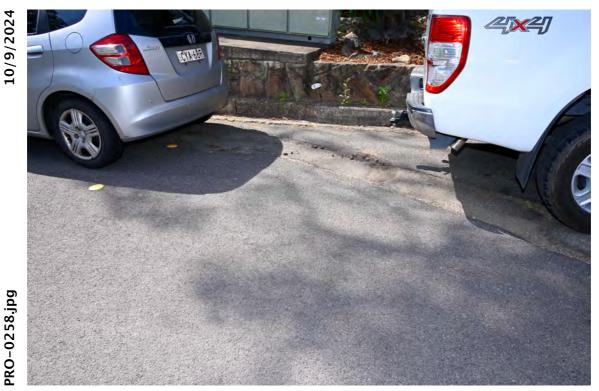
River Road. Area of the proposed substation works. Area on the eastern side of the internal access road. Damaged road paving.

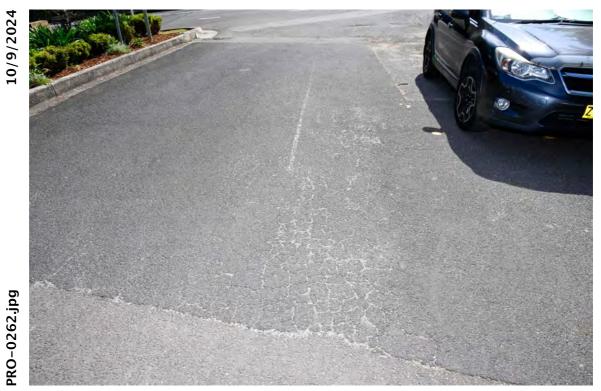
River Road. Area of the proposed substation works. Adjacent internal access road. Heading north towards River Road. Cracked and crazed road paving.

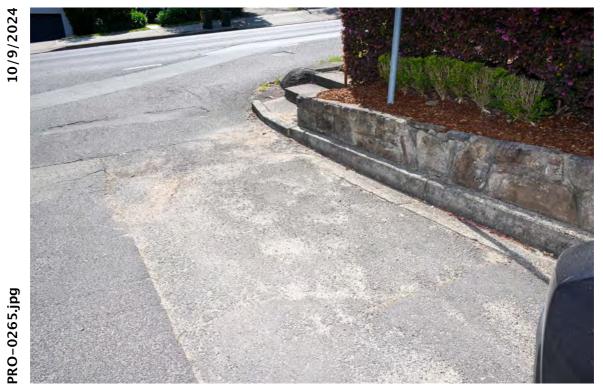
River Road. Area of the proposed substation works. Adjacent internal access road. Heading north towards River Road. Cracked and crazed road paving.

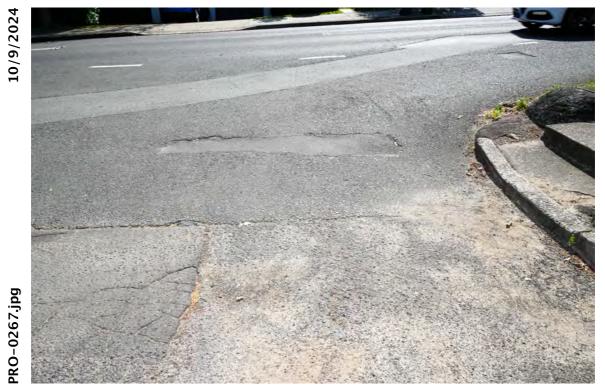
River Road. Area of the proposed substation works. Adjacent internal access road. Heading north towards River Road. Sediment on the road way.

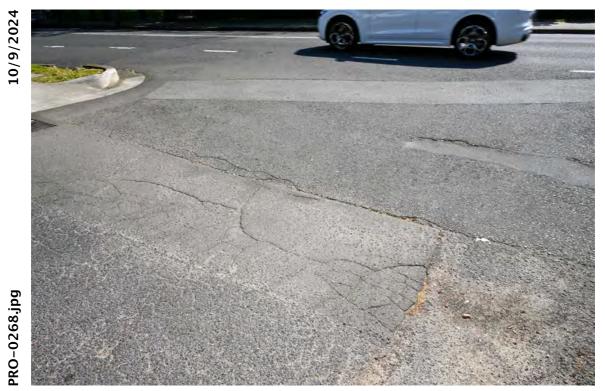
River Road. Area of the proposed substation works. Adjacent internal access road. Heading north towards River Road. Cracked paving.

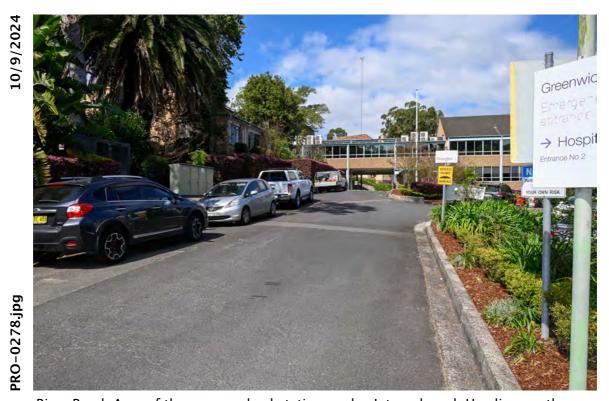
River Road. Area of the proposed substation works. Internal road. Heading south. Cracked and crazed road paving.

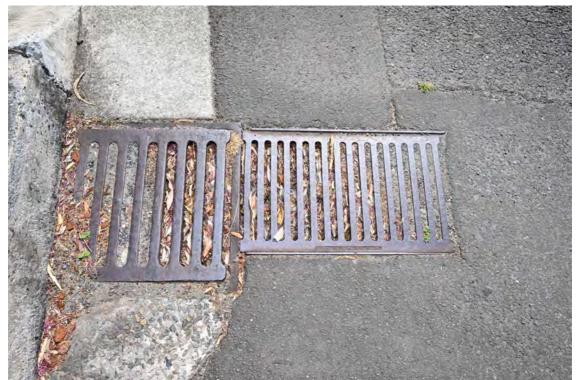
PRO-0279.jpg

River Road. Area of the proposed substation works. Internal road. Heading south. Silted up strip drain.

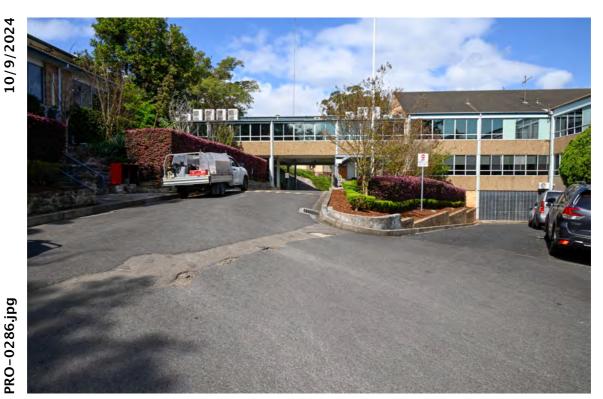
Internal access road from River Road. Heading south approaching the overhead walkway. Damaged road paving.

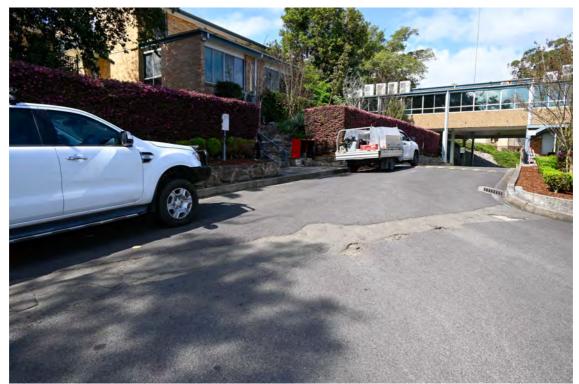
PRO-0287.jpg

Internal access road from River Road. Heading south approaching the overhead walkway. Damaged road paving.

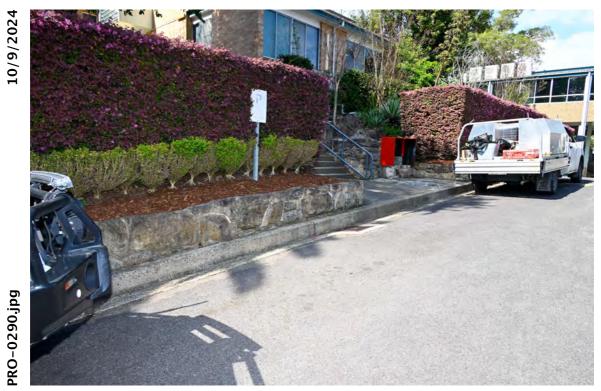
Internal access road from River Road. Heading south approaching the overhead walkway. Damaged road paving.

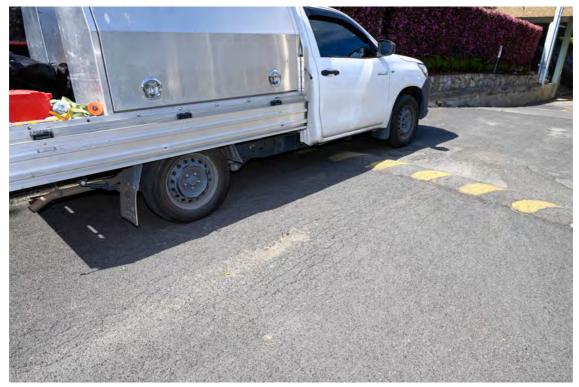
PRO-0299.jpg

Internal access road from River Road. Heading south approaching the overhead walkway. Damaged road paving.

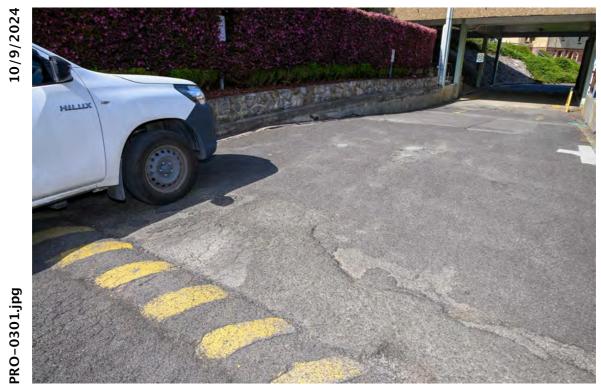
Internal access road from River Road. Heading south approaching the overhead walkway. Damaged road paving.

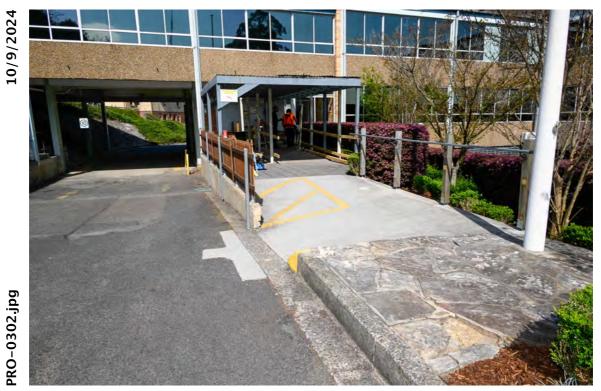
Internal access road from River Road. Heading south approaching the overhead walkway. Damaged road paving.

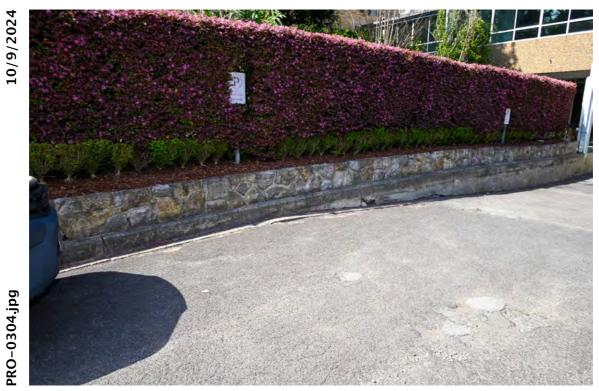
Internal access road from River Road. Heading south approaching the overhead walkway. Damaged road paving.

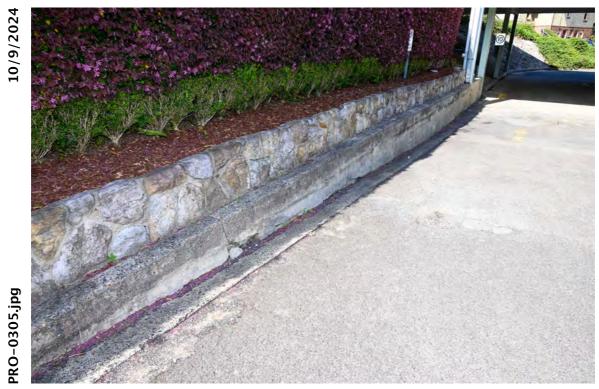
Internal access road from River Road. Heading south approaching the overhead walkway. Damaged road paving.

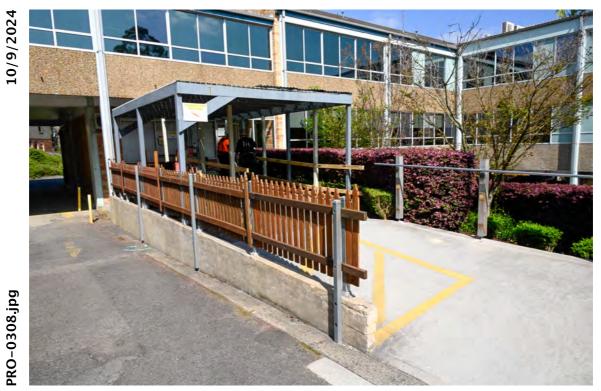
Internal access road from River Road. Heading south approaching the overhead walkway. Western side of the road. Damaged timber flagging.

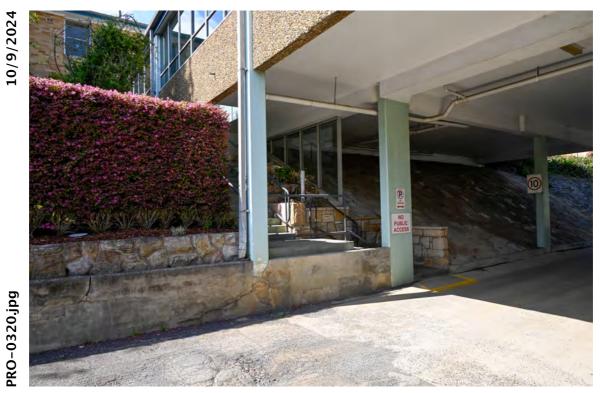
Internal access road from River Road. Heading south through the 'tunnel'. Damaged road paving.

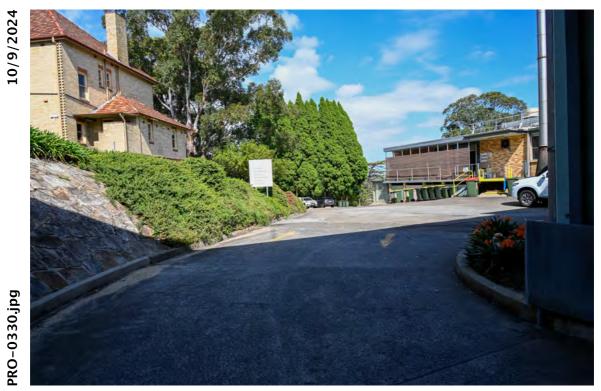
Internal access road from River Road. Heading south through the 'tunnel'. Cracked paving.

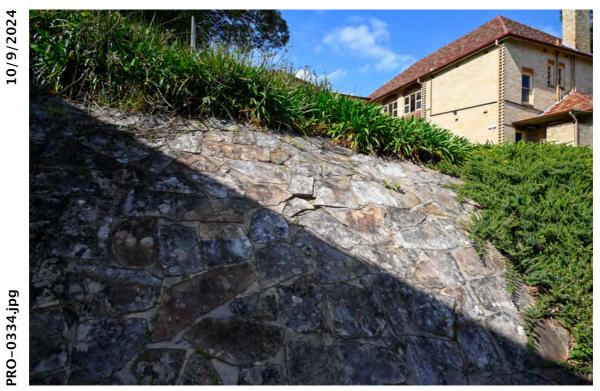
Internal access road from River Road. Heading south. Area of 'Service and deliveries'. Collapsed section of the retaining structure.

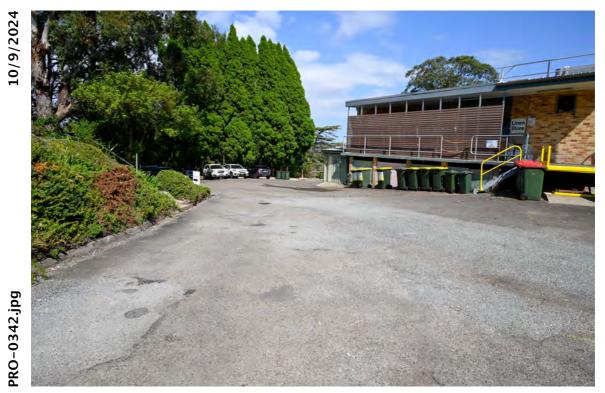
Internal access road. Heading south. Area of 'Service and deliveries'. Retaining structure below the area of road works. Damaged road paving.

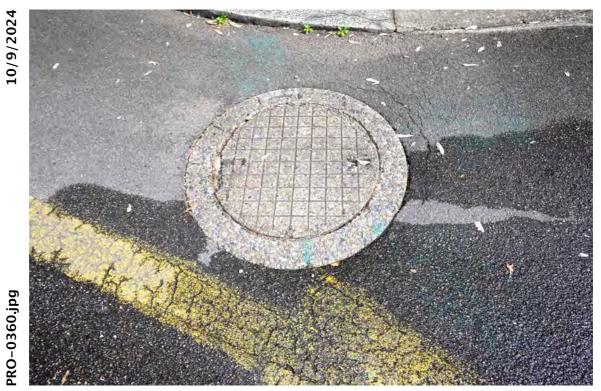
Internal access road. Heading south. Area of 'Service and deliveries'. Lid to the services pit.

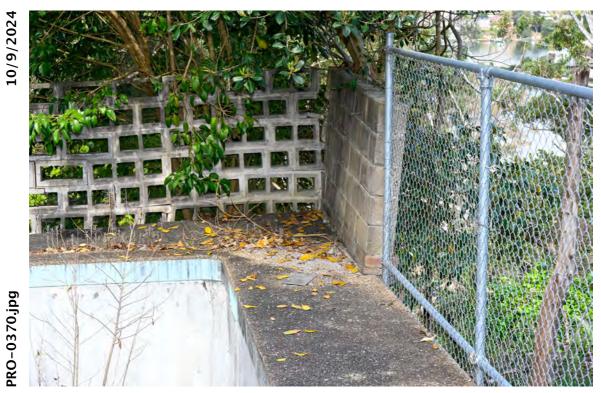
Southern property boundary. Area of the disused swimming pool. Collapsed boundary walls.

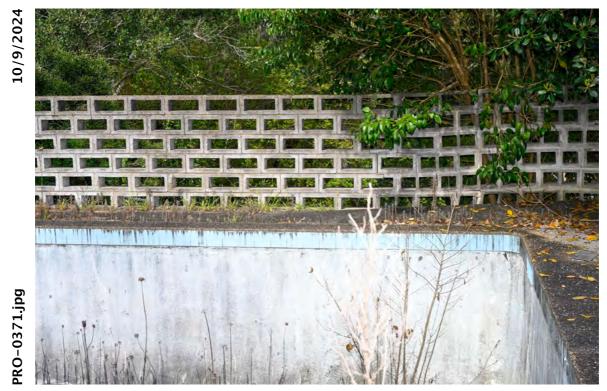
Southern property boundary. Area of the disused swimming pool. Collapsed boundary walls.

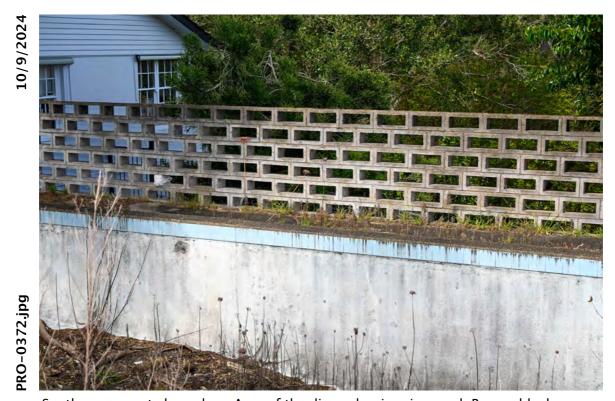
Southern property boundary. Area of the disused swimming pool. Breeze block boundary wall.

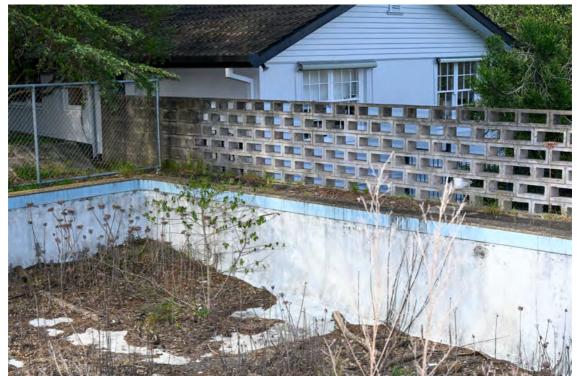
Southern property boundary. Area of the disused swimming pool. Breeze block boundary wall.

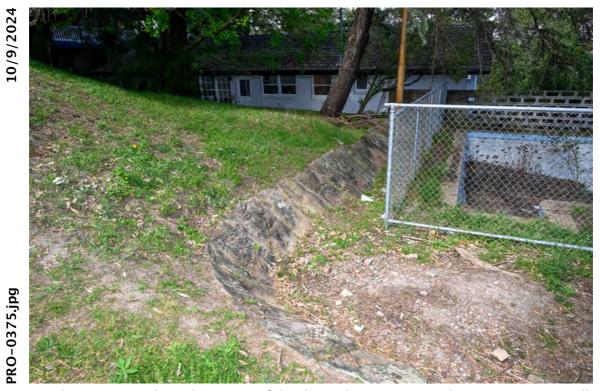
Southern property boundary. Area of the disused swimming pool. Stone retaining wall.

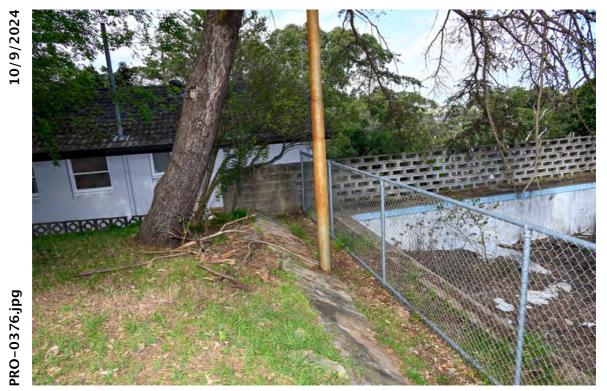
Southern property boundary. Area of the disused swimming pool. Stone retaining wall.

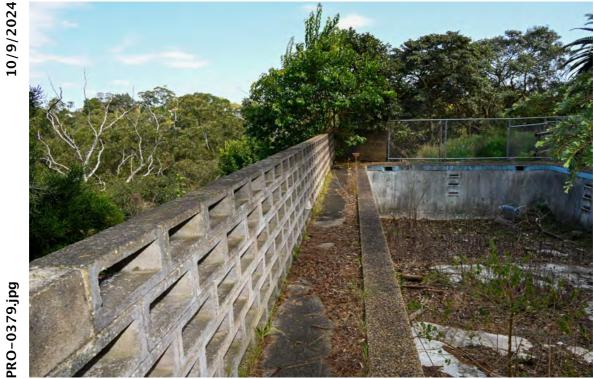
Southern property boundary. Heading east towards St Vincents Road. Breeze block breeze block boundary wall to the unused swimming pool.

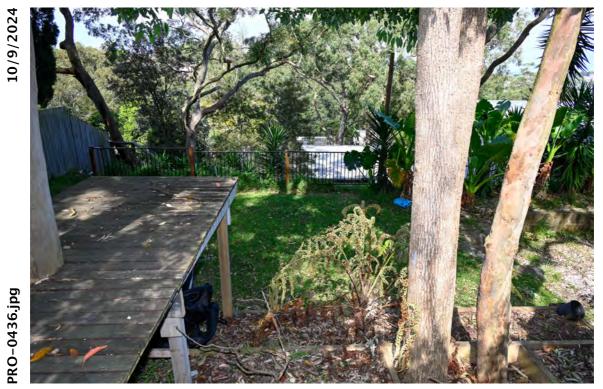
Southern property boundary. Heading east towards St Vincents Road. Common boundary with 51 Gore Street.

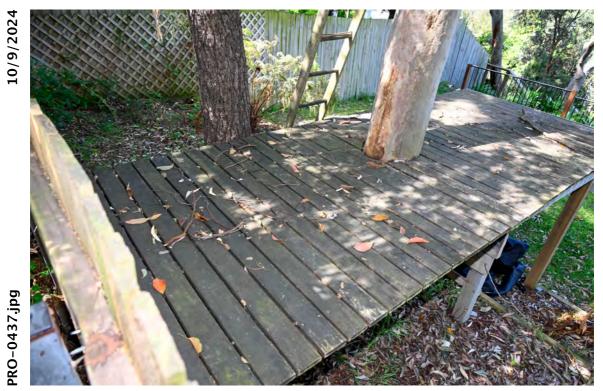
Southern property boundary. Heading east towards St Vincents Road. Common boundary with 51 Gore Street.

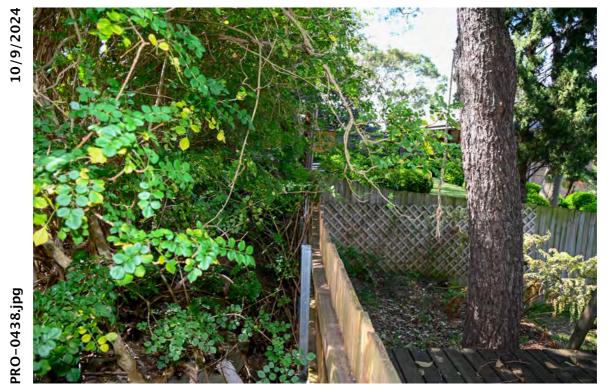
Southern property boundary. Heading east towards St Vincents Road. Common boundary with 51 Gore Street.

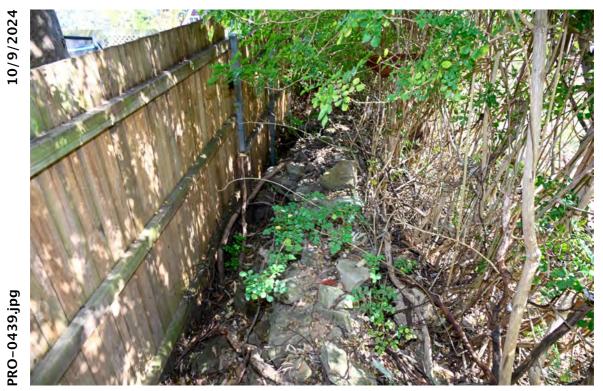
Southern property boundary. Heading east towards St Vincents Road. Common boundary with $51\ \text{Gore}$ Street.

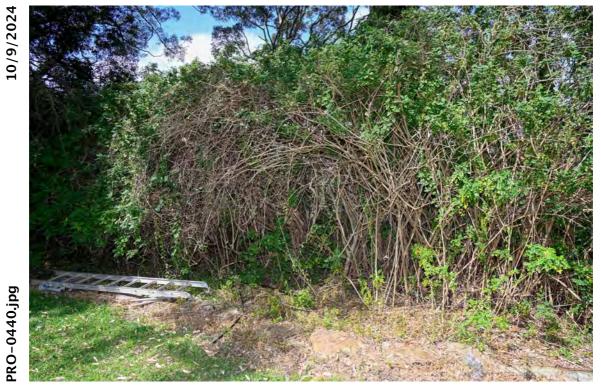
Southern property boundary. Heading east towards St Vincents Road. Common boundary with 51 Gore Street.

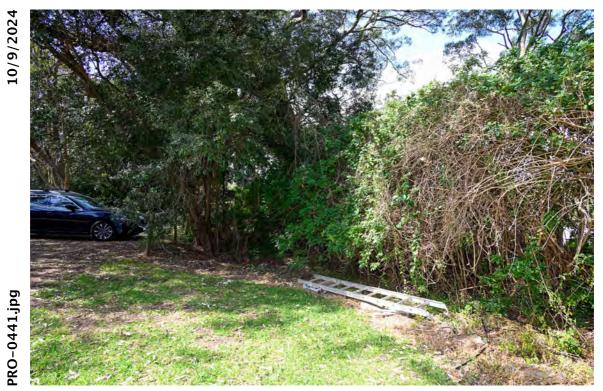
Southern property boundary. Heading east towards St Vincents Road. Common boundary with 51 Gore Street.

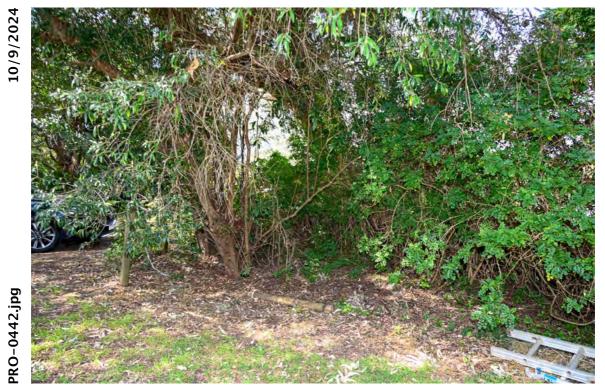
Southern property boundary. Heading east towards St Vincents Road. Common boundary with 51–47 Gore Street.

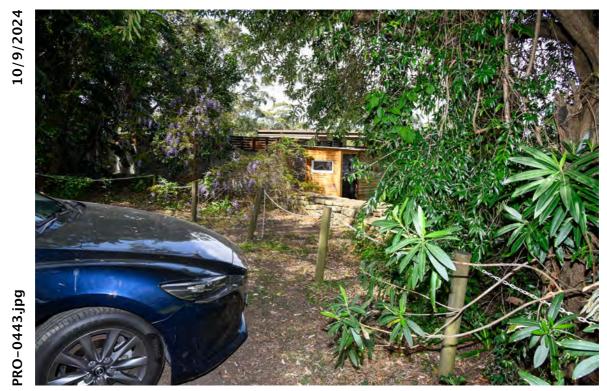
Southern property boundary. Heading east towards St Vincents Road. Common boundary with 51–47 Gore Street.

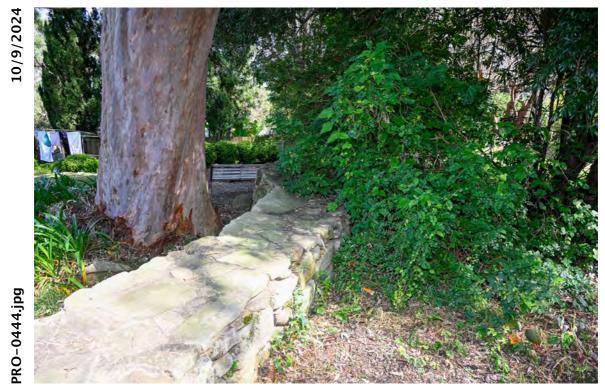
Southern property boundary. Heading east towards St Vincents Road. Common boundary with 51-47 Gore Street.

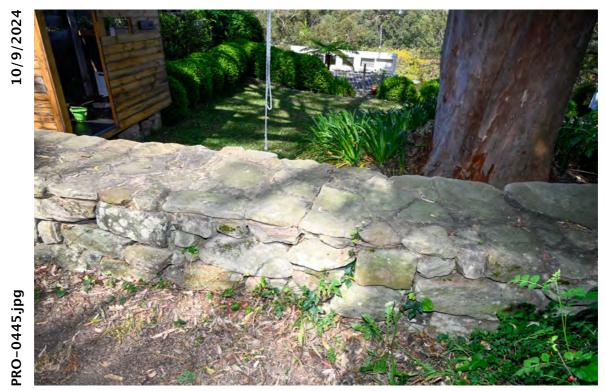
Southern property boundary. Heading east towards St Vincents Road. Common boundary with 51-47 Gore Street.

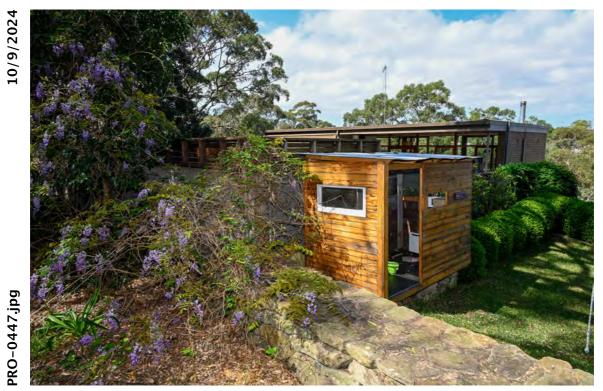
Southern property boundary. Heading east towards St Vincents Road. Common boundary with 51–47 Gore Street.

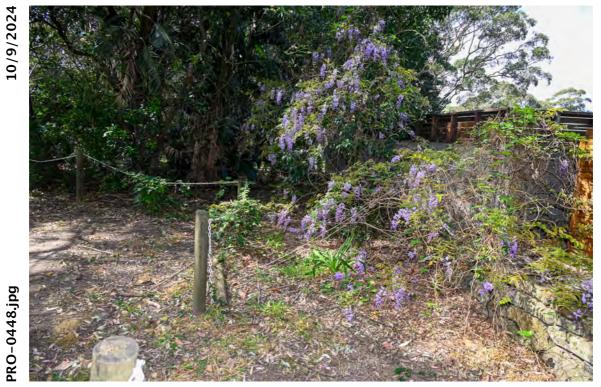
Southern property boundary. Heading east towards St Vincents Road. Common boundary with 51--47 Gore Street.

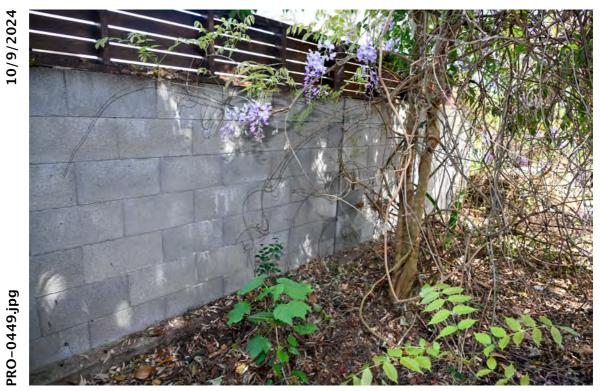
Southern property boundary. Heading east towards St Vincents Road. Common boundary with 51-47 Gore Street.

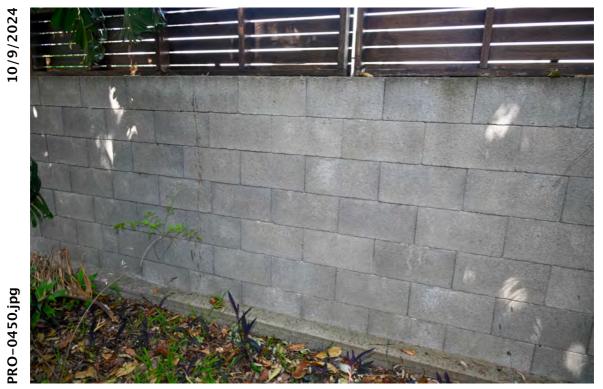
Southern property boundary. Heading east towards St Vincents Road. Common boundary with 51--47 Gore Street.

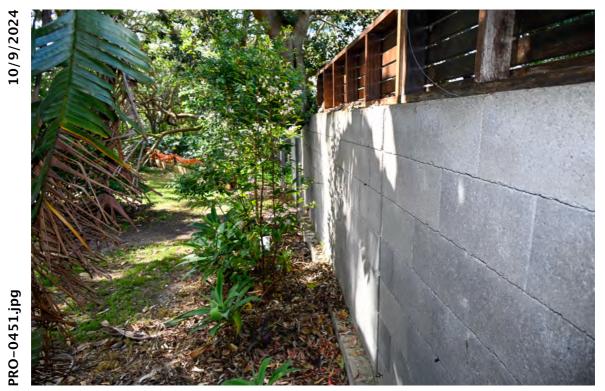
Southern property boundary. Heading east towards St Vincents Road. Common boundary with 51--47 Gore Street.

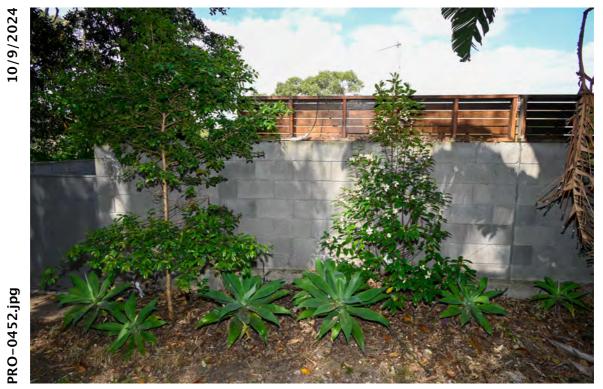
Southern property boundary. Heading east towards St Vincents Road. Common boundary with 51--47 Gore Street.

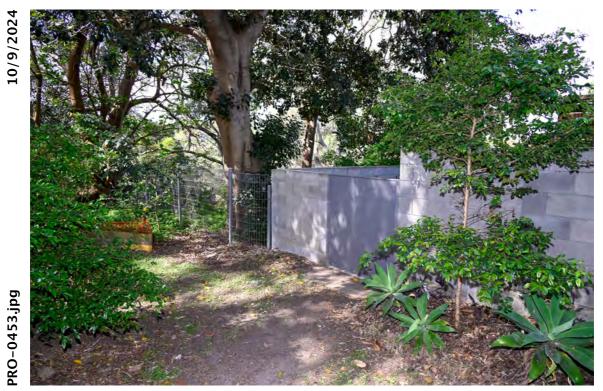
Southern property boundary. Heading east towards St Vincents Road. Common boundary with 51-47 Gore Street.

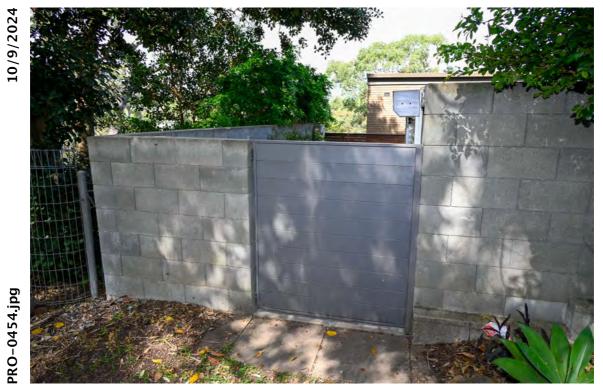
Southern property boundary. Heading east towards St Vincents Road. Common boundary with 51--47 Gore Street.

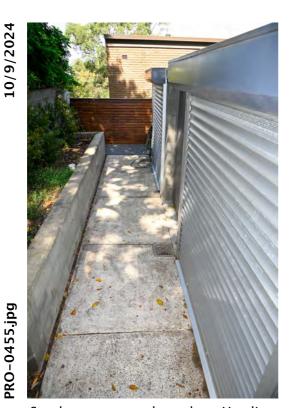
Southern property boundary. Heading east towards St Vincents Road. Common boundary with 51–47 Gore Street.

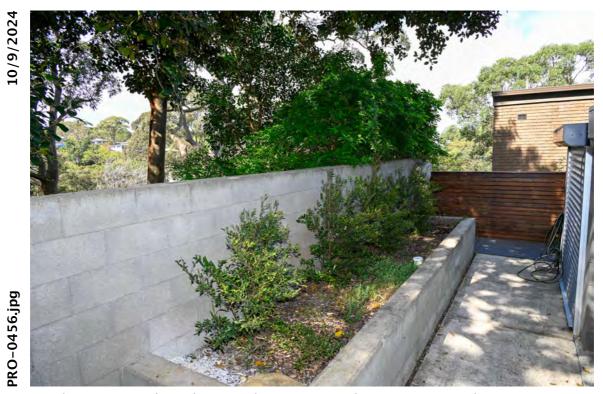
Southern property boundary. Heading east towards St Vincents Road. Common boundary with 51-47 Gore Street.

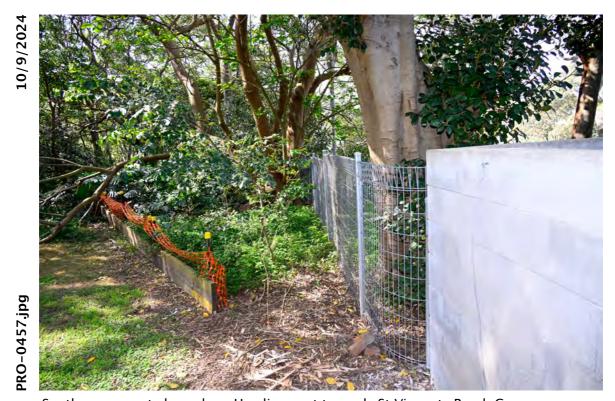
Southern property boundary. Heading east towards St Vincents Road. Common boundary with 47 Gore Street.

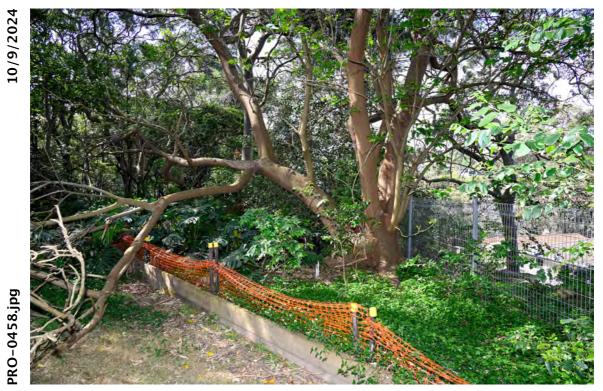
Southern property boundary. Heading east towards St Vincents Road. Common boundary with 47 Gore Street.

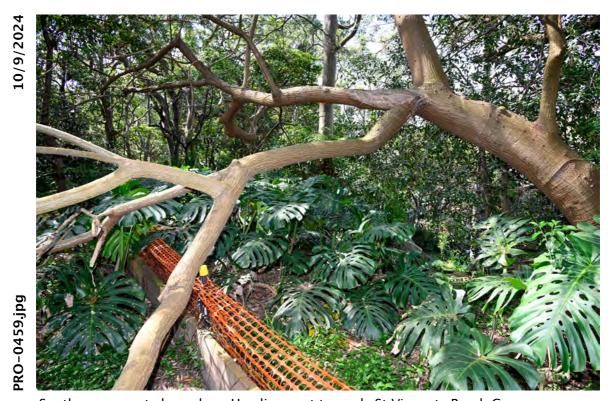
Southern property boundary. Heading east towards St Vincents Road. Common boundary with 47 Gore Street. Fallen tree limb.

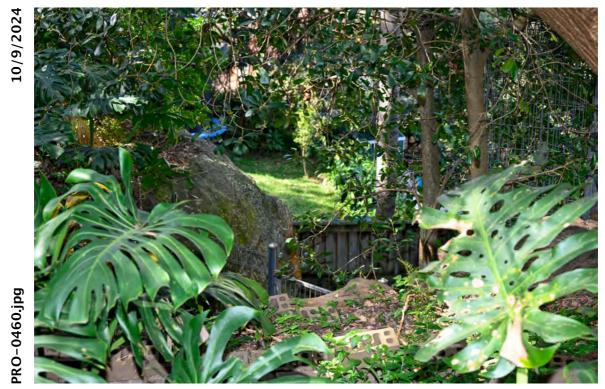
Southern property boundary. Heading east towards St Vincents Road. Common boundary with 47 Gore Street.

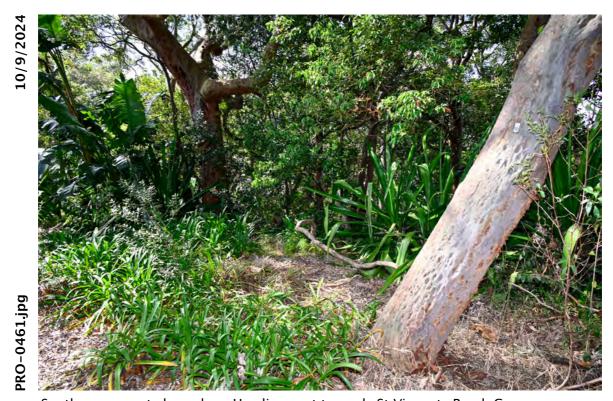
Southern property boundary. Heading east towards St Vincents Road. Common boundary with 45 Gore Street.

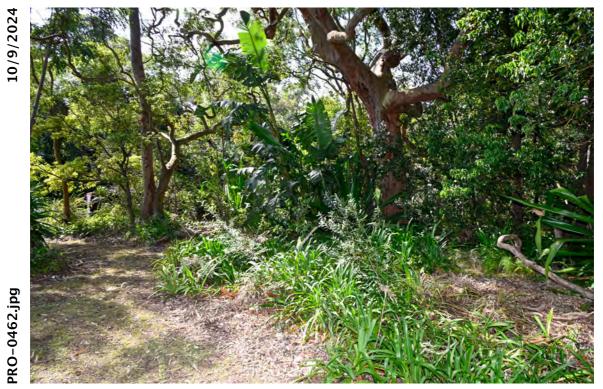
Southern property boundary. Heading east towards St Vincents Road. Common boundary with 45 Gore Street.

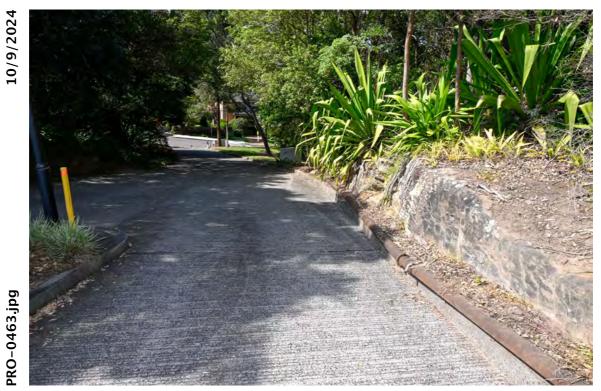
Southern property boundary. Heading east towards St Vincents Road. Area of the common boundary with 43-35 Gore Street.

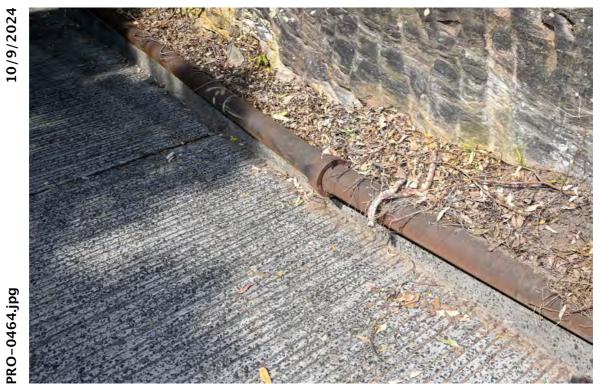
Southern property boundary. Heading east towards St Vincents Road. Area of the common boundary with 43-35 Gore Street.

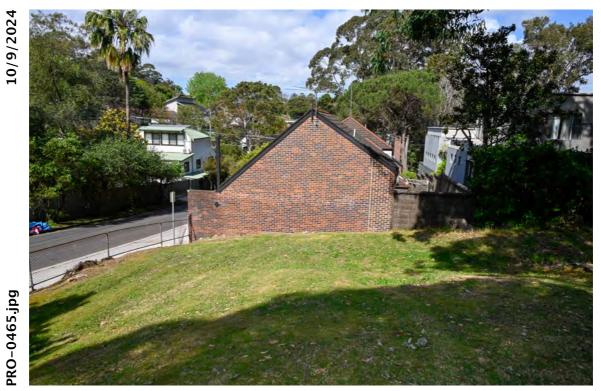
Southern property boundary. Area of the common boundary with 35 Gore Street.
