Greenwich Hospital Redevelopment

Stage 1 - Early Works

DILAPIDATION REPORT

10th September 2024

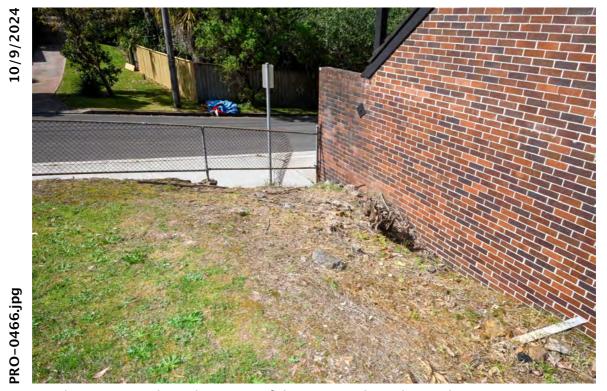
Southern property boundary. Area of the common boundary with 35 Gore Street.

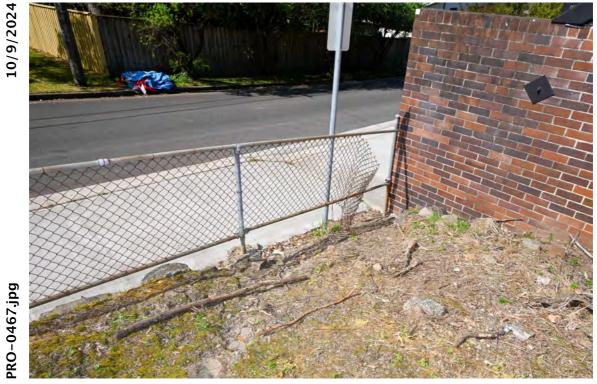
Southern property boundary. Area of the common boundary with 35 Gore Street.

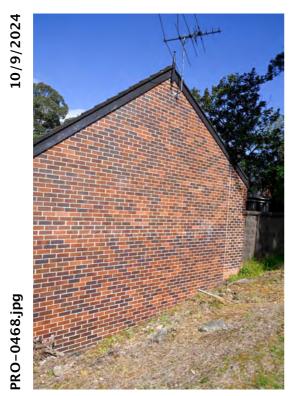
Southern property boundary. Area of the common boundary with 35 Gore Street.

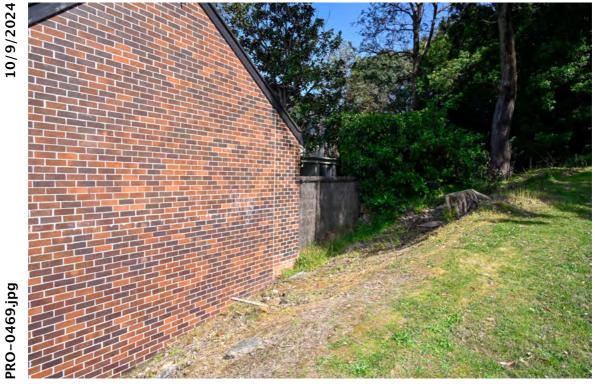
Southern property boundary. Area of the common boundary with 35 Gore Street.

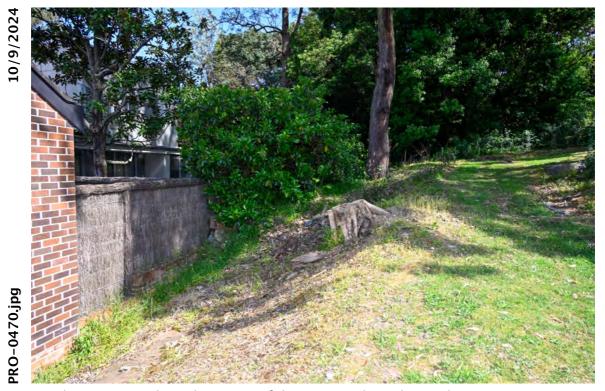
Southern property boundary. Area of the common boundary with 35 Gore Street.

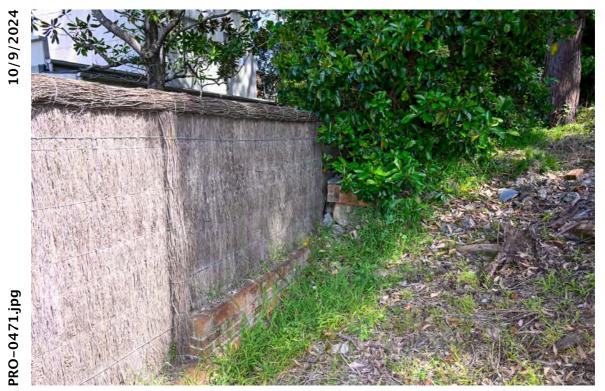
Southern property boundary. Area of the common boundary with 35 Gore Street.

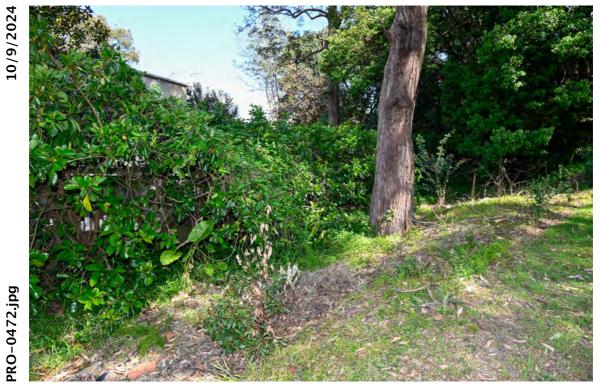
Southern property boundary. Area of the common boundary with 37 Gore Street. Heading west.

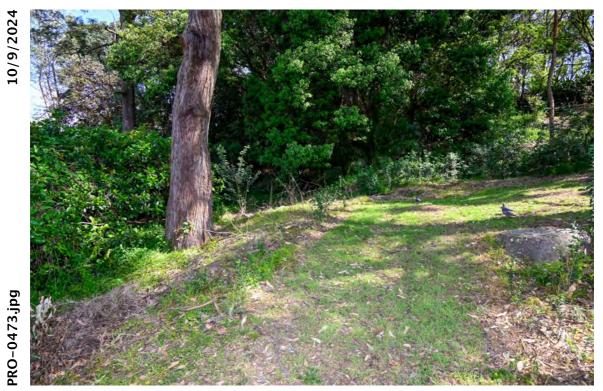
Southern property boundary. Area of the common boundary with 37 Gore Street. Heading west.

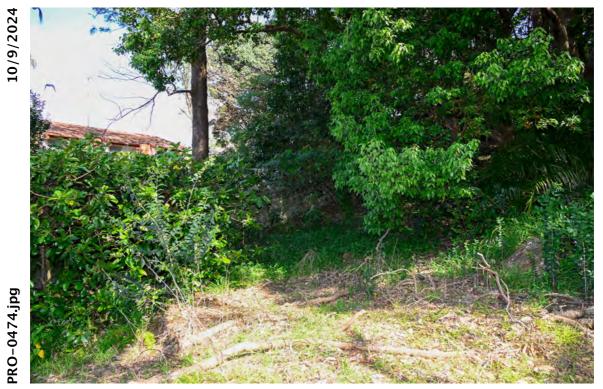
Southern property boundary. Area of the common boundary with 37 Gore Street. Heading west.

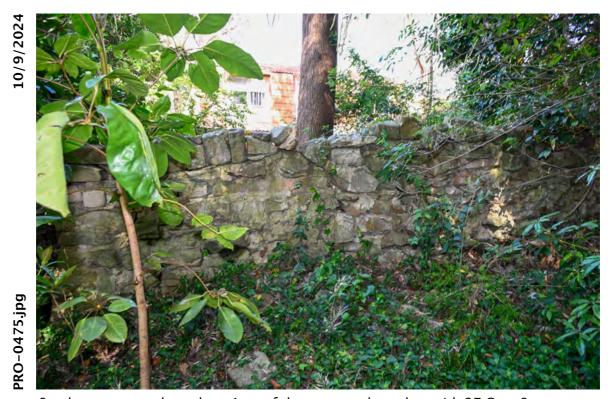
Southern property boundary. Area of the common boundary with 37 Gore Street. Heading west.

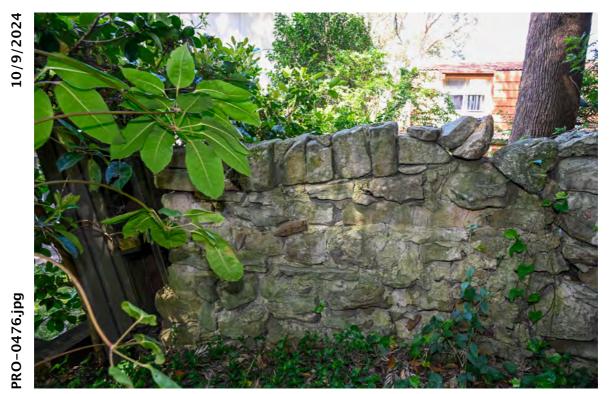
Southern property boundary. Area of the common boundary with 39 Gore Street. Heading west.

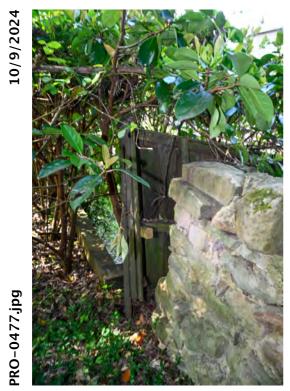
Southern property boundary. Area of the common boundary with 39 Gore Street. Heading west.

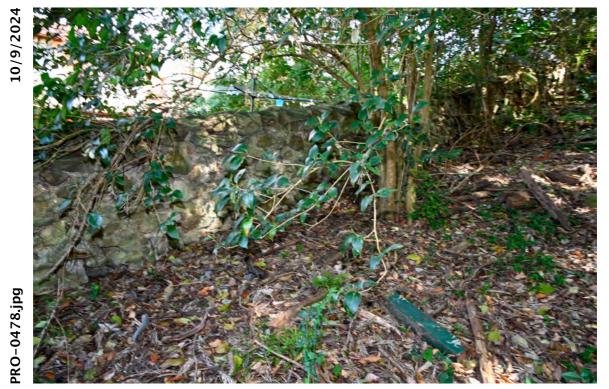
Southern property boundary. Area of the common boundary with 39 Gore Street. Heading west.

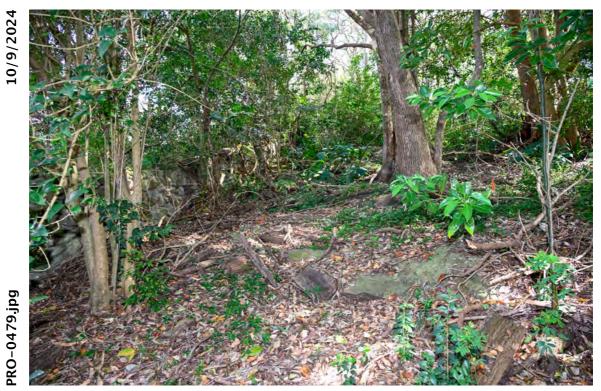
Southern property boundary. Area of the common boundary with 39 Gore Street. Heading west.

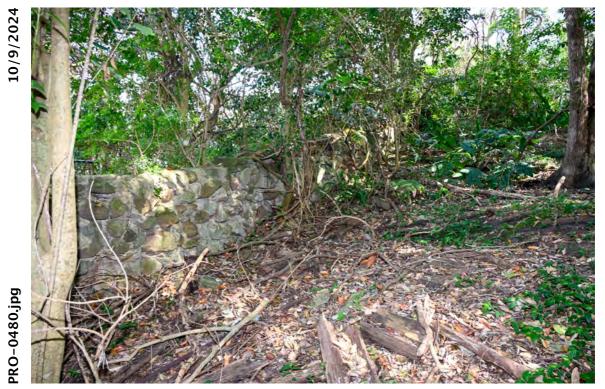
Southern property boundary. Area of the common boundary with 39 Gore Street. Heading west.

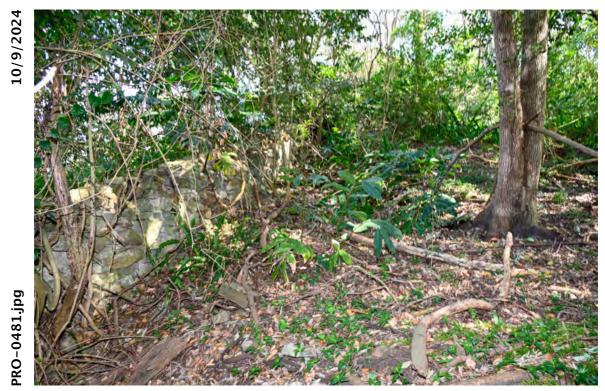
Southern property boundary. Area of the common boundary with 39 Gore Street. Heading west.

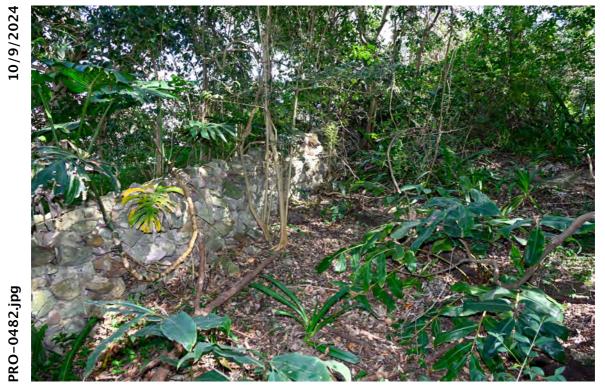
Southern property boundary. Area of the common boundary with 39 Gore Street. Heading west.

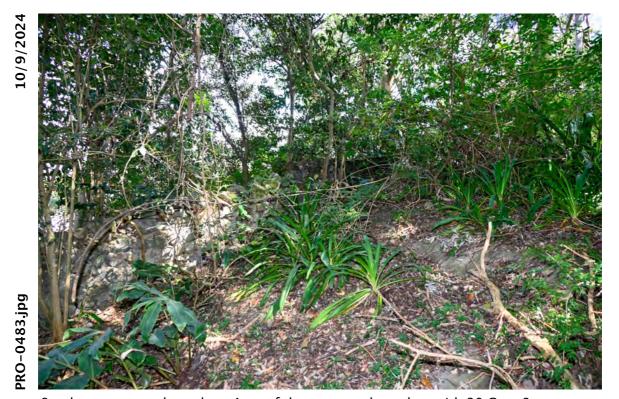
Southern property boundary. Area of the common boundary with 39 Gore Street. Heading west.

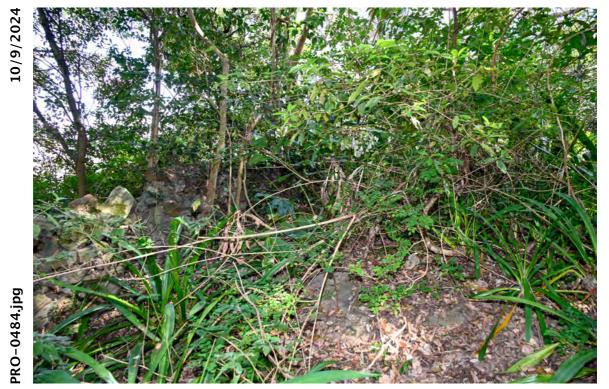
Southern property boundary. Area of the common boundary with 39 Gore Street. Heading west.

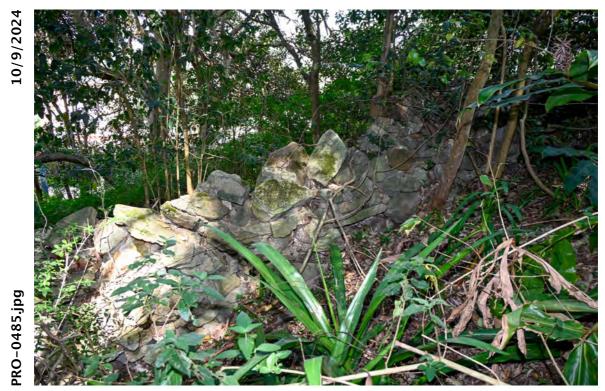
Southern property boundary. Area of the common boundary with 39 Gore Street. Heading west.

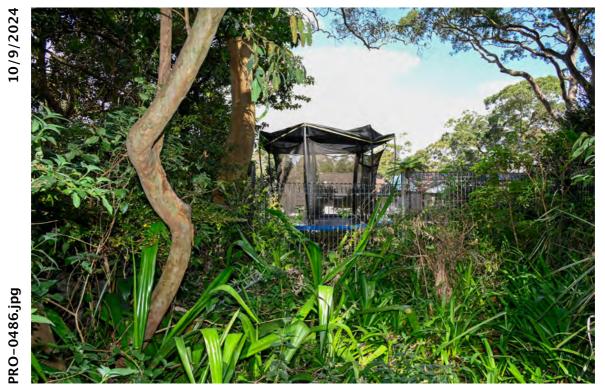
Southern property boundary. Area of the common boundary with 41 Gore Street. Heading west.

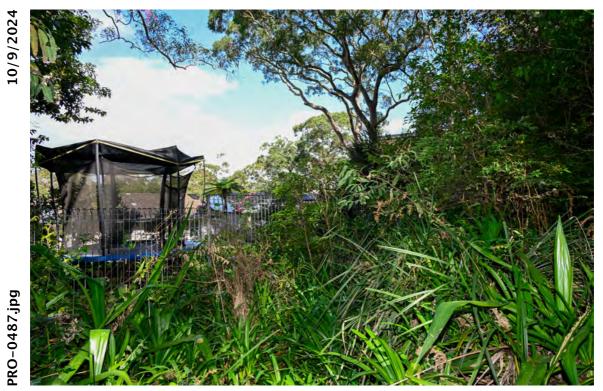
Southern property boundary. Area of the common boundary with 41 Gore Street. Heading west.

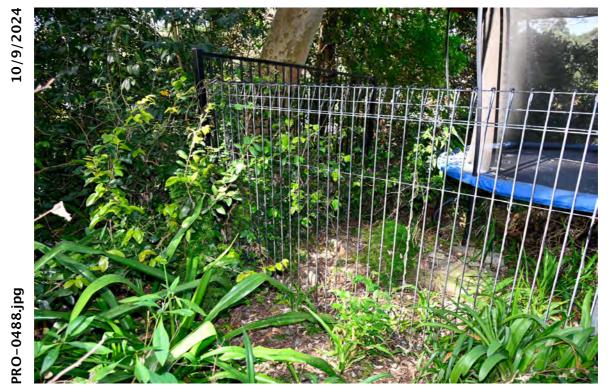
Southern property boundary. Area of the common boundary with 41 Gore Street. Heading west.

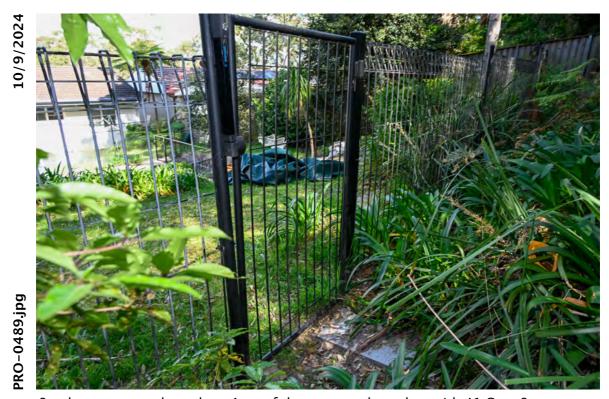
Southern property boundary. Area of the common boundary with 41 Gore Street. Heading west.

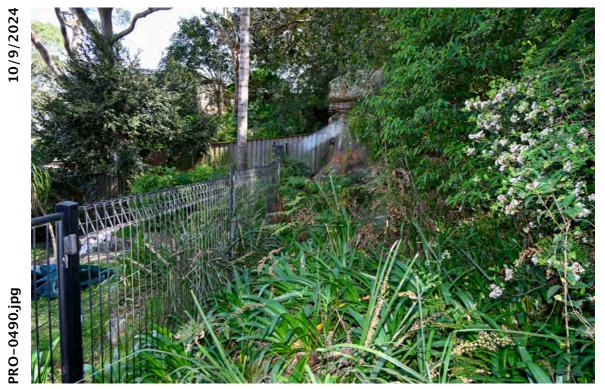
Southern property boundary. Area of the common boundary with 41 Gore Street. Heading west.

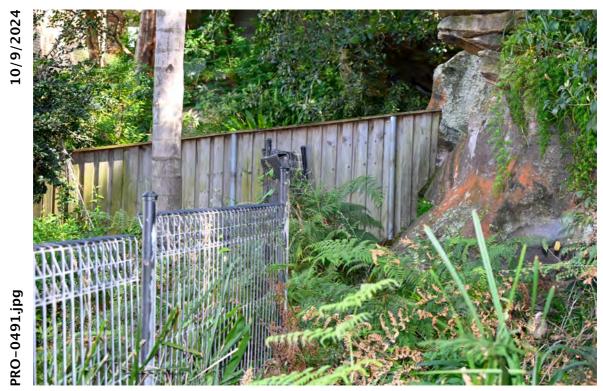
Southern property boundary. Area of the common boundary with 41 Gore Street. Heading west.

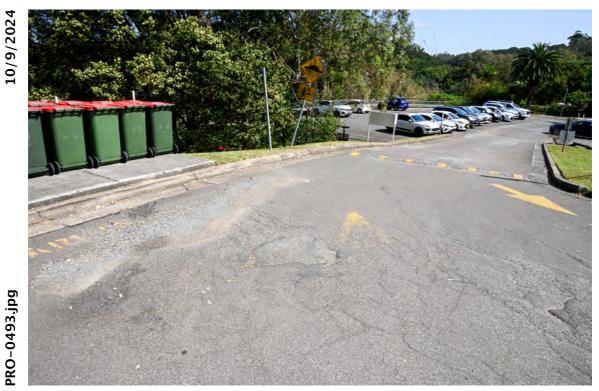
Western side of the property. Internal access road. Heading north towards River Road. Damaged road paving.

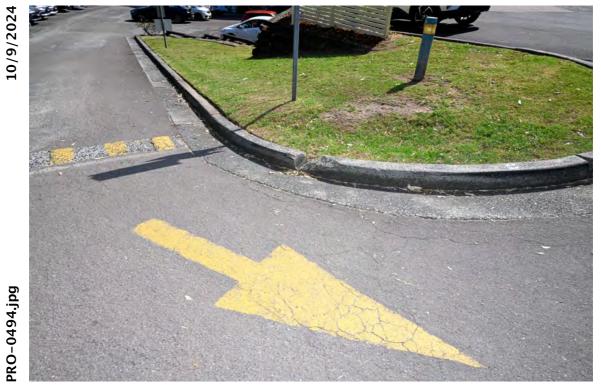
Western side of the property. Internal access road. Heading north towards River Road. Damaged kerb.

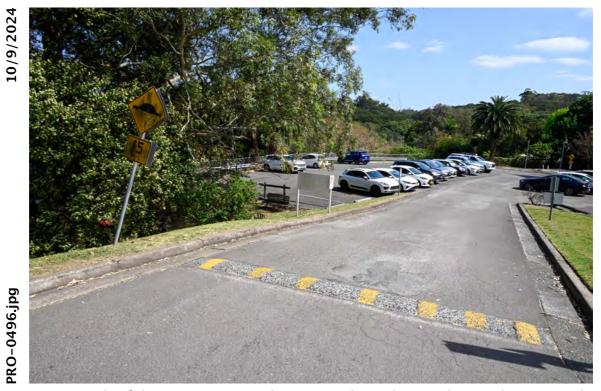
Western side of the property. Internal access road. Heading north towards River Road. Damaged road paving.

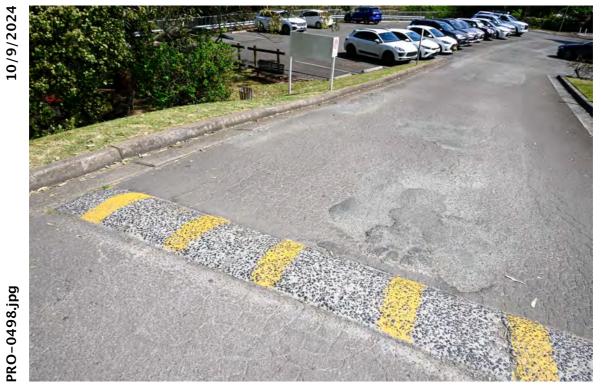
Western side of the property. Internal access road. Heading north towards River Road. Damaged road paving.

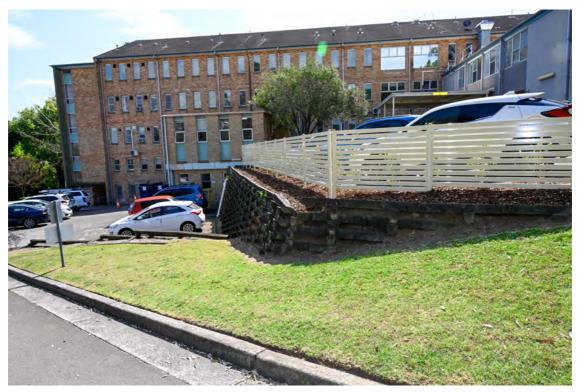
PRO-0500.jpg

Western side of the property. Internal access road. Heading north towards River Road. Damaged road paving.

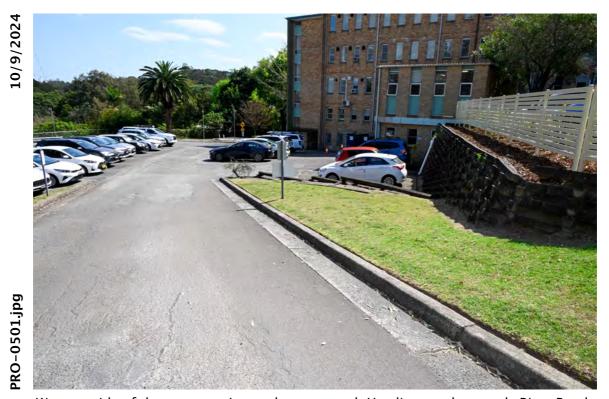
Western side of the property. Internal access road. Heading north towards River Road. Damaged road paving.

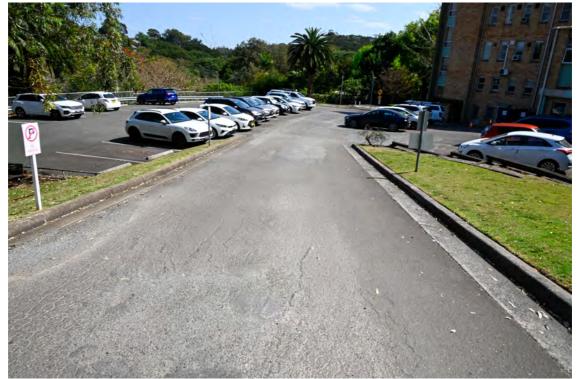
PRO-0502.jpg

Western side of the property. Internal access road. Heading north towards River Road. Damaged road paving.

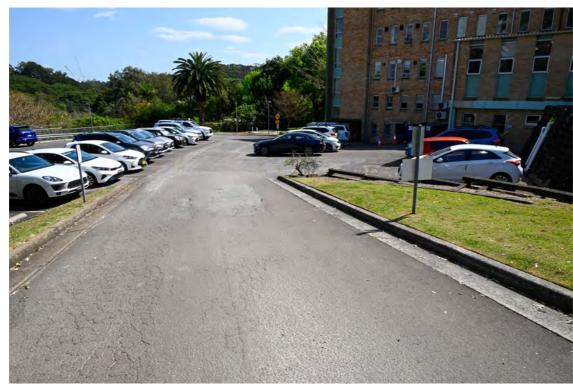
PRO-0506.jpg

Western side of the property. Internal access road. Heading north towards River Road. Damaged road paving.

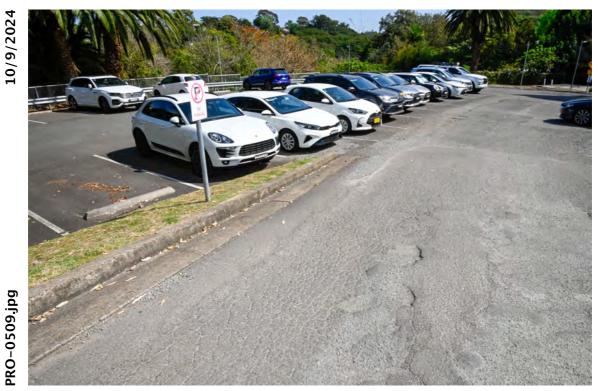
Western side of the property. Internal access road. Heading north towards River Road. Damaged road paving.

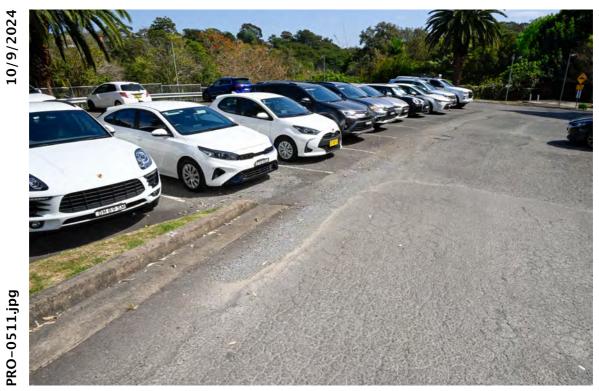
Western side of the property. Internal access road. Heading north towards River Road. Damaged road paving.

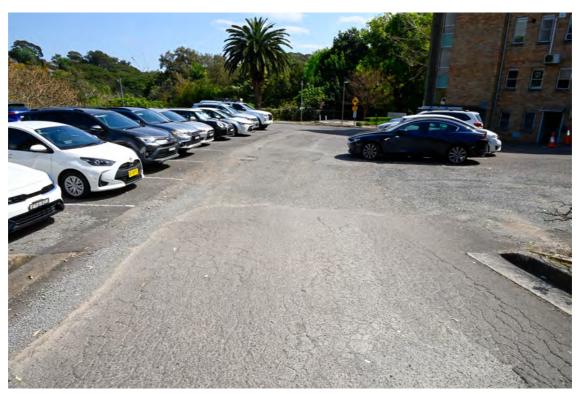
PRO-0512.jpg

Western side of the property. Internal access road. Heading north towards River Road. Damaged road paving.

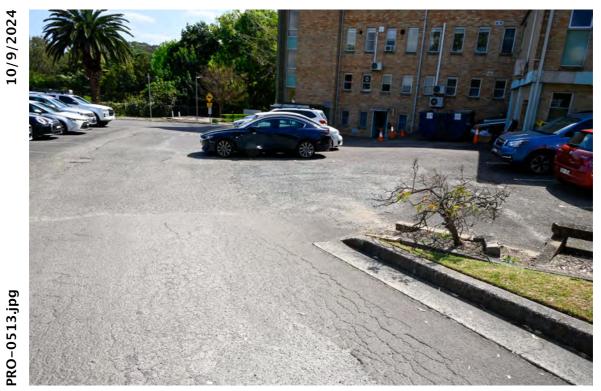
Western side of the property. Internal access road. Heading north towards River Road. Damaged road paving.

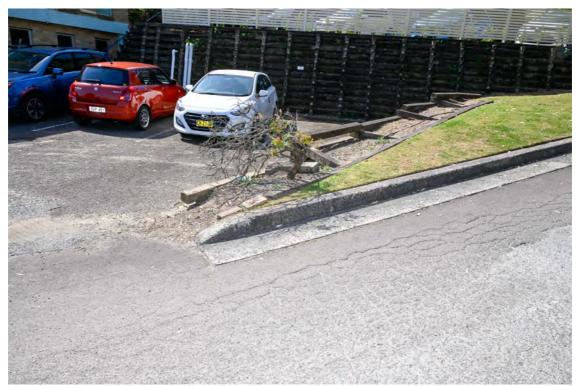
PRO-0514.jpg

Western side of the property. Internal access road. Heading north towards River Road. Damaged road paving.

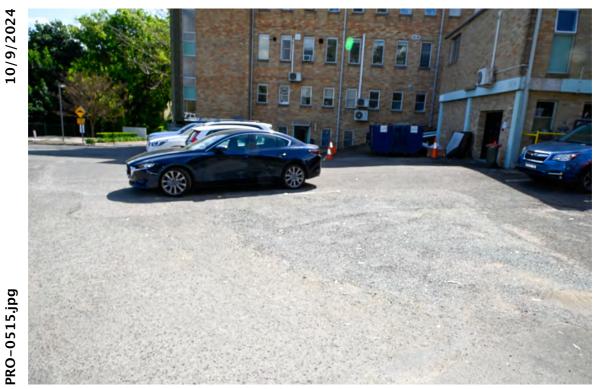
Western side of the property. Internal access road. Heading north towards River Road. Damaged road paving.

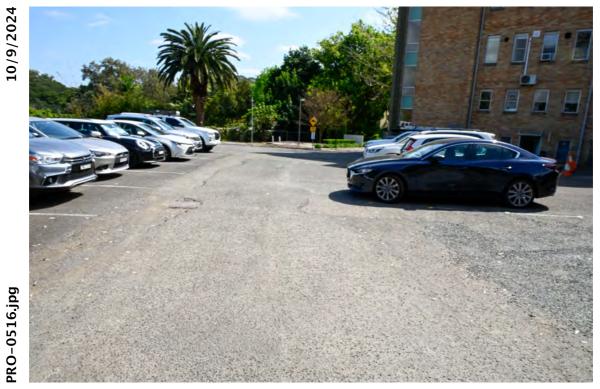
Western side of the property. Internal access road. Heading north towards River Road. Damaged road paving.

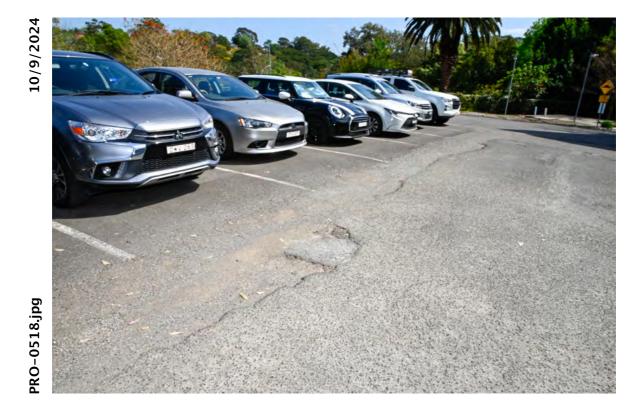
Western side of the property. Internal access road. Heading north towards River Road. Damaged road paving.

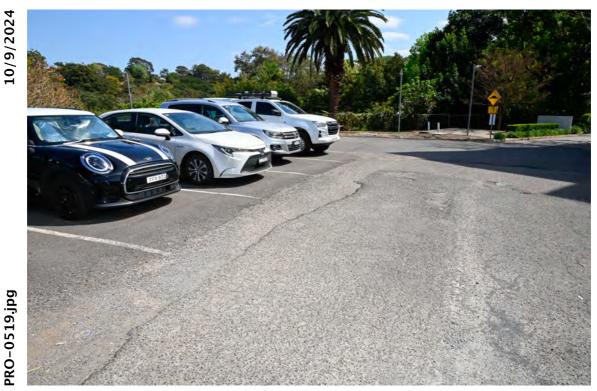
Western side of the property. Internal access road. Heading north towards River Road. Damaged road paving.

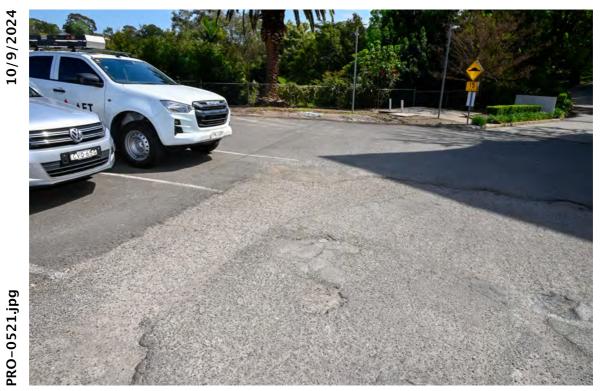
Western side of the property. Internal access road. Heading north towards River Road. Damaged road paving.

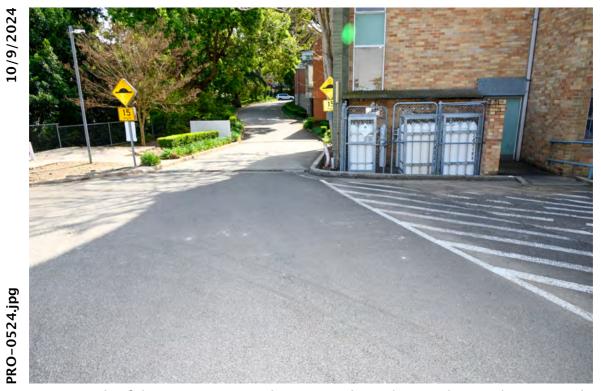
Western side of the property. Internal access road. Heading north towards River Road. Damaged road paving.

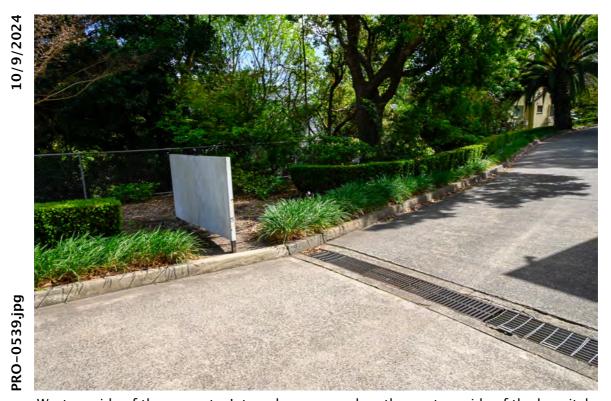
Western side of the property. Internal access road on the western side of the hospital building. Heading north towards River Road. Strip drain.

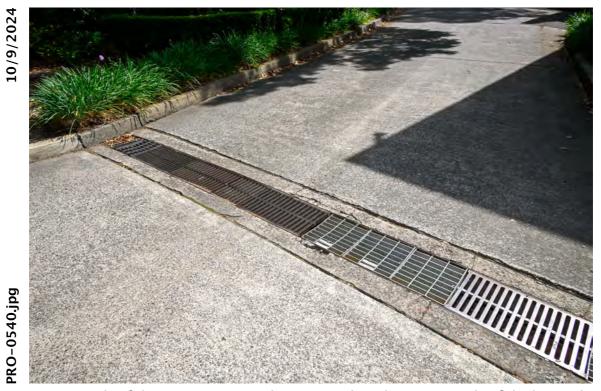
Western side of the property. Internal access road on the western side of the hospital building. Heading north towards River Road. Strip drain.

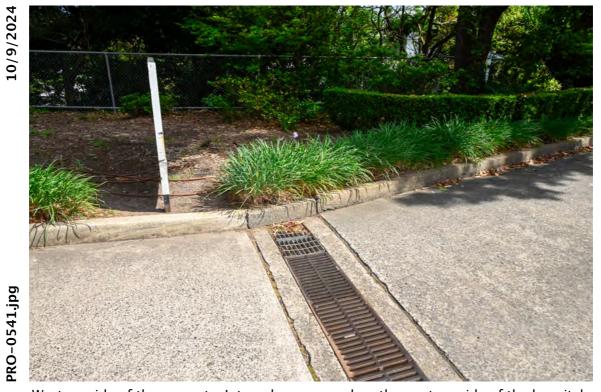
Western side of the property. Internal access road on the western side of the hospital building. Heading north towards River Road. Strip drain.

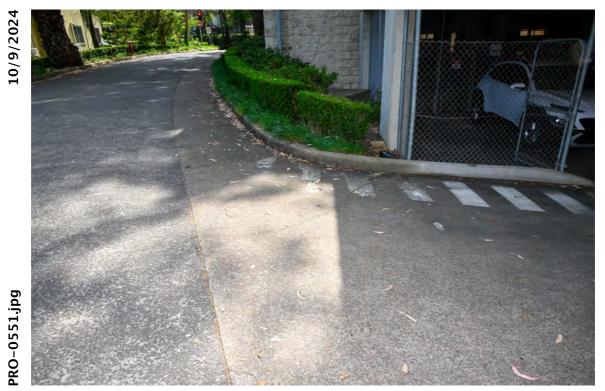
Western side of the property. Internal access road on the western side of the hospital building. Heading north towards River Road. Cracked paving.

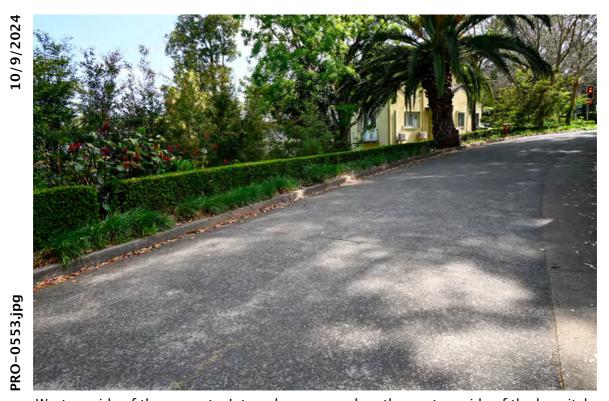
Western side of the property. Internal access road on the western side of the hospital building. Heading north towards River Road. Cracked paving.

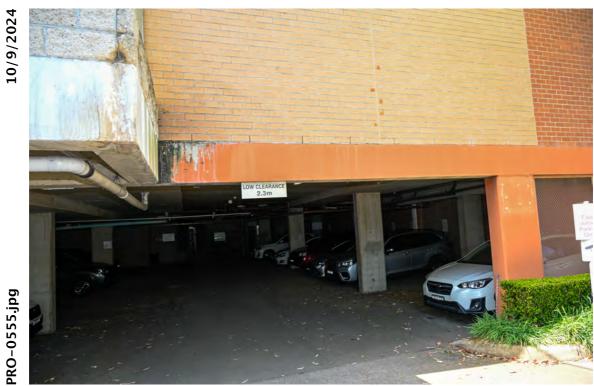
Western side of the property. Internal access road on the western side of the hospital building. Heading north towards River Road. Structure above the undercover parking.

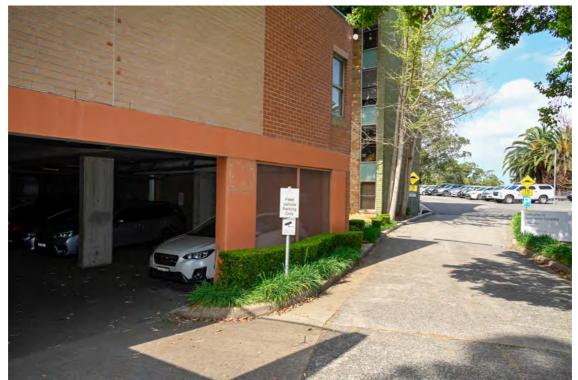
PRO-0556.jpg

Western side of the property. Internal access road on the western side of the hospital building. Heading north towards River Road. Structure above the undercover parking.

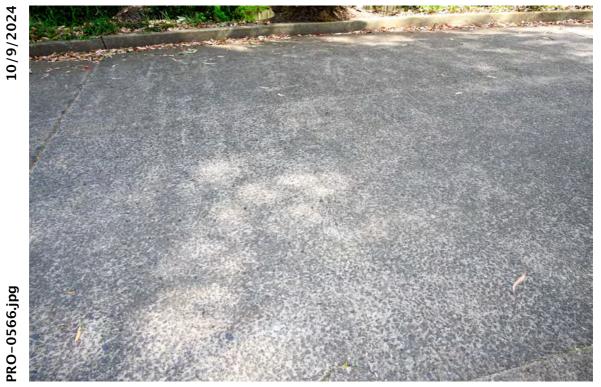
Western side of the property. Internal access road on the western side of the hospital building. Heading north towards River Road. Cracked paving.

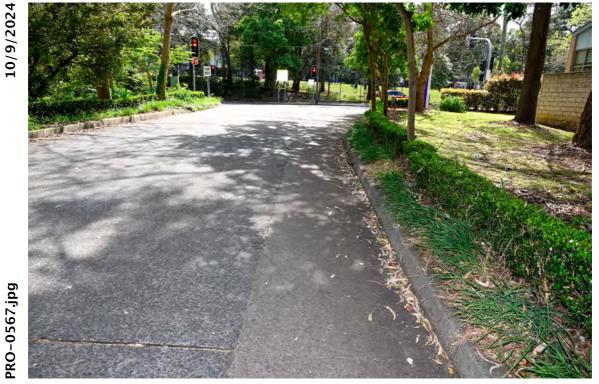
Western side of the property. Internal access road on the western side of the hospital building. Heading north towards River Road. Cracked paving.

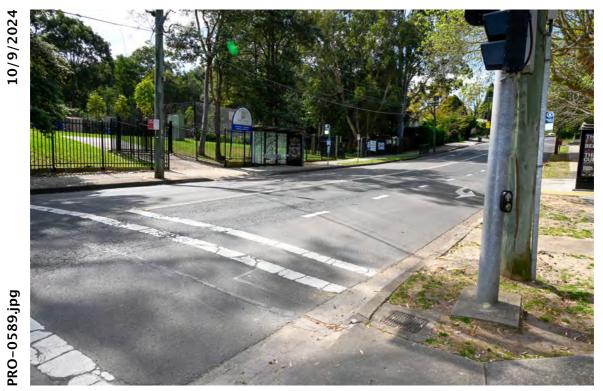
Internal access road on the western side of the hospital building. Intersection with River Road. Cracked and crazed road paving.

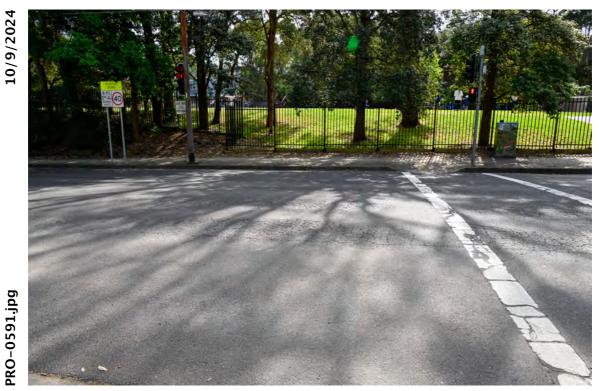
Internal access road on the western side of the hospital building. Intersection with River Road. Cracked and crazed road paving.

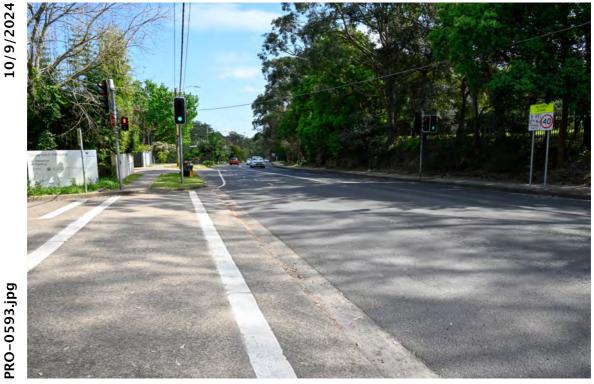
Internal access road on the western side of the hospital building. Intersection with River Road. Cracked and crazed road paving.

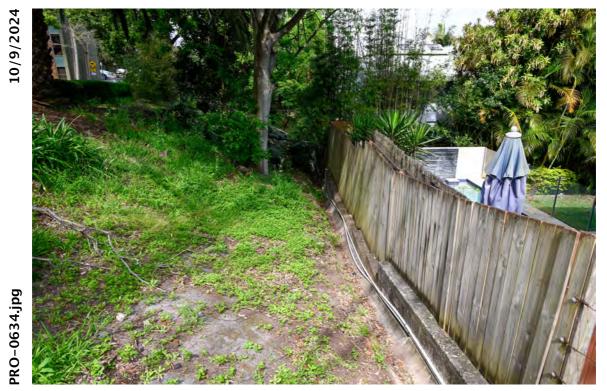
Western hospital boundary. Heading south. Area adjacent to the common boundary with 117 River Road.

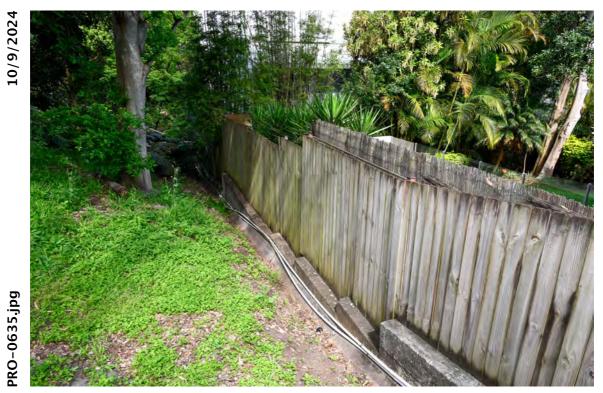
Western hospital boundary. Heading south. Area adjacent to the common boundary with 117 River Road.

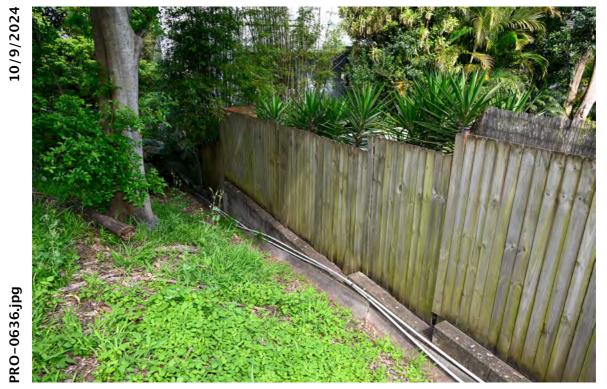
Western hospital boundary. Heading south. Area adjacent to the common boundary with 117 River Road.

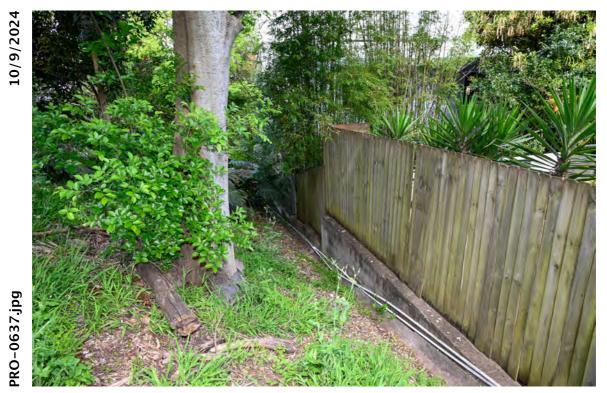
Western hospital boundary. Heading south. Area adjacent to the common boundary with 117 River Road.

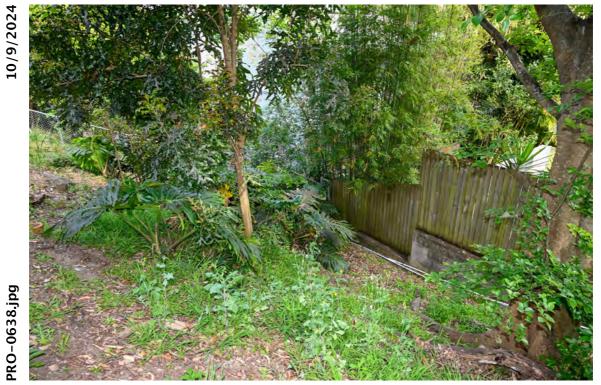
Western hospital boundary. Heading south. Area adjacent to the common boundary with 117 River Road.

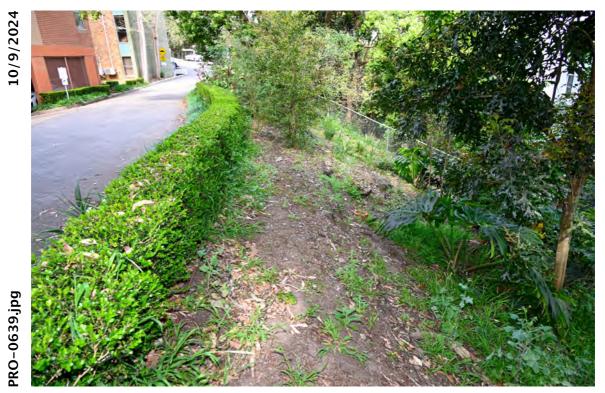
Western hospital boundary. Heading south. Area adjacent to the common boundary with 117 River Road.

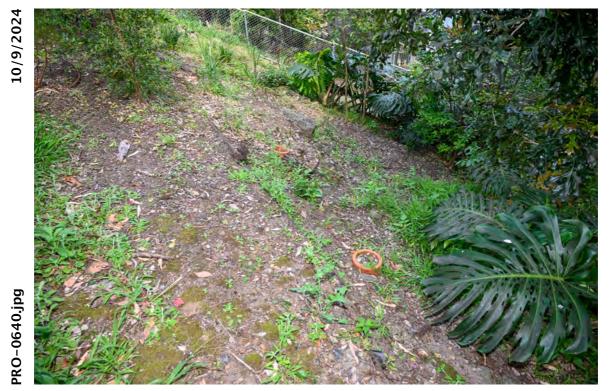
Western hospital boundary. Heading south. Area adjacent to the common boundary with 117 River Road.

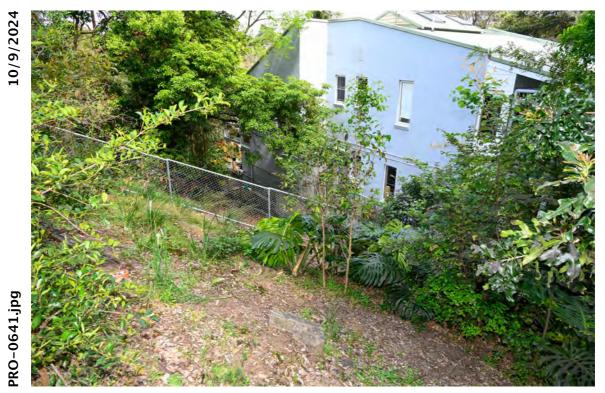
Western hospital boundary. Heading south. Area adjacent to the common boundary with 117 River Road.

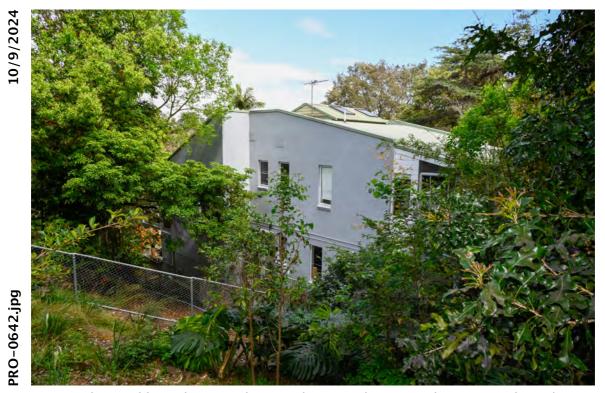
Western hospital boundary. Heading south. Area adjacent to the common boundary with 117B River Road.

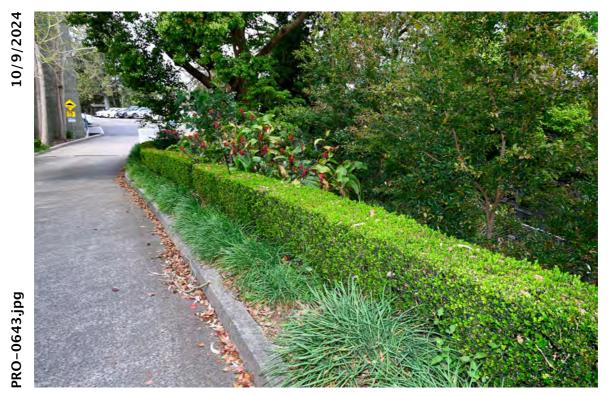
Western hospital boundary. Heading south. Area adjacent to the common boundary with 117B River Road.

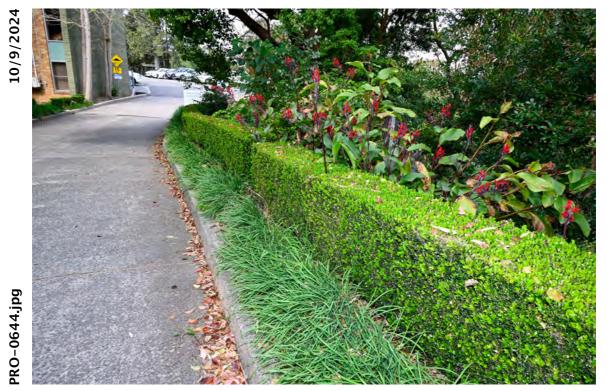
Western hospital boundary. Heading south. Area adjacent to the common boundary with 117B River Road.

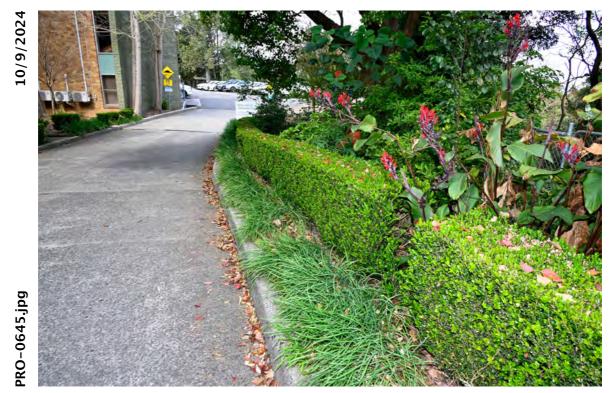
Western hospital boundary. Heading south. Area adjacent to the common boundary with 117B River Road.

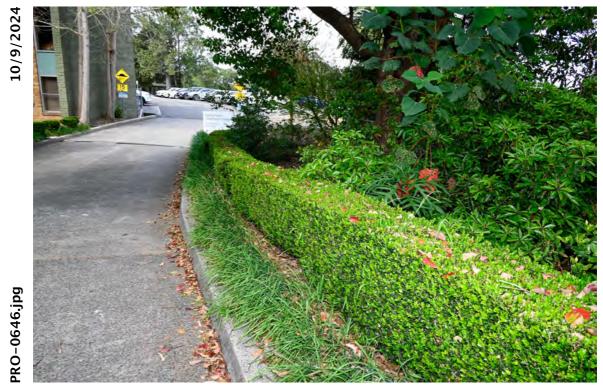
Western hospital boundary. Heading south. Area adjacent to the common boundary with 117B River Road.

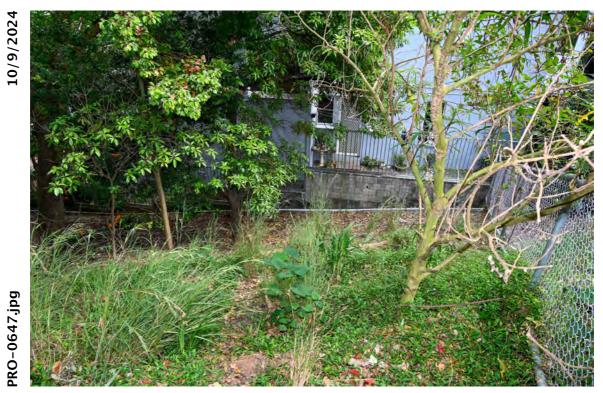
Western hospital boundary. Heading south. Area adjacent to the common boundary with 117B River Road.

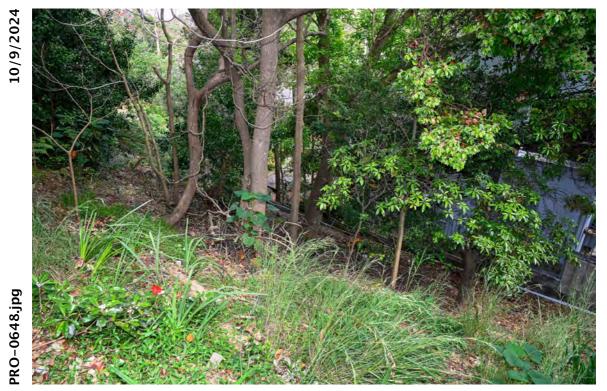
Western hospital boundary. Heading south. Area adjacent to the common boundary with 117B River Road.

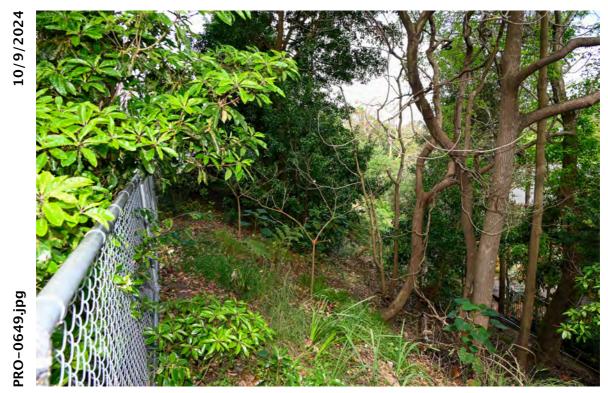
Western hospital boundary. Heading south. Area adjacent to the common boundary with 117B River Road.

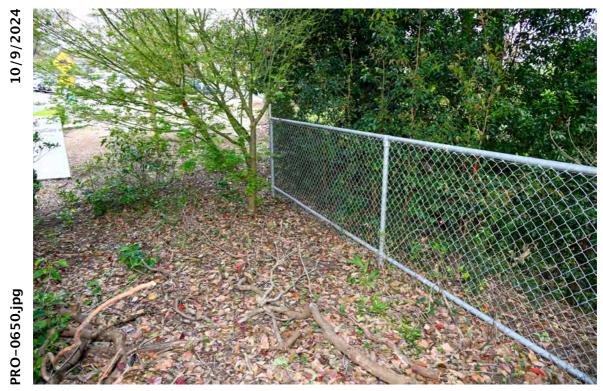
Western hospital boundary. Heading south. Area adjacent to the common boundary with 117B River Road.

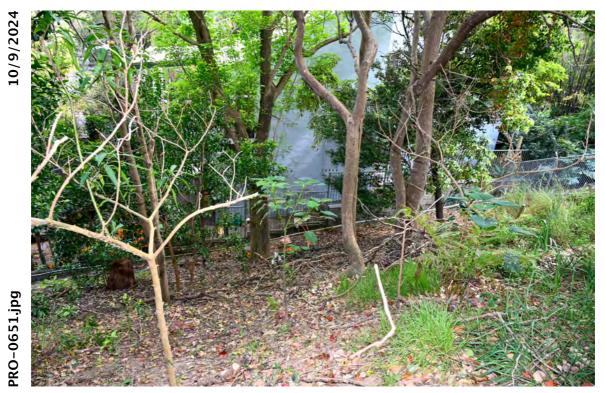
Western hospital boundary. Heading south. Area adjacent to the common boundary with 117B River Road.

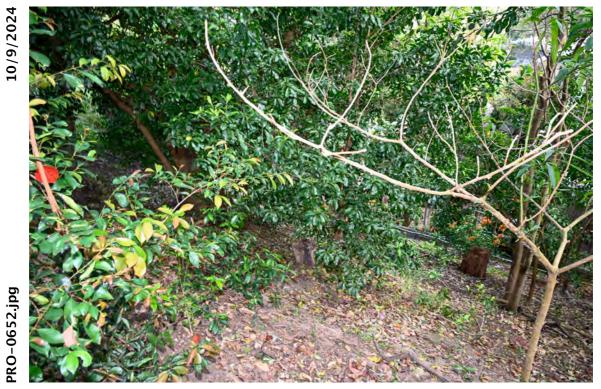
Western hospital boundary. Heading south. Area adjacent to the common boundary with 117B River Road.

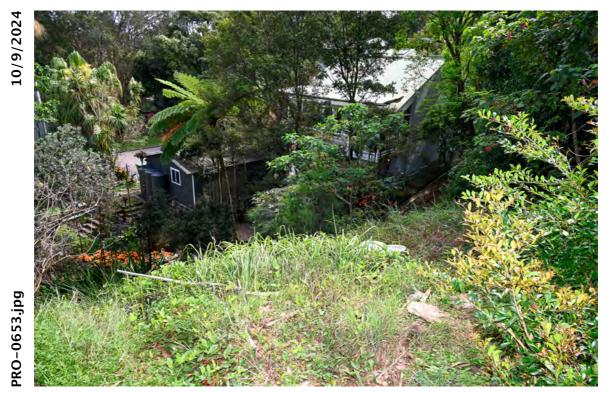
Western hospital boundary. Heading south. Area adjacent to the common boundary with 117B River Road.

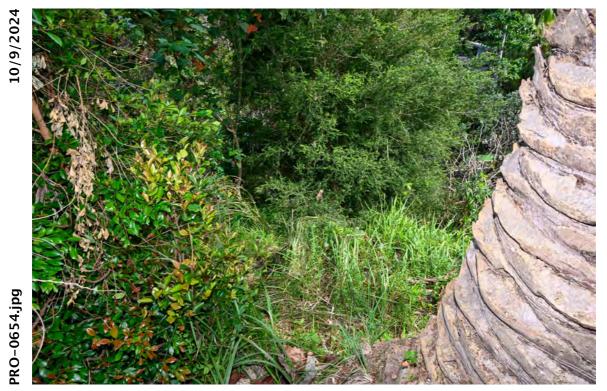
Western hospital boundary. Heading south. Area adjacent to the common boundary with 117B River Road.

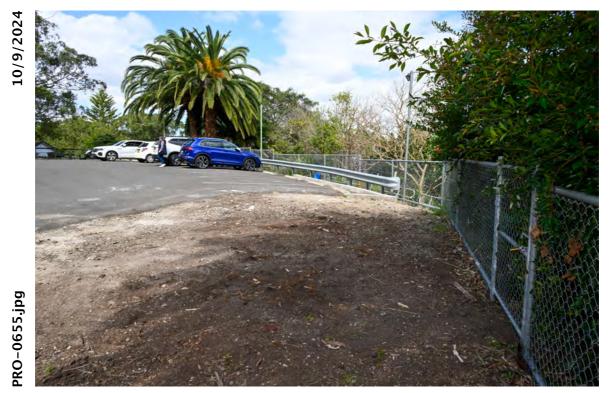
Western hospital boundary. Heading south. Area adjacent to the common boundary with 117B River Road.

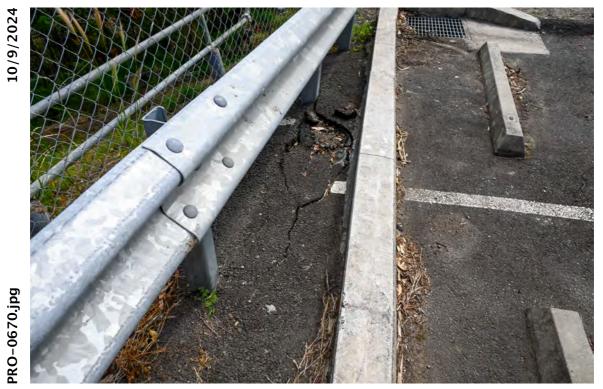
Western hospital boundary. Heading south. Area adjacent to the common boundary with 117B River Road.

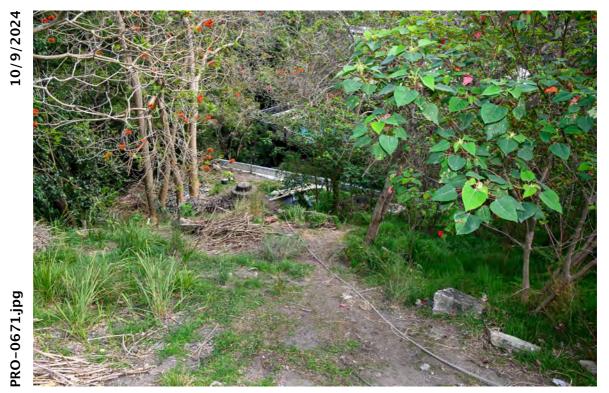
Western hospital boundary. Heading south. Area adjacent to the common boundary with 117B River Road. Subsistence to the paving.

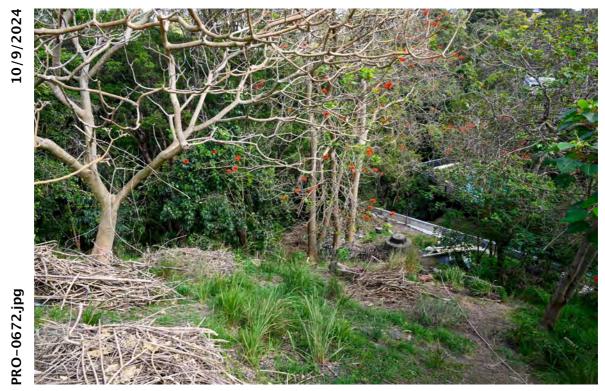
Western hospital boundary. Heading south. Area adjacent to the common boundary with 117B River Road.

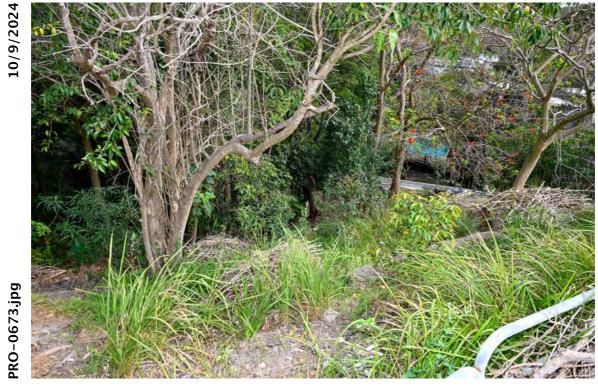
Western hospital boundary. Heading south. Area adjacent to the common boundary with 117A River Road.

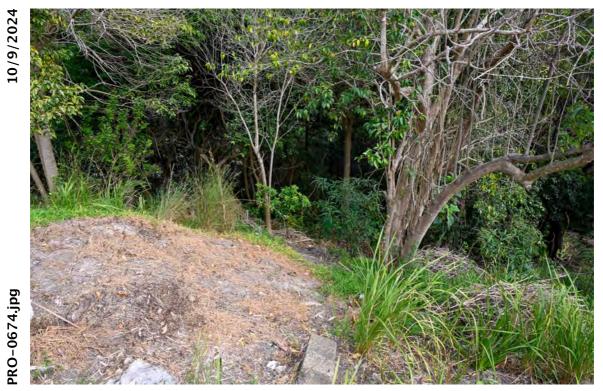
Western hospital boundary. Heading south. Area adjacent to the common boundary with 117A River Road.

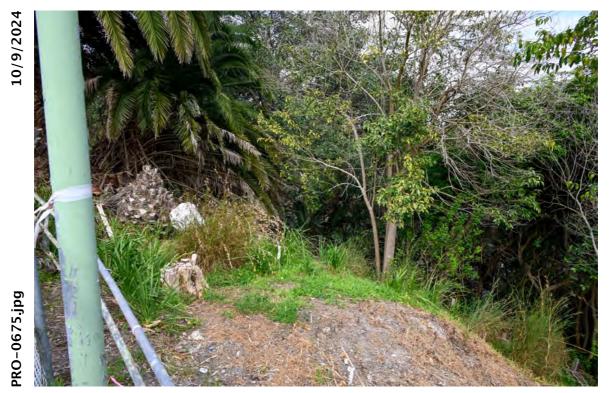
Western hospital boundary. Heading south. Area adjacent to the common boundary with 117A River Road.

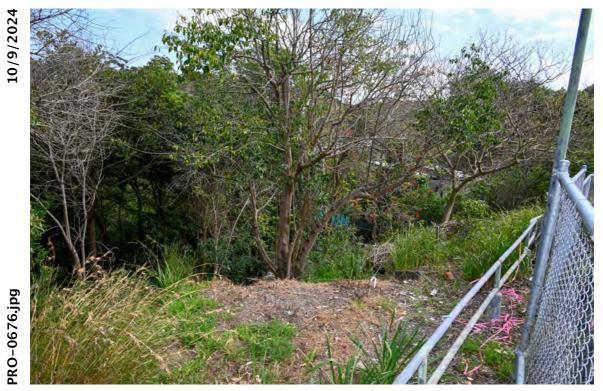
Western hospital boundary. Heading south. Area adjacent to the common boundary with 117A River Road.

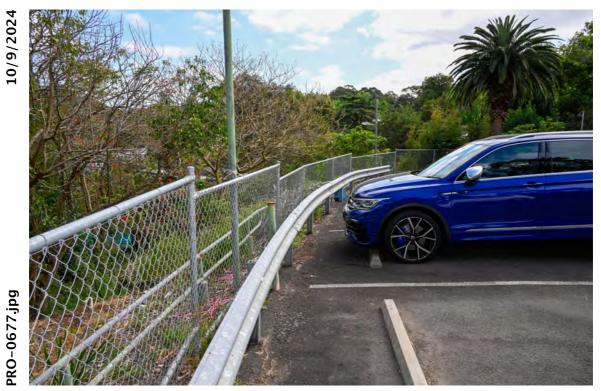
Western hospital boundary. Heading south. Area adjacent to the common boundary with 117A River Road.

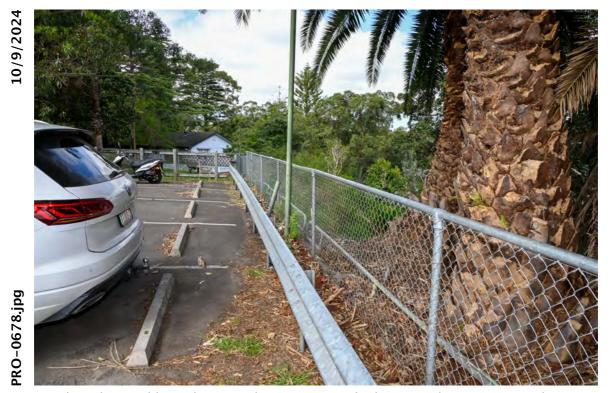
Southern hospital boundary. Heading east towards the unused swimming pool.
