Greenwich Hospital Redevelopment

Stage 1 - Early Works

DILAPIDATION REPORT

10th September 2024

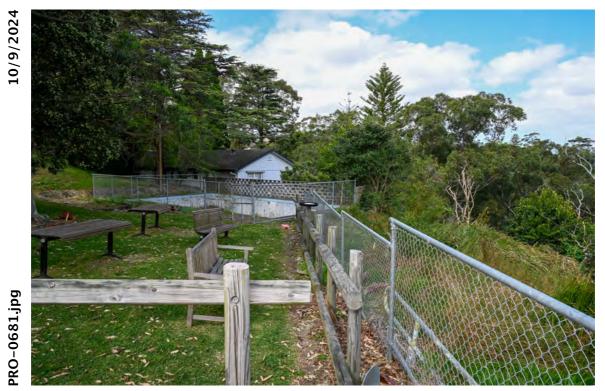
Southern hospital boundary. Heading east towards the unused swimming pool.

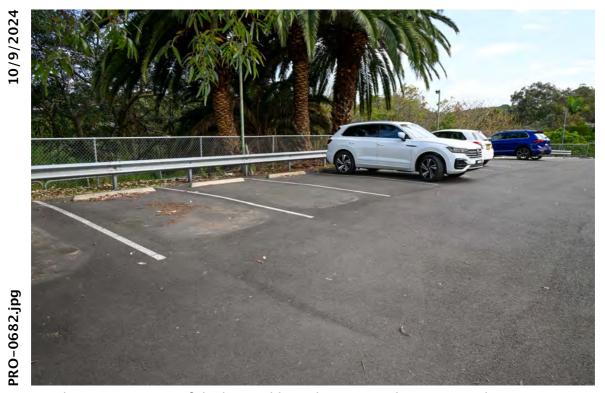
South-western corner of the hospital boundary. Car park. Facing north-west.

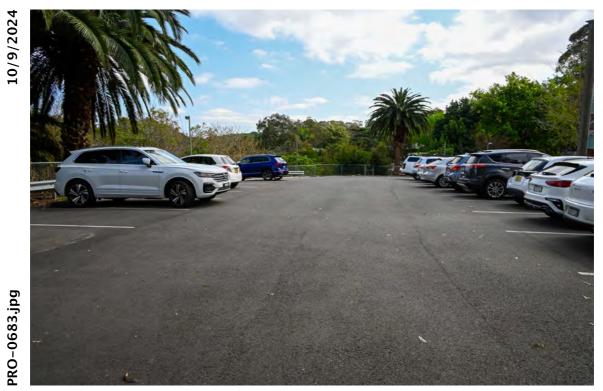
South-western corner of the hospital boundary. Car park. Heading north-west.

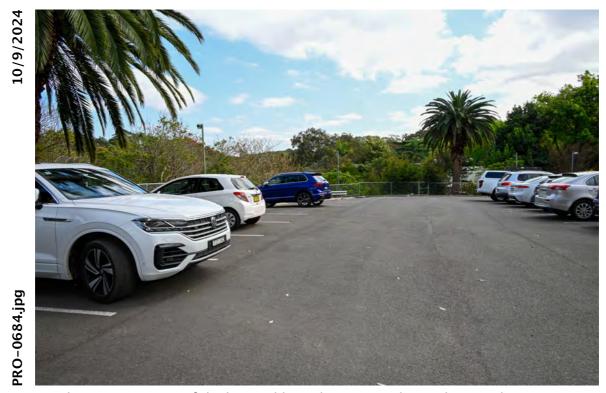
South-western corner of the hospital boundary. Car park. Heading north-west.

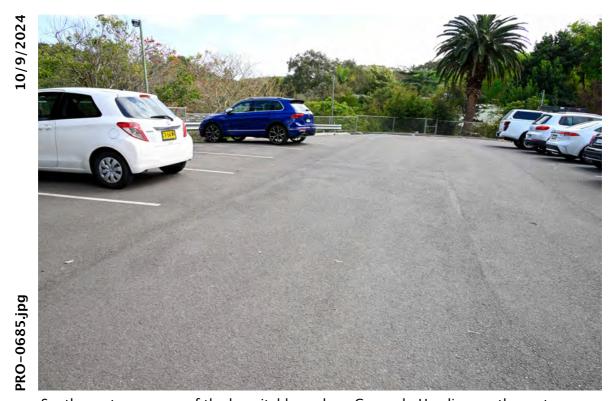
South-western corner of the hospital boundary. Car park. Heading north-west.

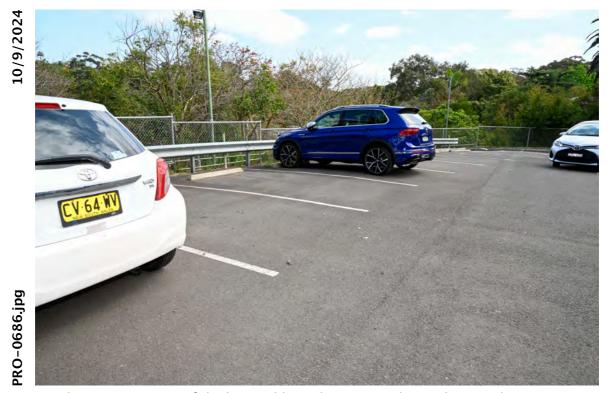
South-western corner of the hospital boundary. Car park. Heading north-west.

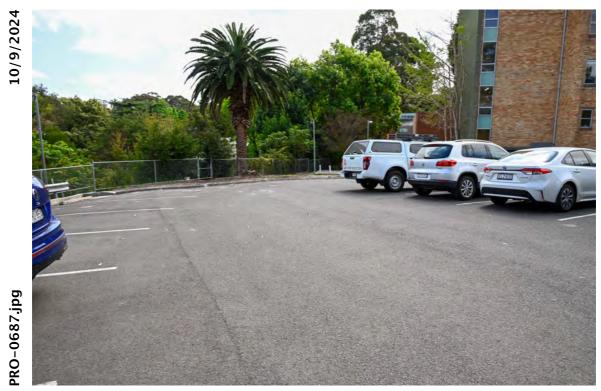
South-western corner of the hospital boundary. Car park. Heading north-west.

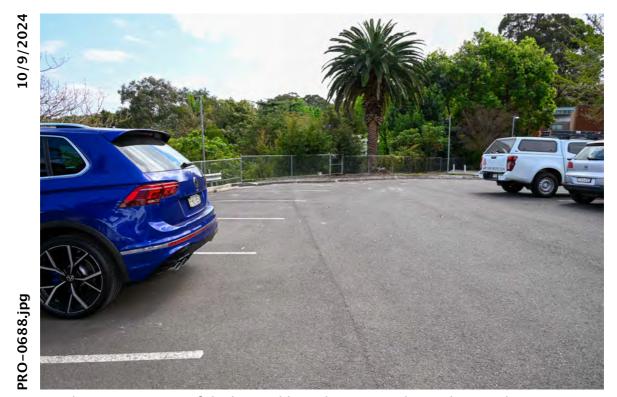
South-western corner of the hospital boundary. Car park. Heading north-west.

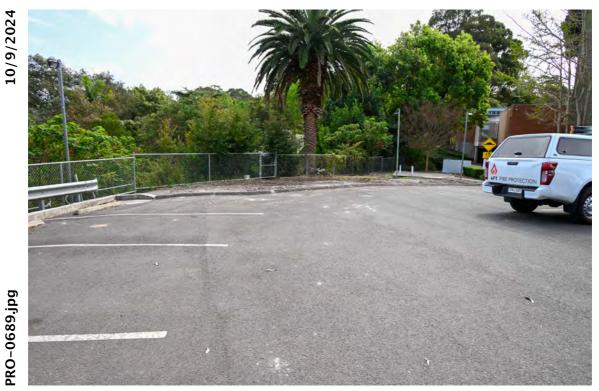
South-western corner of the hospital boundary. Car park. Heading north-west.

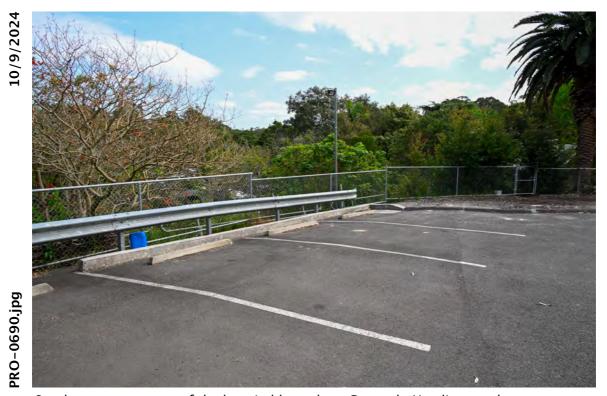
South-western corner of the hospital boundary. Car park. Heading north-west.
